## INSPECTION REPORT – MUNICIPAL WASTE LANDFILL

Site I.D. 255983Site Name IESI PA BETHLEHEM LANDFILLAddress 2335 APPLEBUTTER RDMunicipality 8924 LOWER SAUCONResponsible Official SAMUEL DONATO, JR.Person Interviewed AL SCHLEYERInspector WALTER F. GOVERNeFACTS ID # PF 268729SF 266826

Date of Inspection 06/16/2014 Identification Number 100020

**Case:** IESI Storm Water Incident  
**Location:** 2335 Applebutter Road  
**Municipality:** Lower Saucon Township  
**County:** Northampton  
**Date / Time:** 06/16/2014 / 1400  
**Photographer:** Walter F. Govern III

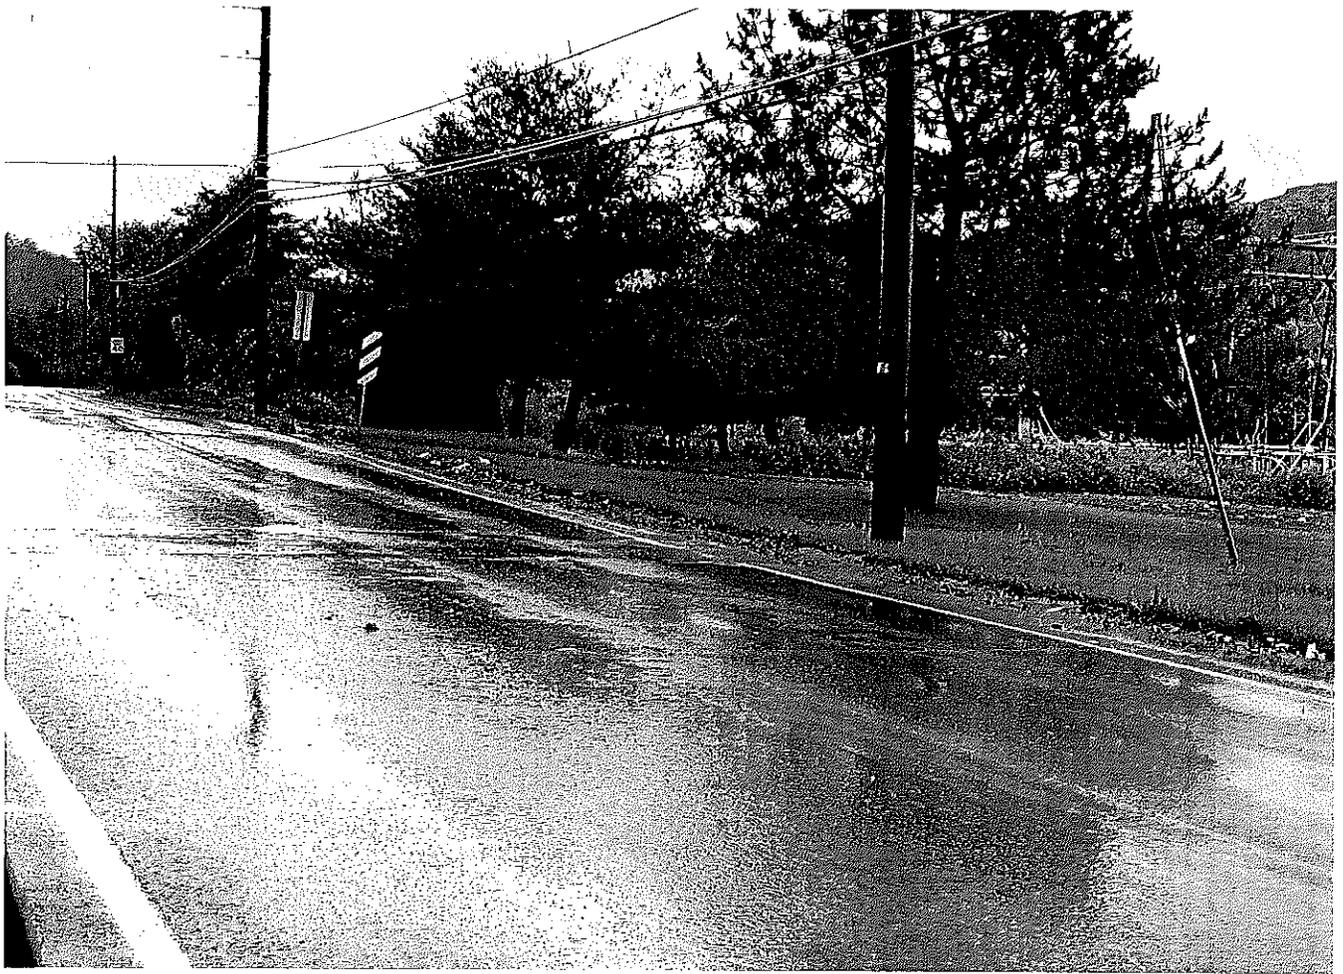
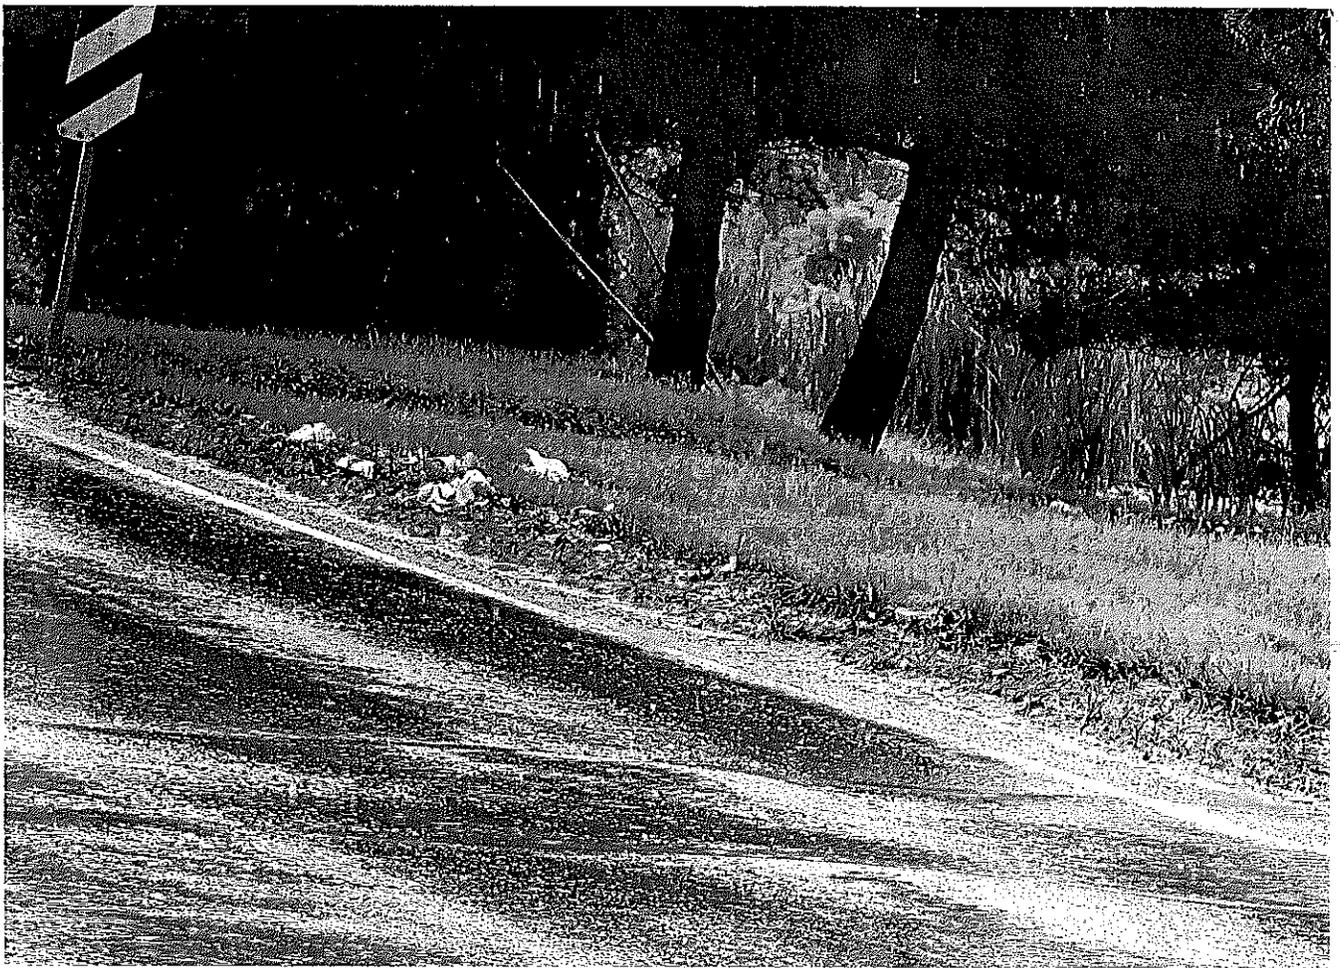
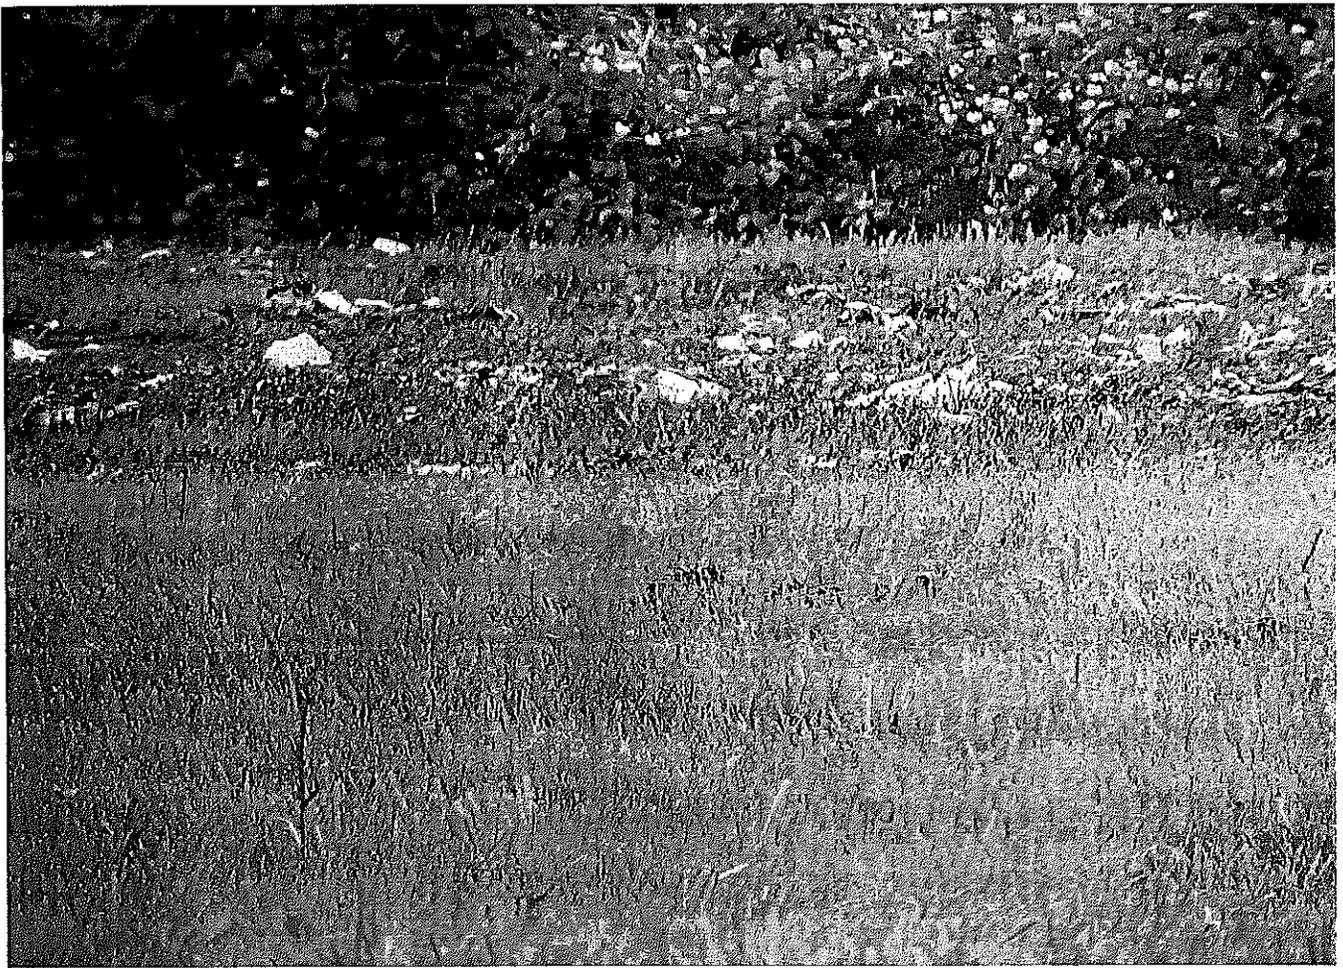
I understand that there was a mudslide at the landfill on Friday afternoon. A resident called me to let me know around 4 pm. I did drive out there and saw workers cleaning up the area inside the landfill, on Applebutter road and the surrounding area with equipment. I also notice lots of trash, etc. mixed in the mud along the road and in a large section of the grassy area across the street from the entrance to landfill.

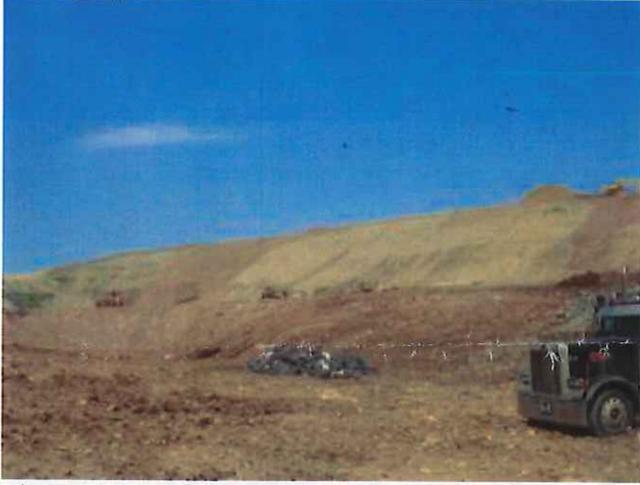
View of the western slope, no significant erosion channels observed.

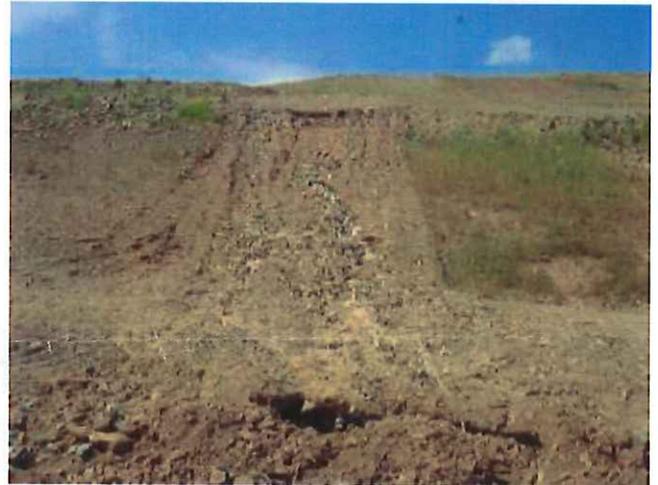
Close-up of the erosion channel from the previous photo.

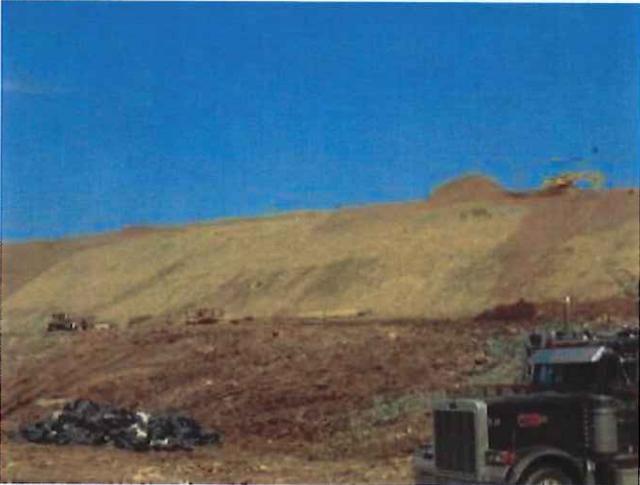
View of the western slope, no significant erosion channels observed.

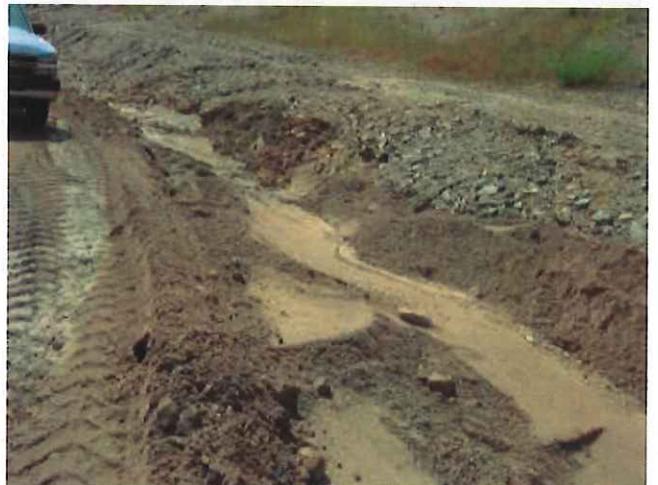
Sediment in the storm water (SW) channel heading east along the southern slope of the landfill. Looking west towards the erosion channel from the previous photos.

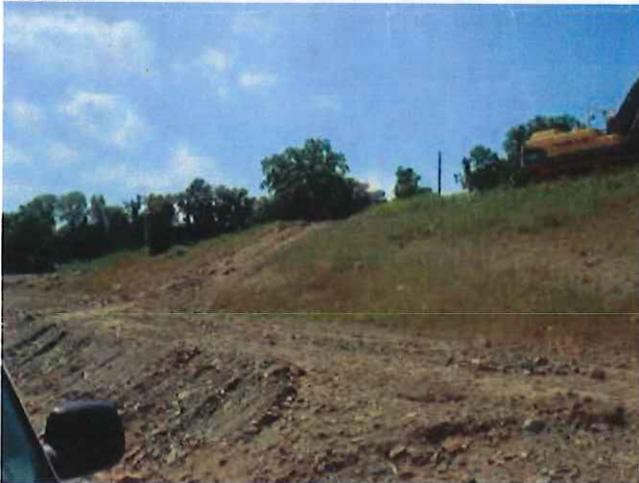
Erosion channel at the corner of the western and southern slopes of the landfill.

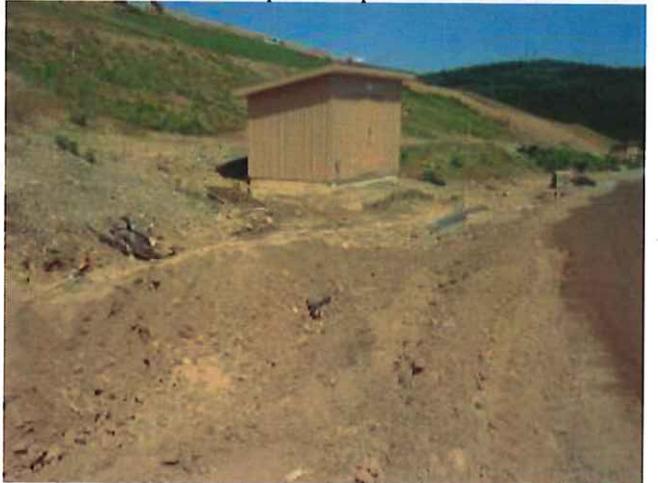
SW Channel looking east to Pumphouse 2 (pictured)

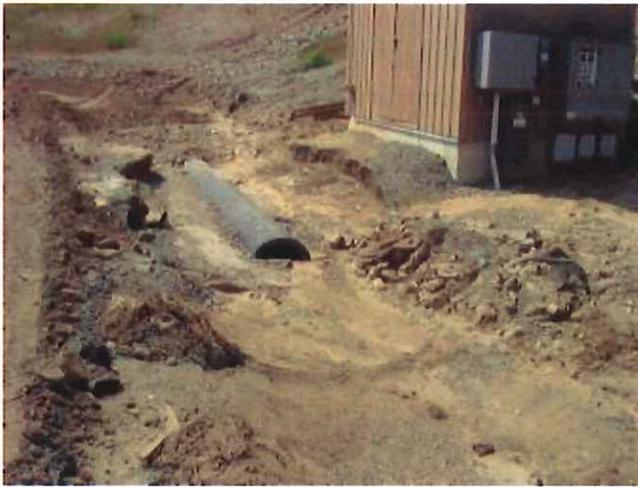
Silted over pipe in front of Pumphouse 2.

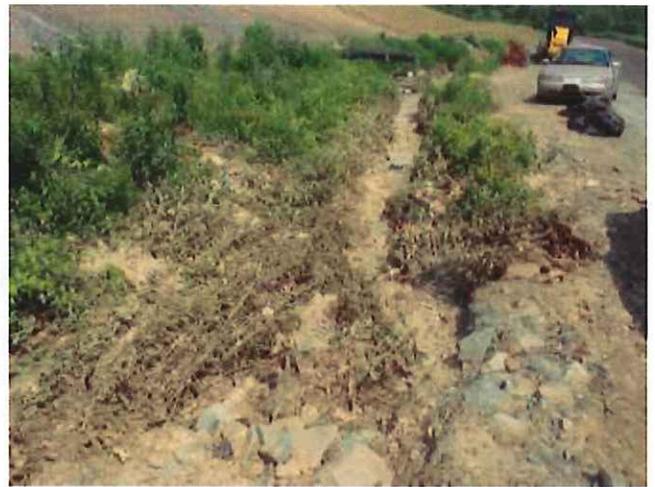
Photo of sediment in the SW channel, picture looking southeast.

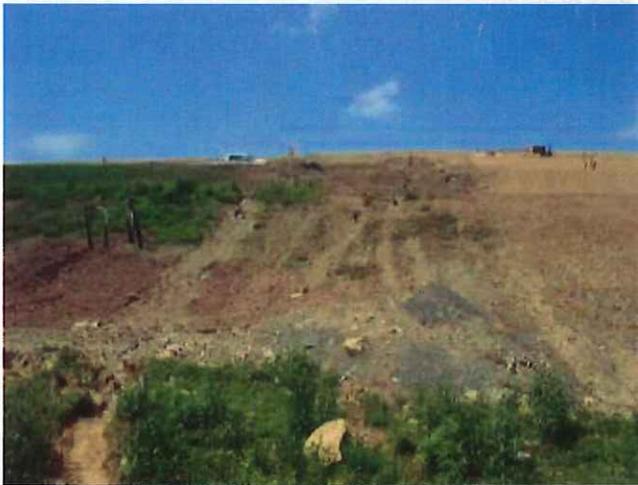
Erosion Channel on the southern slope east of Pumphouse 2.

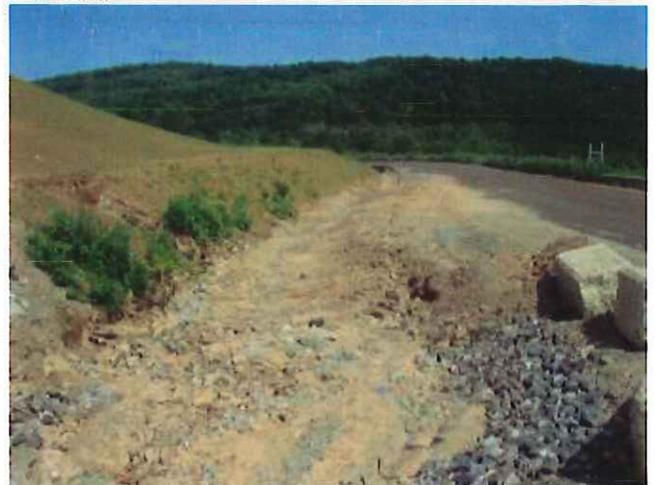
Following the SW channel again looking southeast to the eastern corner of the southern slope.

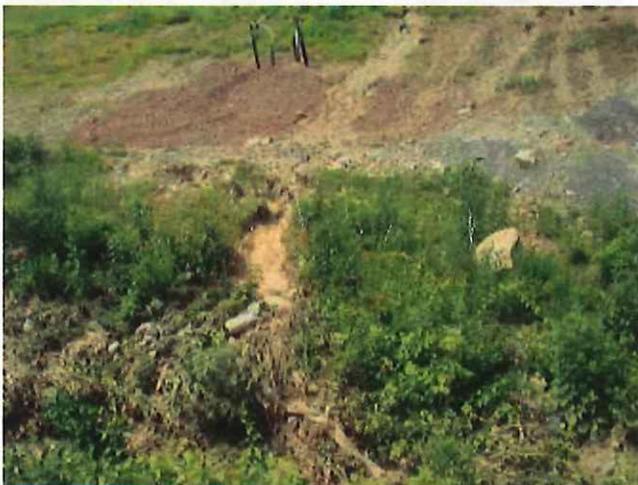
Close-up of erosion through the vegetation below the erosion channels pictured above.

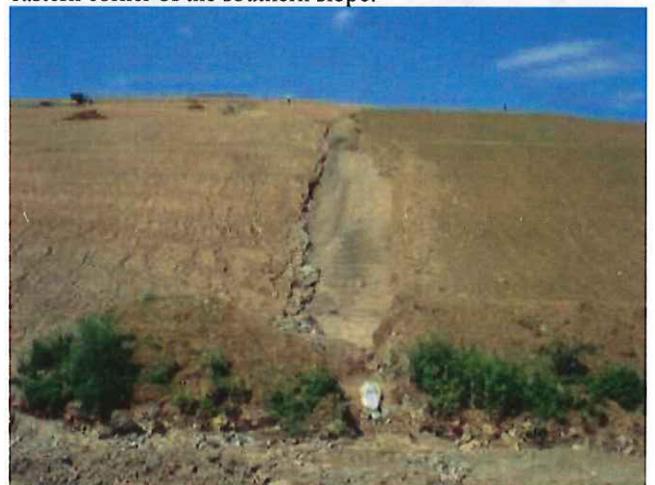
Erosion at the tie-in of the new cap area on the southern slope.

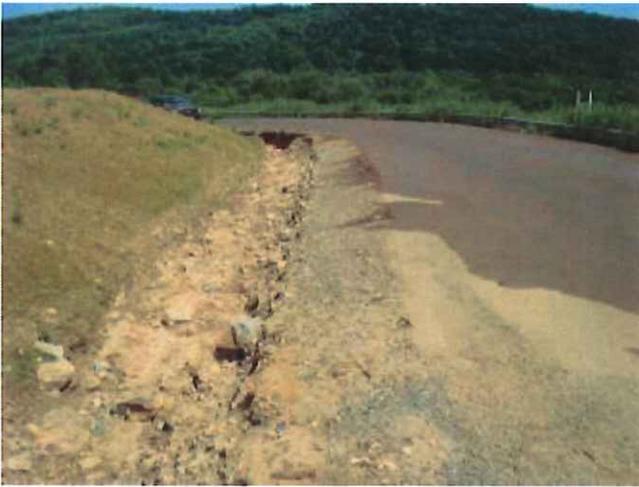
Following the SW channel again looking southeast to the eastern corner of the southern slope.

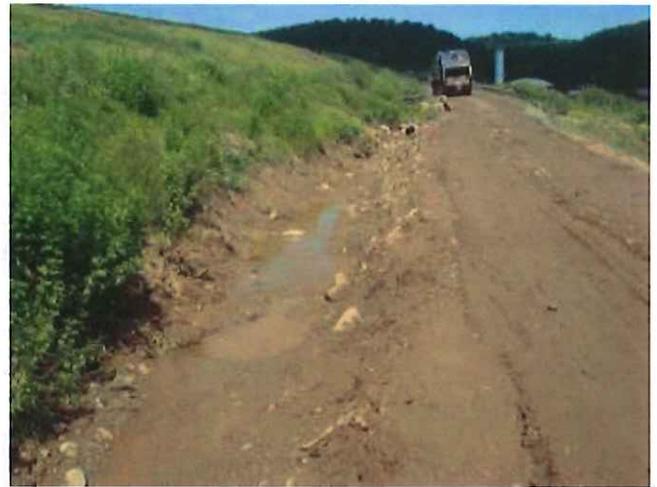
Following SW channel past Pumphouse 1 towards the inlet pipe to basin 4.

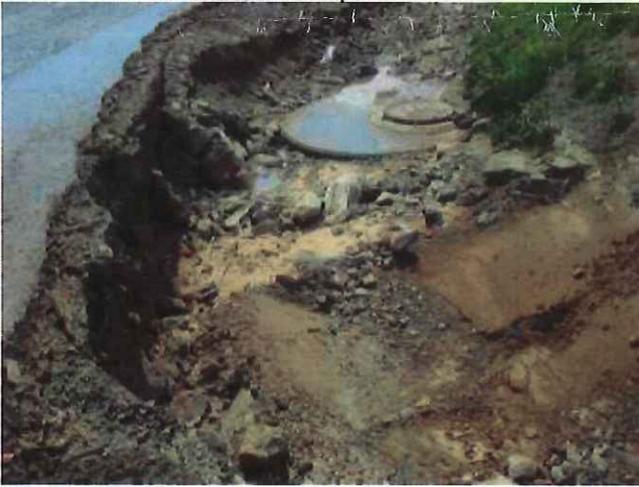
Ersosion of the SW Channel at the corner mentioned above.

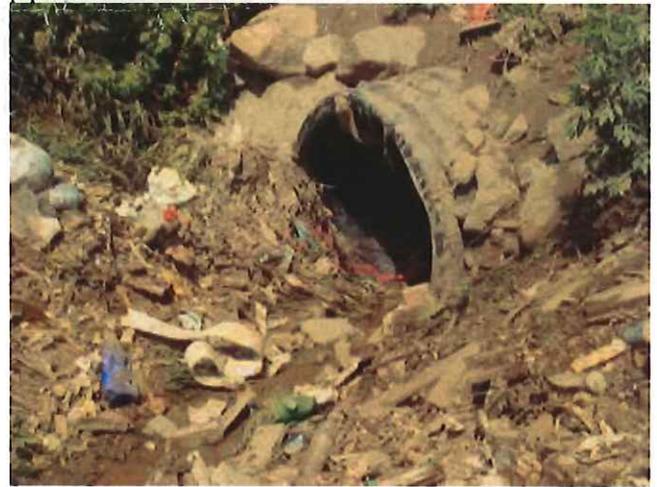
Close-up of inlet pipe to basin 4 from the SW channel side of the pipe.

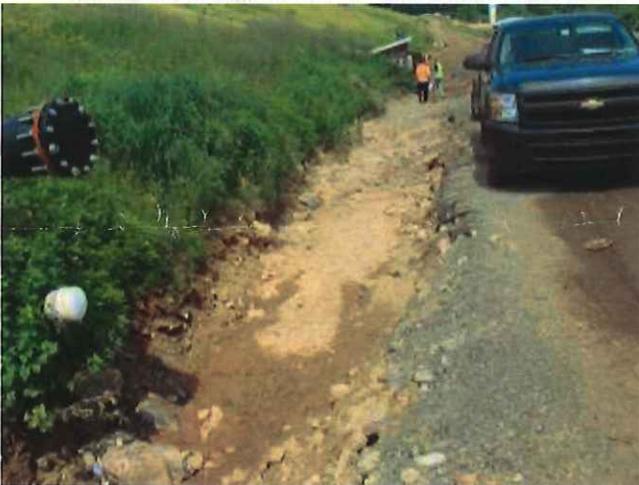
Following the SW channel looking east Pumphouse 1.

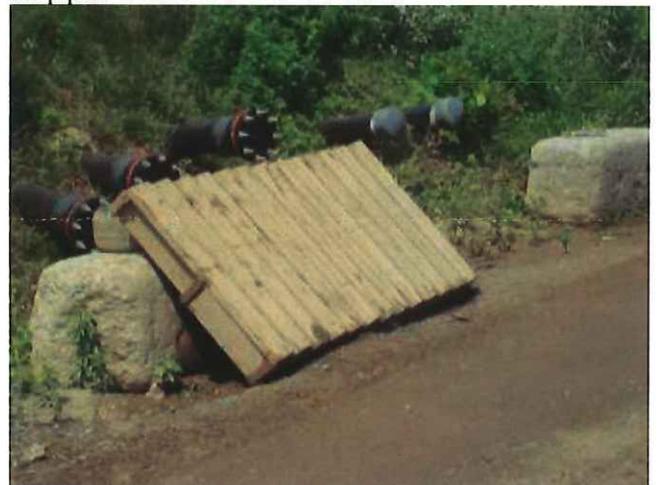
Floating walkway that was washed down the SW channel from Pumphouse 1, that caused the partial blockage of the inlet pipe to basin 4.

**FOLLOW UP ACTION TAKEN:** Clean out SW channel and affected areas. Clean out storm water control devices, inlet boxes, trough at gate and connected piping. Redesign/evaluate different access to PS-1 to eliminate potential for floating/removable access structure.

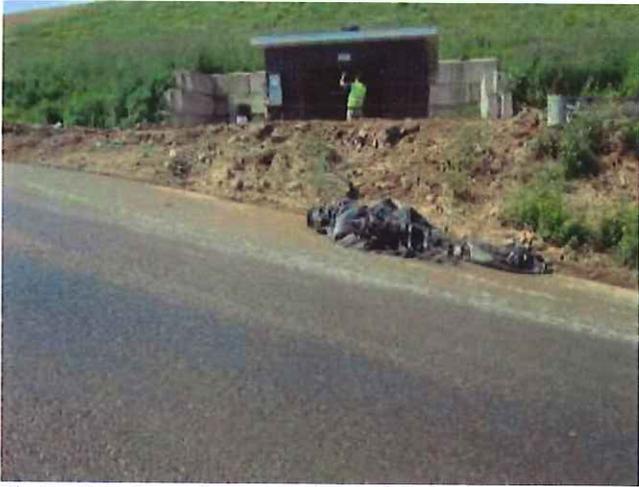
Photo of erosion, where water jumped the bank of the storm water channel and traveled towards the working face western access road.

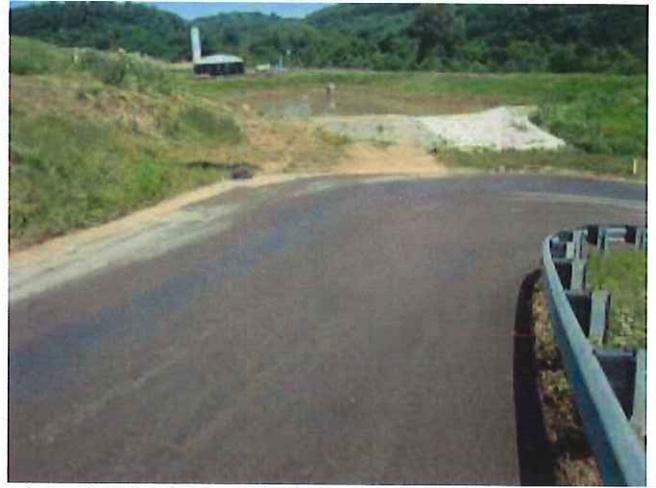
View of Basin 4 from the western access road. Photo shows the access road is clear of sediment and passable.

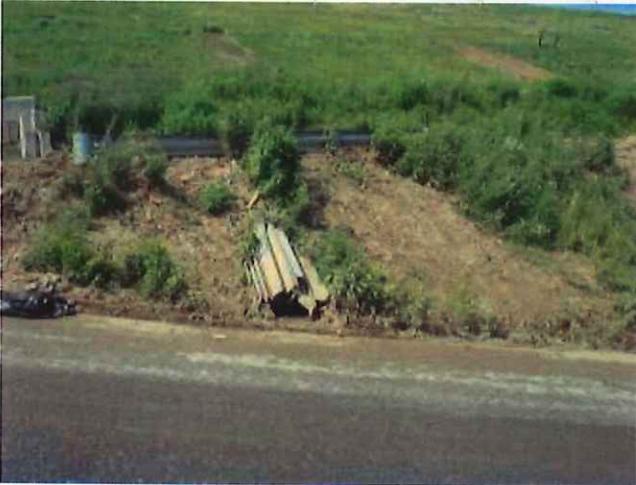
Sedimentation in the vegetation of the north bank to the western access road.

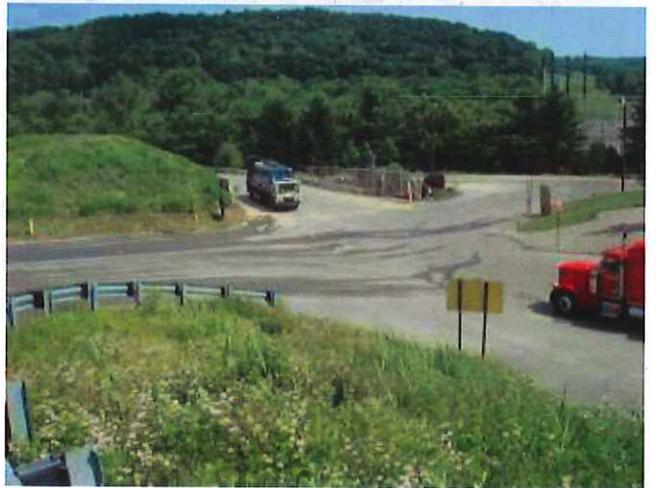
Access road heading south to the entrance to the landfill. Road is clear of sediment at the time of this inspection.

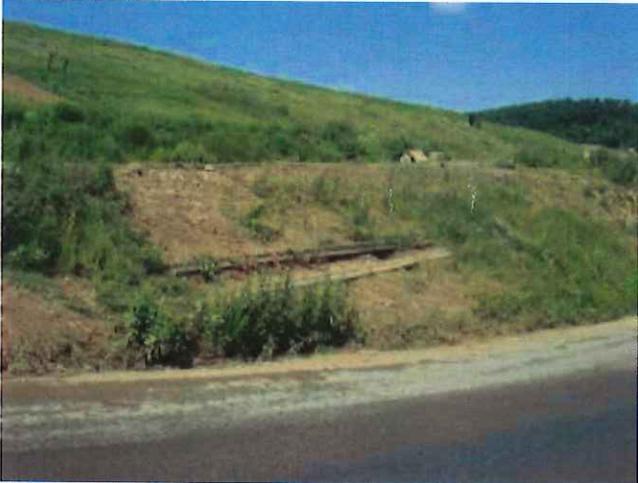
Sedimentation in the vegetation of the north bank to the western access road.

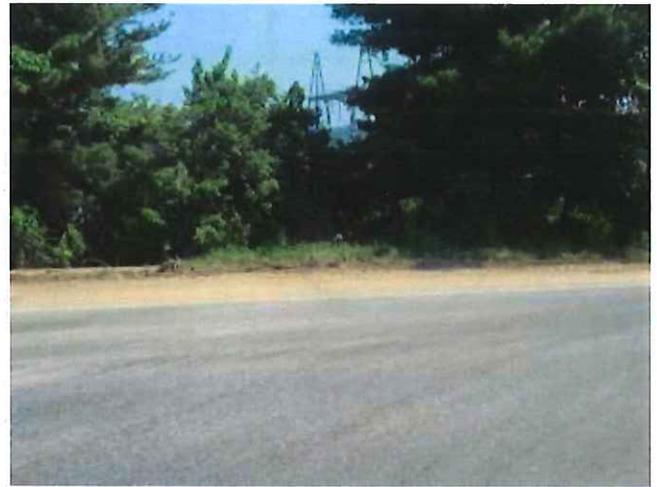
Photo 2 of 3 showing sediment along the southern side of Applebutter Road across from the IESI entrance.

This inspector observed a deposit of silt on the south side of Applebutter Road across from the entrance to IESI. This deposit of silt should also be included in IESI clean-up plans. Lower Saucon Township Host Municipality Inspector, Chris Taylor of Hanover Engineering, conducted a follow-up inspection on June 16, 2014. Mr. Taylor was not present at the landfill during the time of this inspector's inspection. Mr. Taylor's comments regarding this incident are attached to this inspection report.

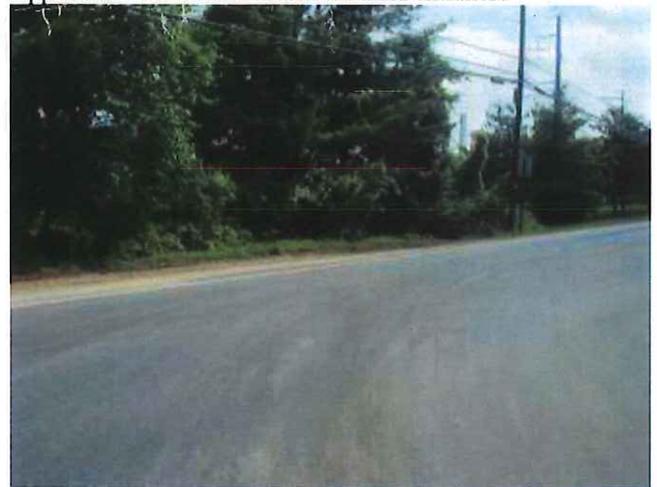
Photo 3 of 3 showing sediment along the southern side of Applebutter Road across from the IESI entrance.

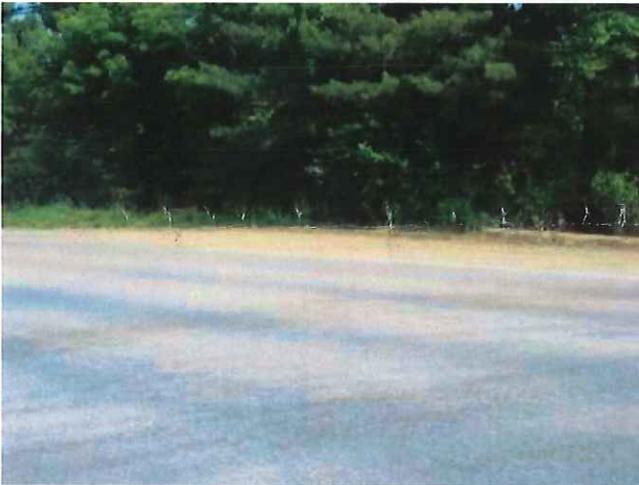
Photo 1 of 3 showing sediment that should be cleaned-up along the southern side of Applebutter Road across from the IESI entrance.

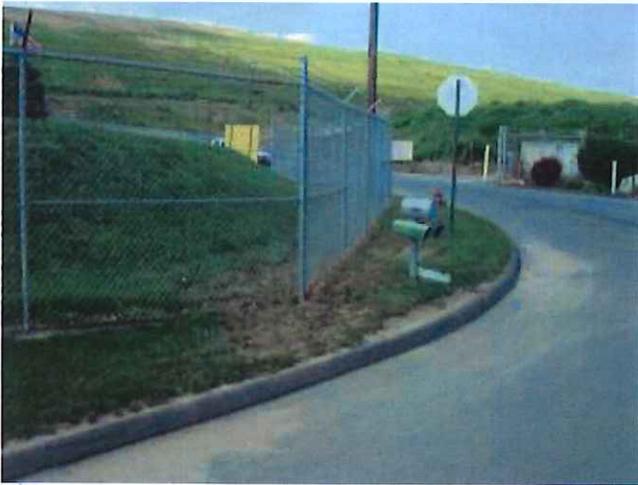
Photo along the perimeter fence at the entrance to the landfill showing path of storm water.

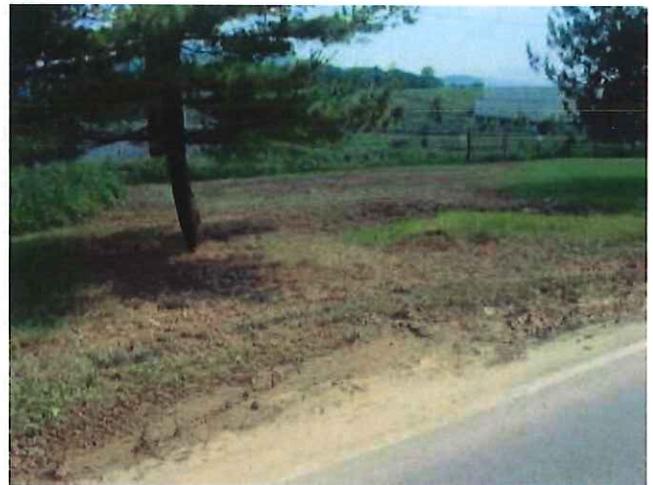
Photo showing the path of storm water onto the neighboring property owned by Calpine.

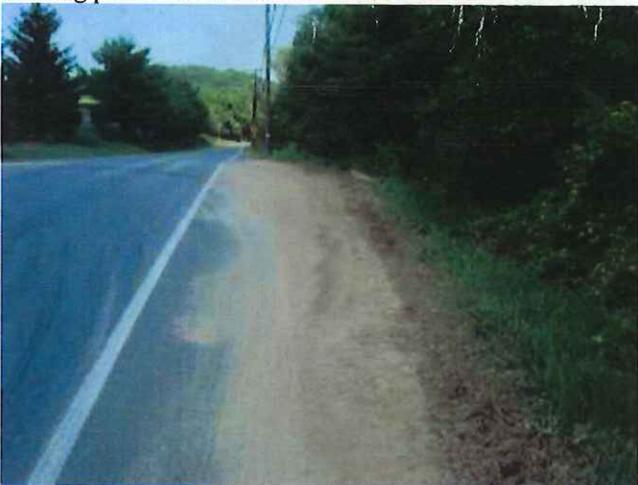
Photo showing sediment along the southern side of Applebutter Road across from the IESI entrance looking east

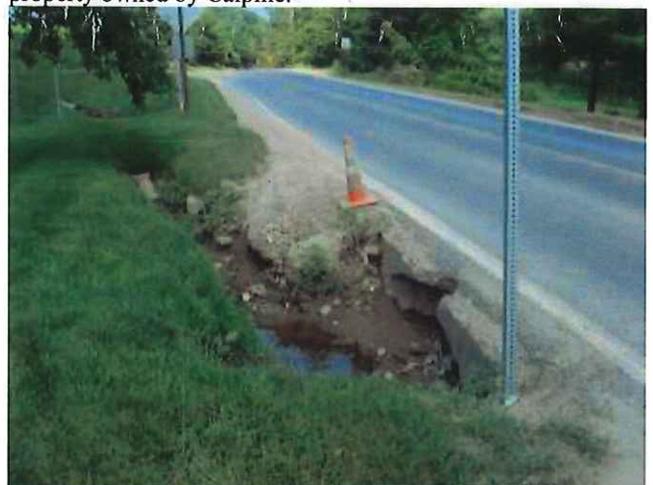
Storm water pipe traveling under Applebutter Road. Photo looking west.

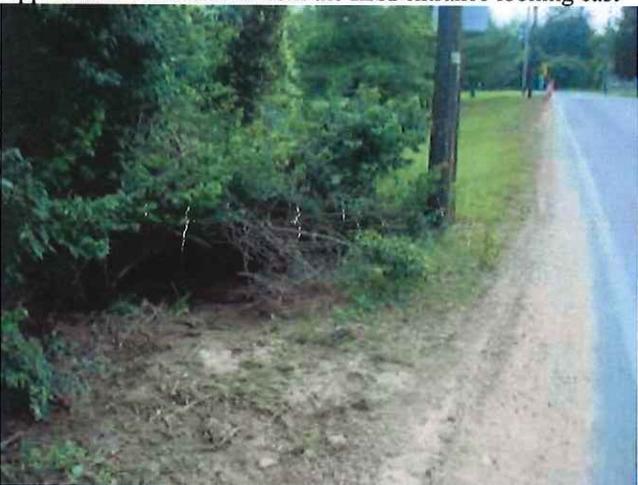
Sedimentation on the southern side of Applebutter road looking west.

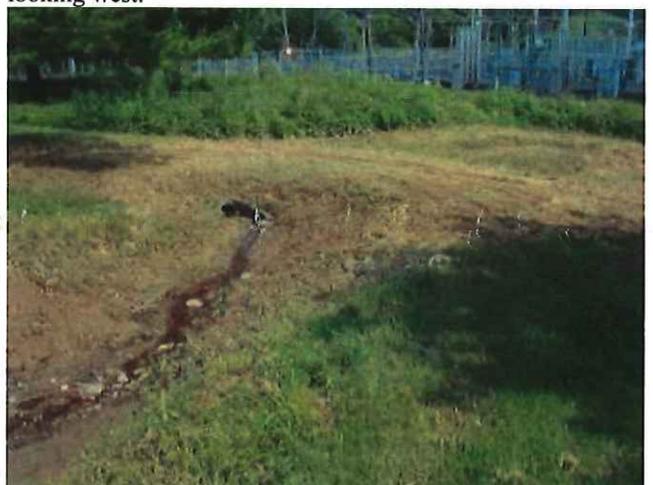
Storm water channel from the pipe from the previous photo.

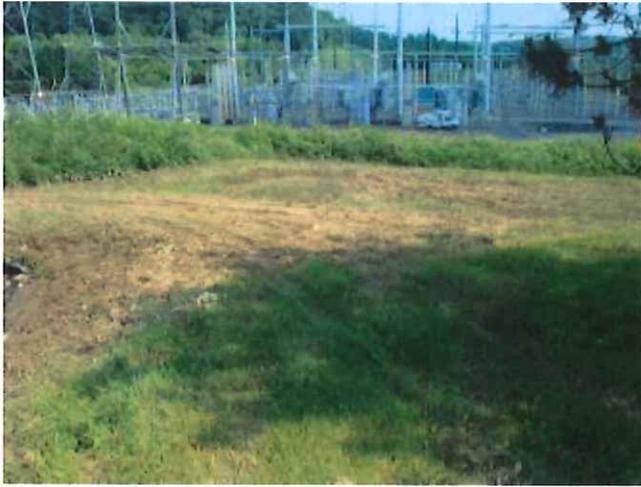
Photo 1 of 2 of area where litter was observed off-site by Ms. DeLeon. Litter is confirmed to be collected as of the time of this inspection.

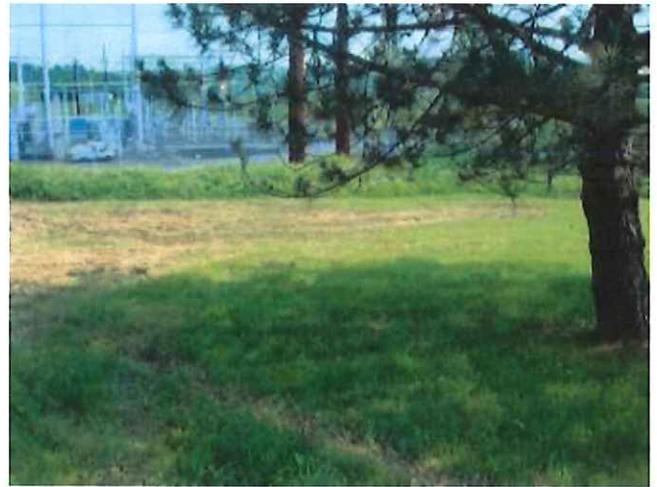
Photo 2 of 2 of area where litter was observed off-site by Ms. DeLeon. Litter is confirmed to be collected as of the time of this inspection.

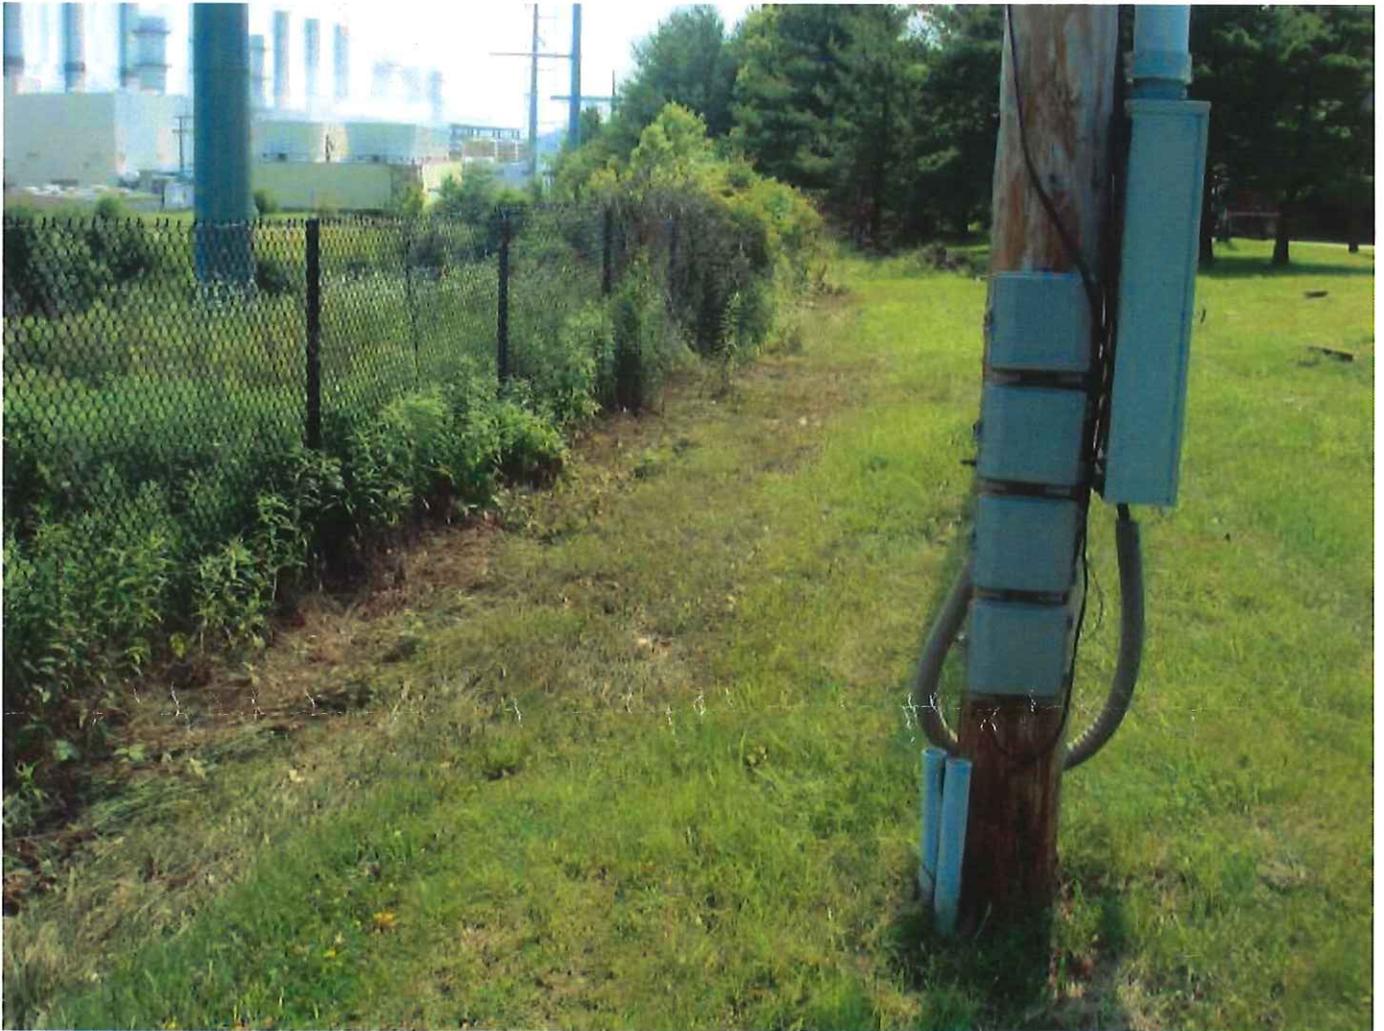
End of visible area of the path of storm water from the incident that occurred at IESI.
