50 YEARS Hanover Engineering

September 10, 2020

RE: Inspection Conducted on September 3, 2020
IESI Bethlehem Landfill
Hanover Project LS90-7

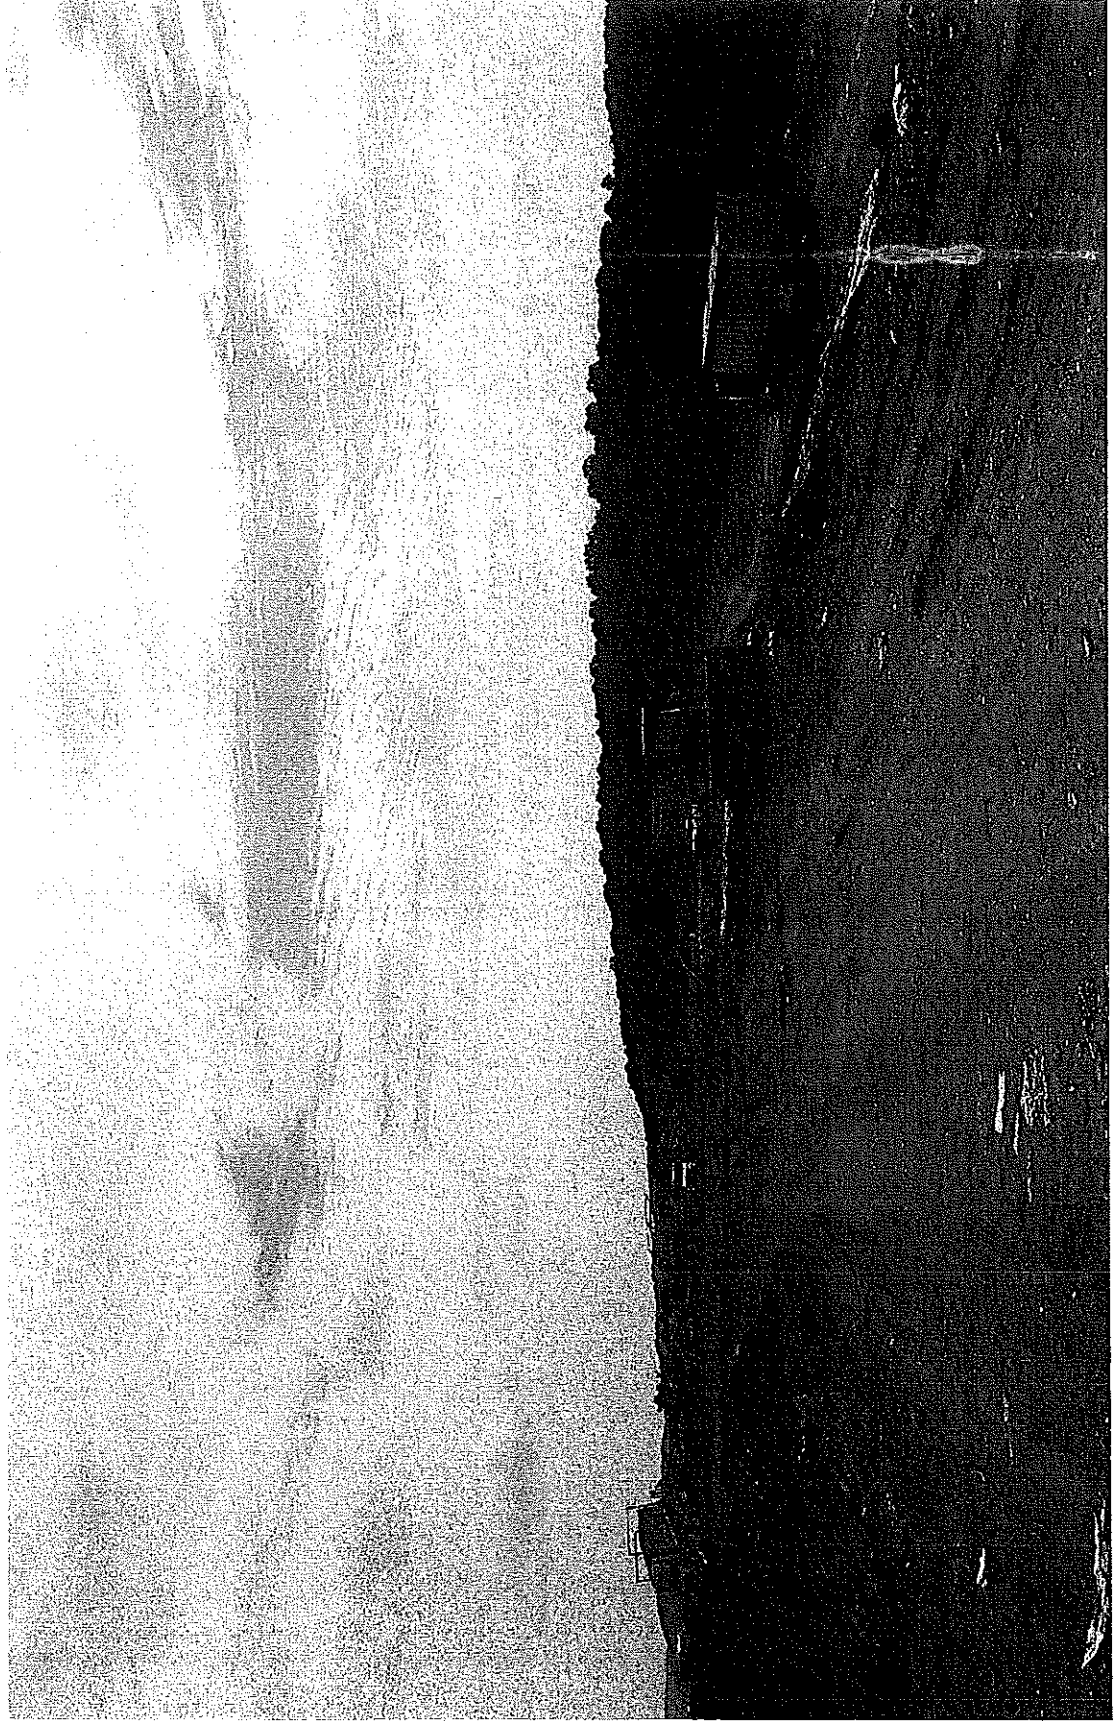
Photo 1

6. The truck wash was open and being utilized.
7. One (1) picker was observed working on site to remove blown litter from the north slope of the working face. Temporary litter fence was in place at several locations around the working face (See photo 1 for fencing).

8. Garbage was being disposed at the top of Cell 1B, see photo 1. The approach to and departure from the working face was stable and passable. The trailer tipper was in use. Trucks were also unloading waste conventionally. One (1) compactor was working in the garbage. One (1) dozer was spreading soil to spread cover on the south face near the working face. Very slight garbage odor was detected while we were at the top of the landfill observing the daily operation two hundred (200) yards west of the working face.

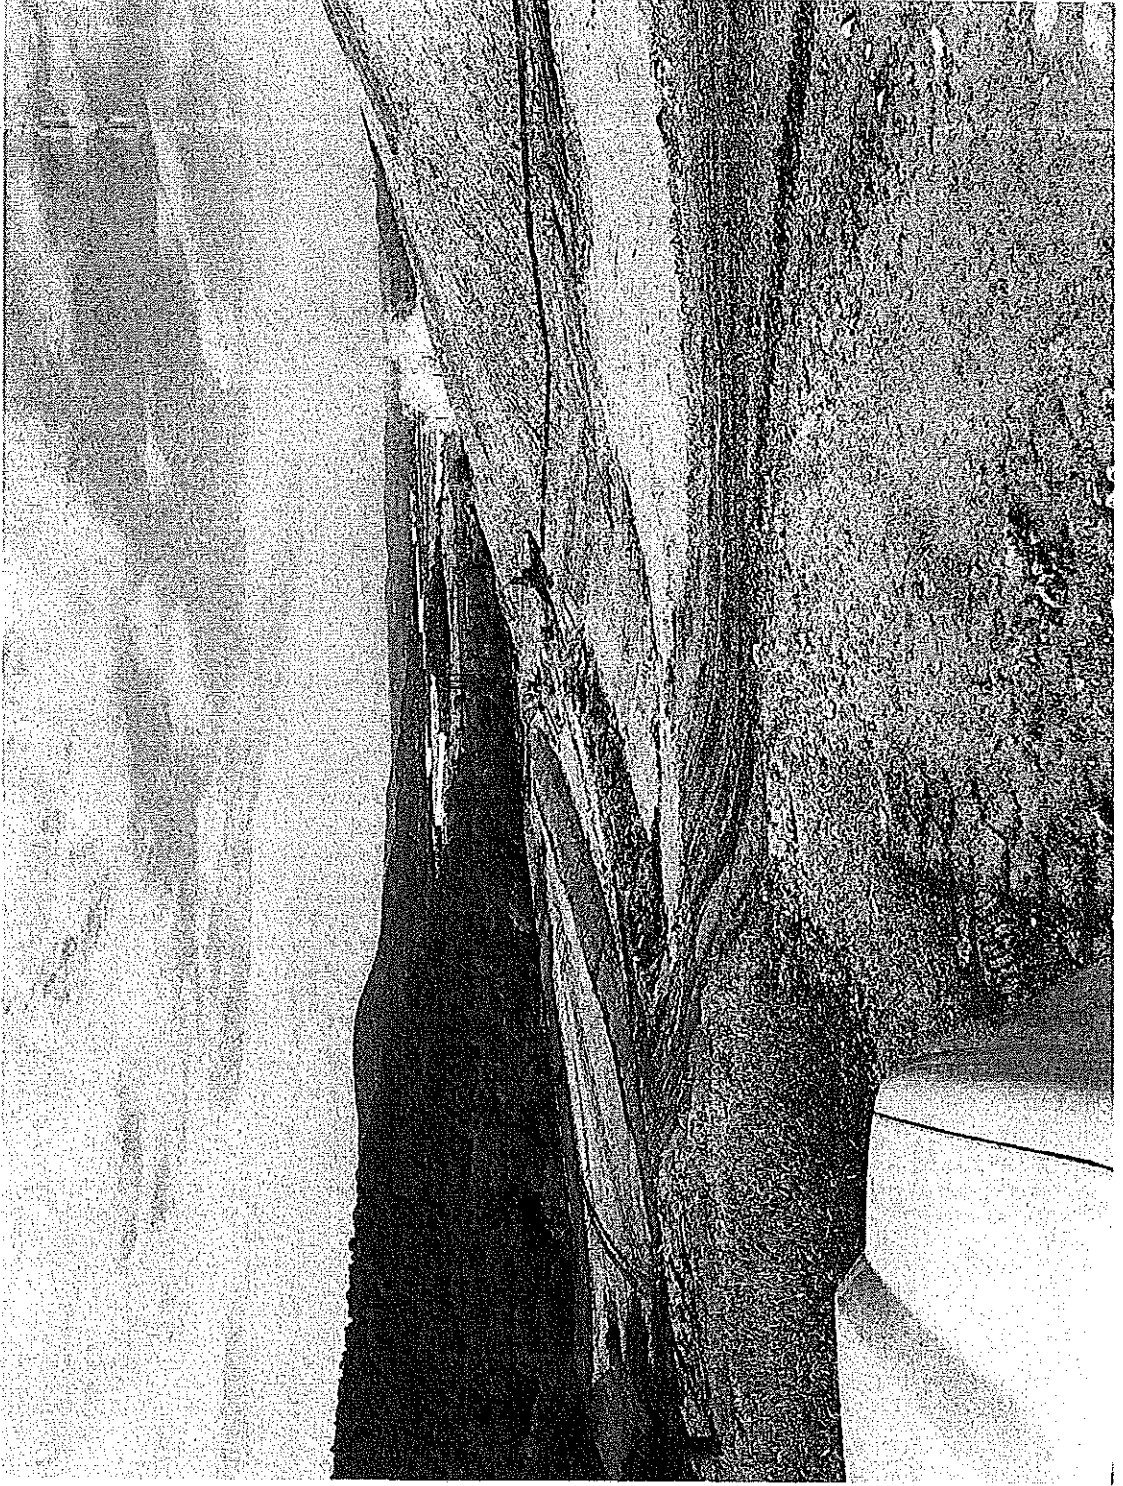
Photo 2

15. Work on the MSE wall at the southern end of Cell 1A and 1B is almost completed (See photo 2). Anticipated completion by the end of September.
16. All materials for the final capping of the area noted in the April DEP NOV are on site with possible start of construction by the beginning of October.

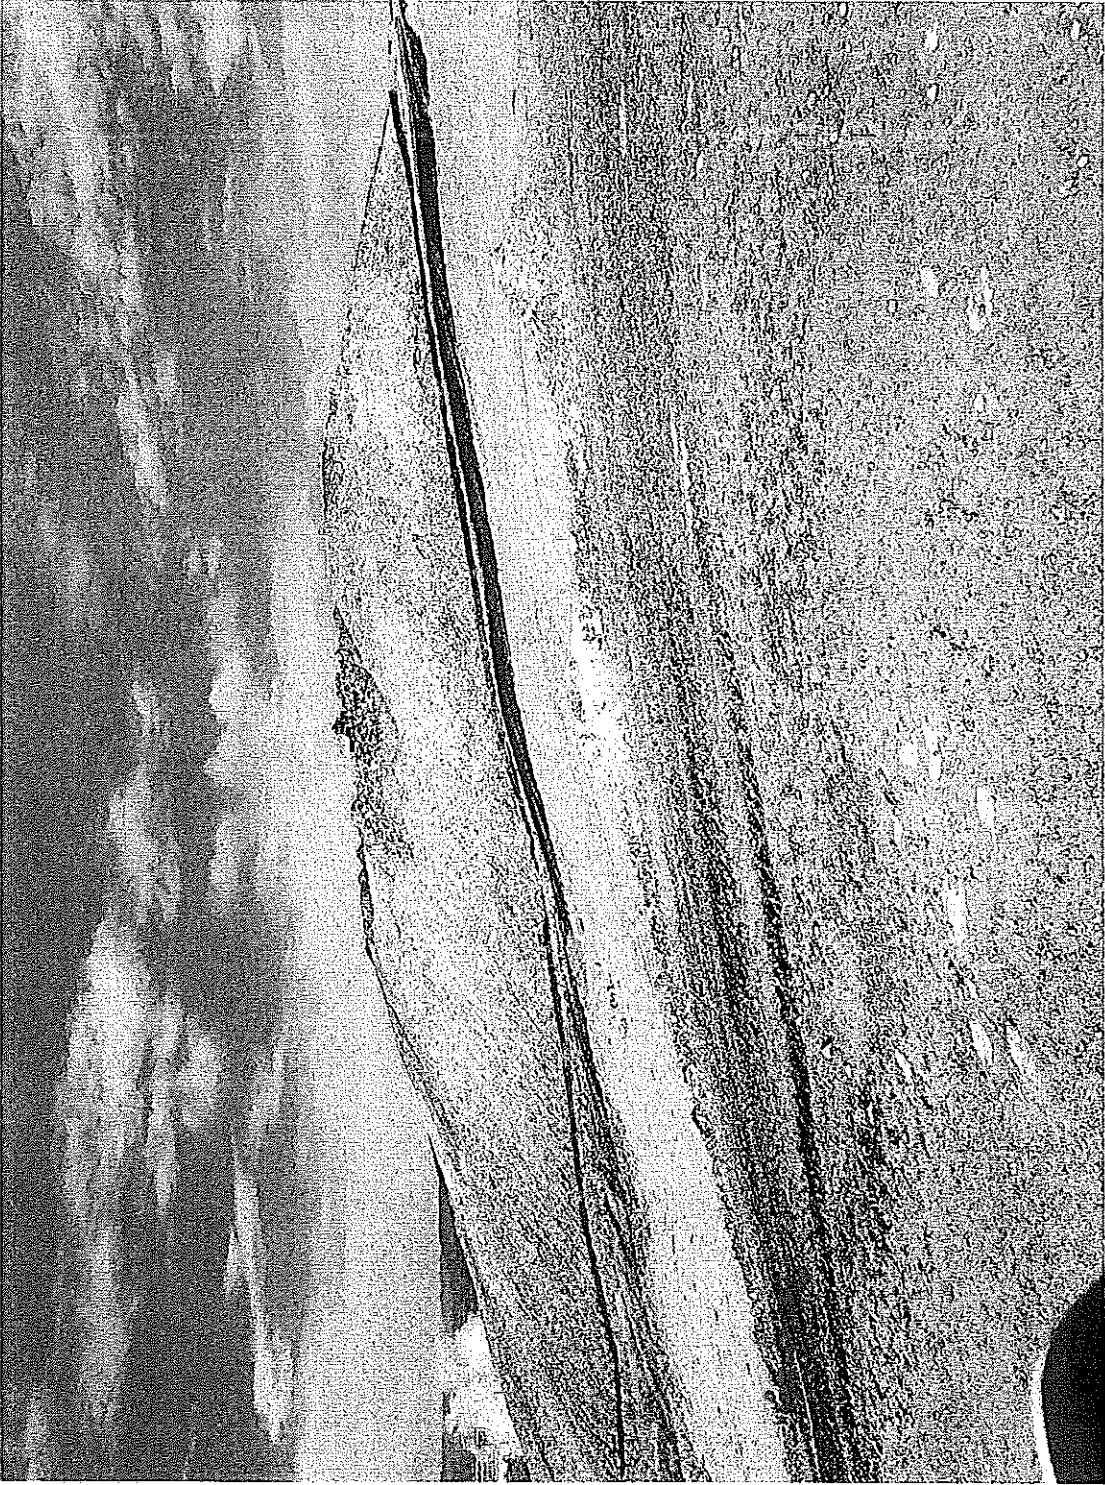
Photo 3

5. Stormwater is being controlled properly and no substantial erosion rills were observed. Since the August 4th hurricane, the north slope access road has been repaired, the intermediate cover erosion rills on the southern slope of cell 1B have been graded out (See photo 3) and the stormwater collection system for cell 3A that drains to sedimentation pond #1 has been repaired.
