50 YEARS Hanover Engineering

October 4, 2021

RE: Inspection Conducted on September 16, 2021
Bethlehem Landfill
Hanover Project LS90-7

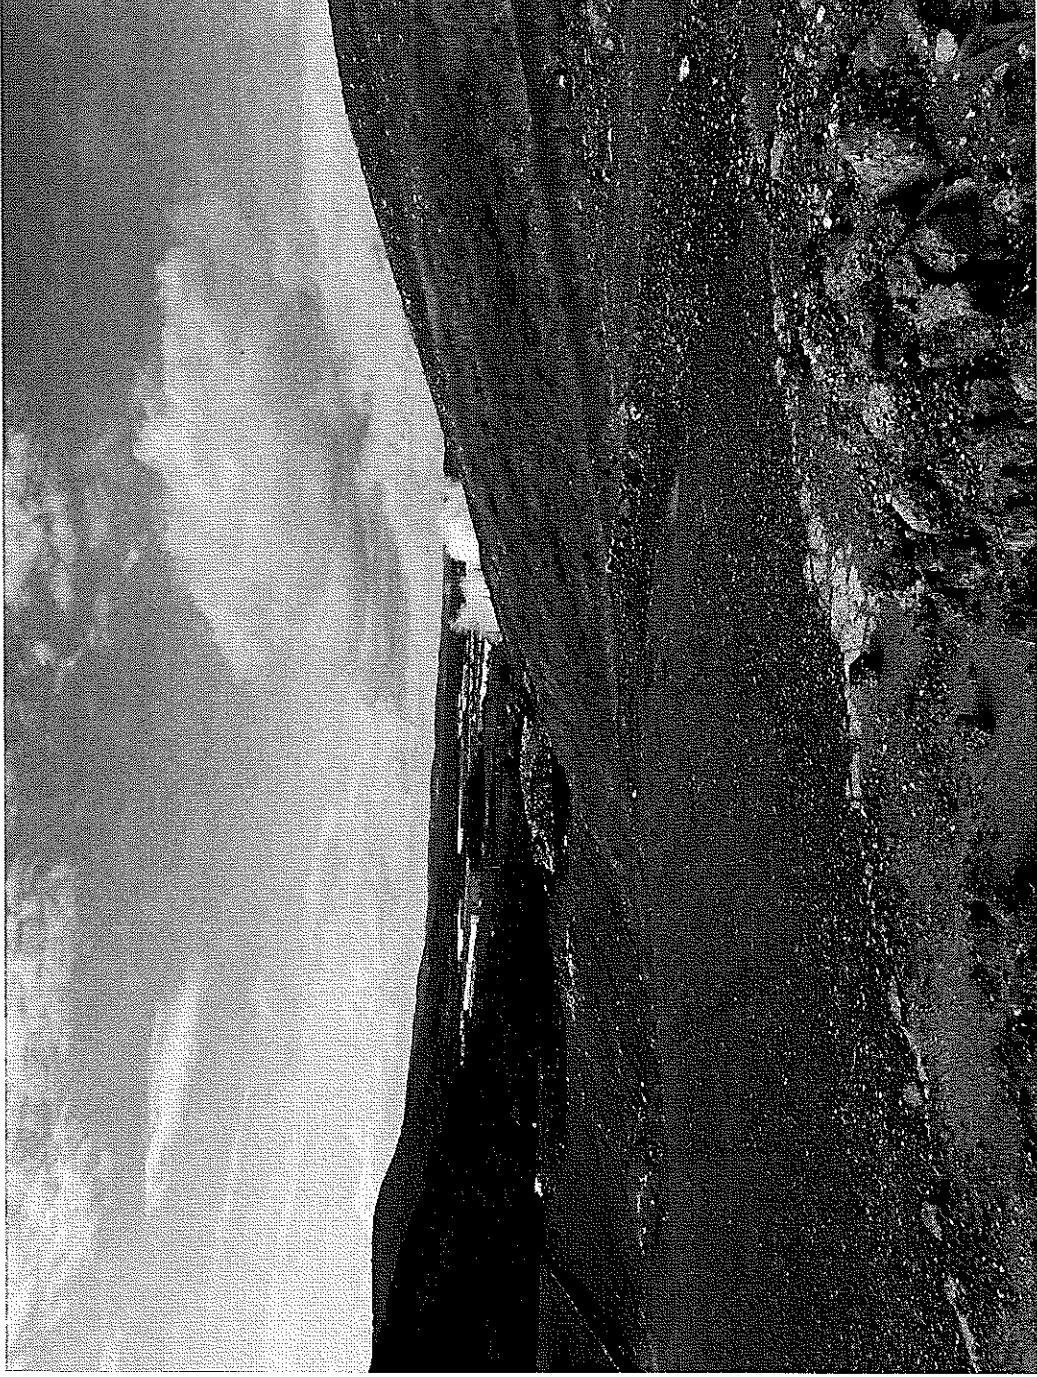
Photo 1

6. The truck wash was observed in use. The shaker grate is being utilized.
7. Garbage was being disposed in Cell SE2-AB Phase 1 (see Photo 1) looking from the top of the cell southward). The approach to and departure from the working face was stable and passable with a pickup truck. The trailer tipper was in use on the north end of the cell. One (1) compactor and one (1) dozer were working in the garbage at this location. No garbage odor was detected at the north end of the cell. Portable litter fencing is being utilized.

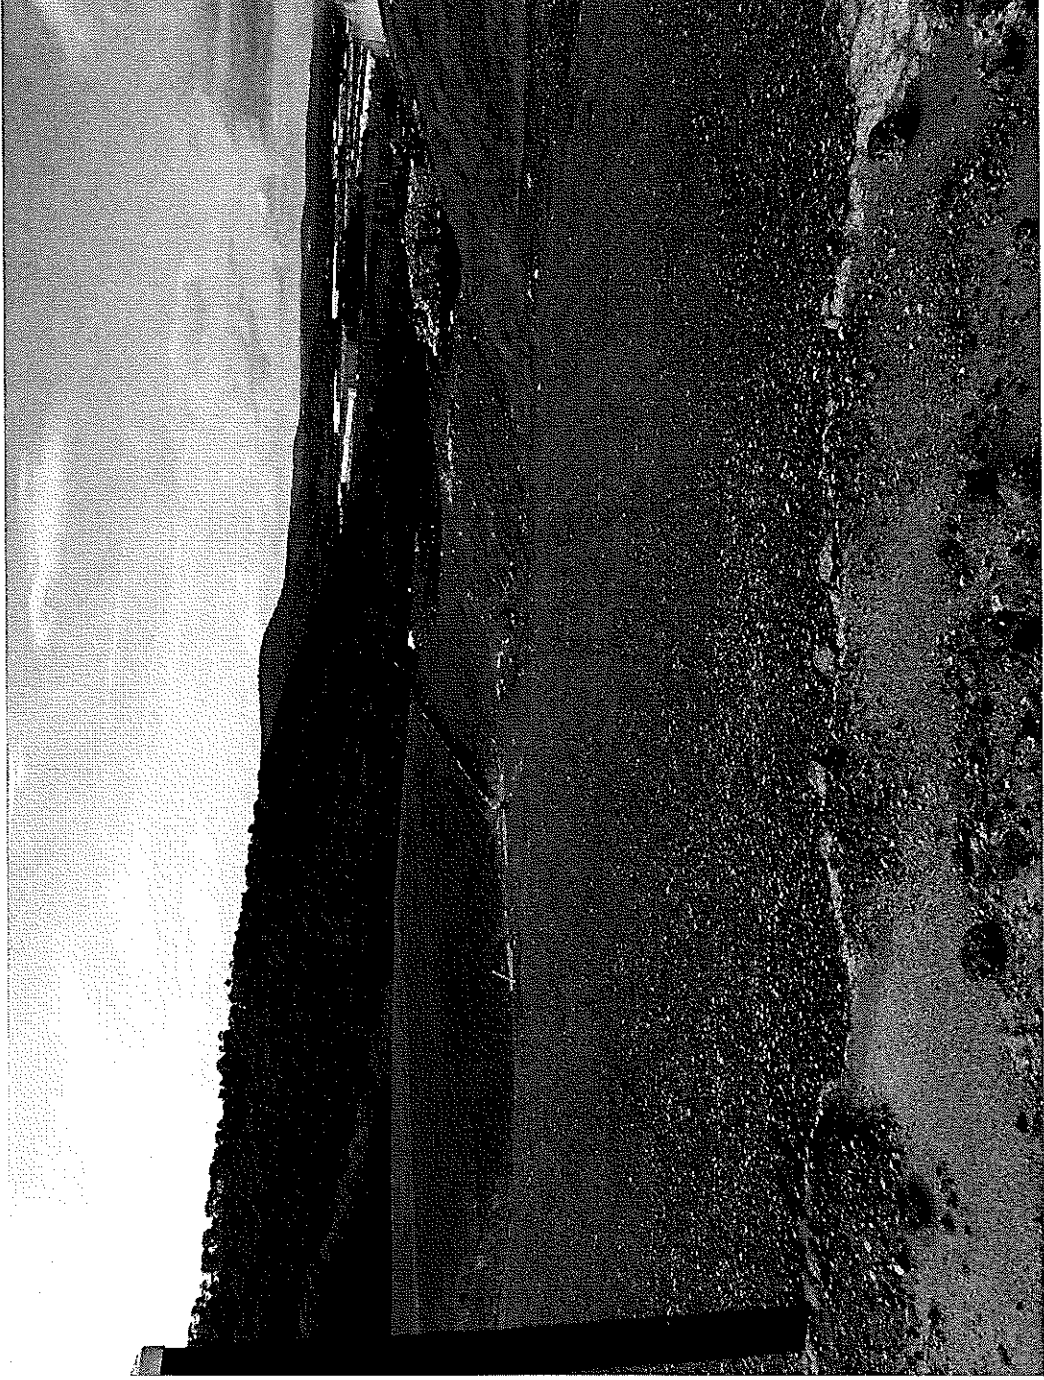
Photo 2

- A. The erosion rills throughout the newly constructed subbase for Cell SE2-A have ben substantially repaired, but the mud will have to be cleaned out of the sump when it dries out (see Photo 2).
