50 YEARS Hanover Engineering

November 17, 2021

RE: Inspection Conducted on October 21, 2021
Bethlehem Landfill
Hanover Project LS90-7

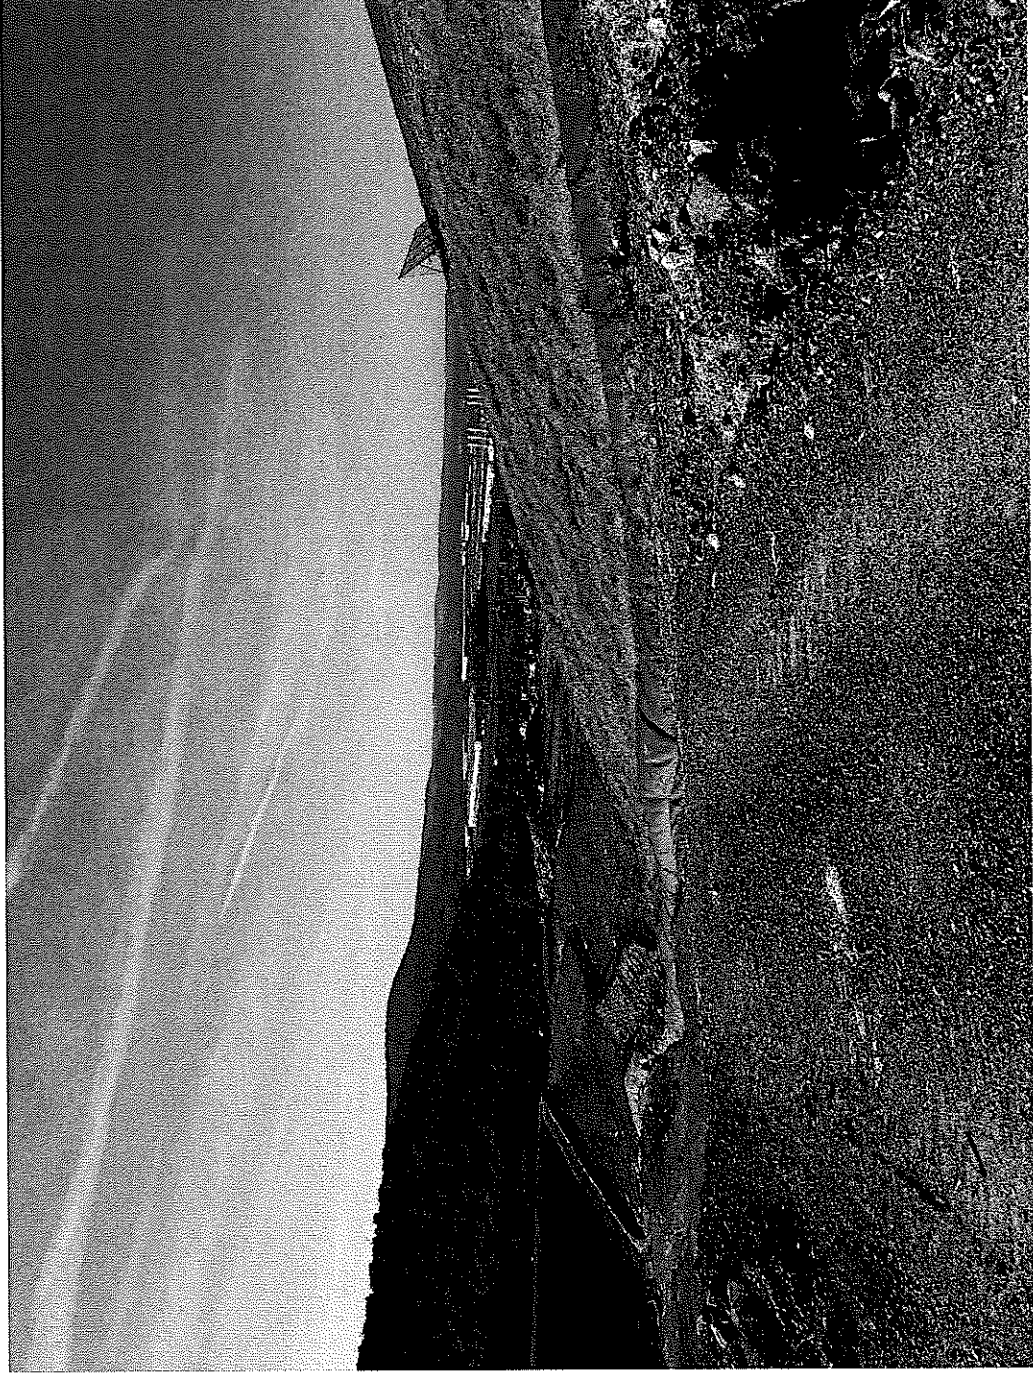
Photo 1

6. The truck wash was observed in use and the shaker grate is being utilized.
7. Garbage was being disposed in Cell SE2-AB Phase 1 (see Photos 1) looking from the top of the cell to the southeast). The approach to and departure from the working face was stable and passable with a pickup truck. The trailer tipper was in use on the north end of the cell. One (1) compactor and one (1) dozer were working in the garbage at this location. No garbage odor was detected at the north end of the cell. Portable litter fencing is being utilized.

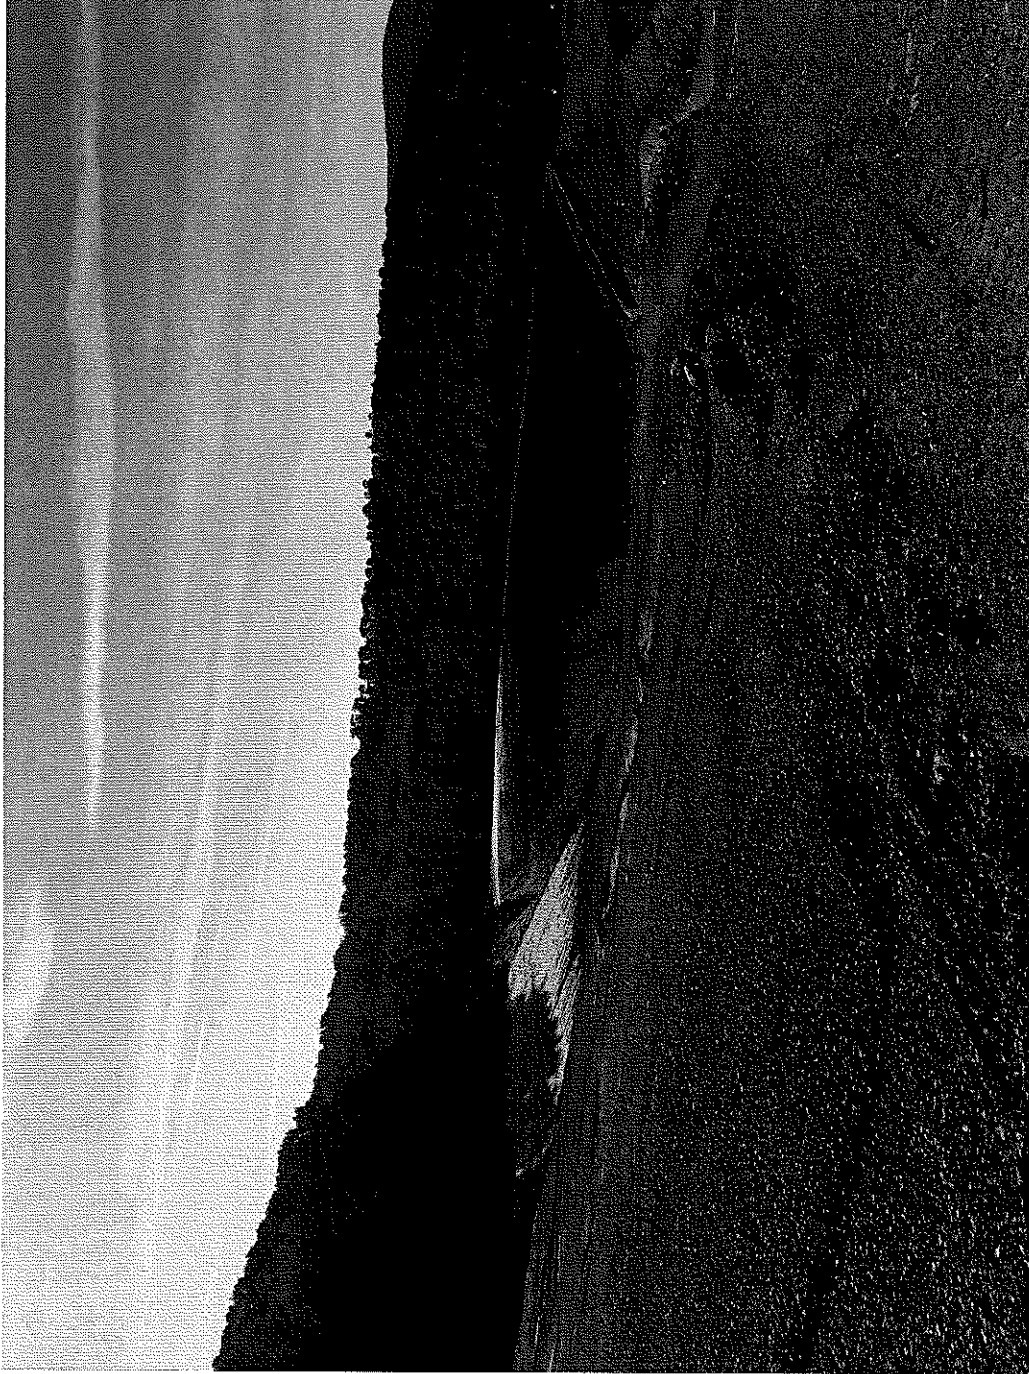
Photo 2

14. The west high wall was observed to be stable.
15. We did not enter the scale house to inspect trucking slips.
16. A very slight odor was detected south of the working face along Applebutter Road. Prior to the LF inspection. Following the inspection, I conducted a driving patrol along Applebutter Road, Skyline Drive, through Steel City and along Riverside Drive. A slight offsite landfill-related odor was detected near the intersection of Applebutter Road and Ringhoffer Road. A slight sewage odor was detected at the City's WWTP.
17. Astor advised me that DEP has hired a new inspector for the BL facility, and he anticipates inspections will be more consistent.
18. Construction of the new Cell SE-2AB continues (see Photo 2).
