Engineering Associates Inc

February 17, 2016

RE: Incident at IESI Bethlehem Landfill Involving  
Landfill Flare on February 16, 2016  
Hanover Project LS90-07

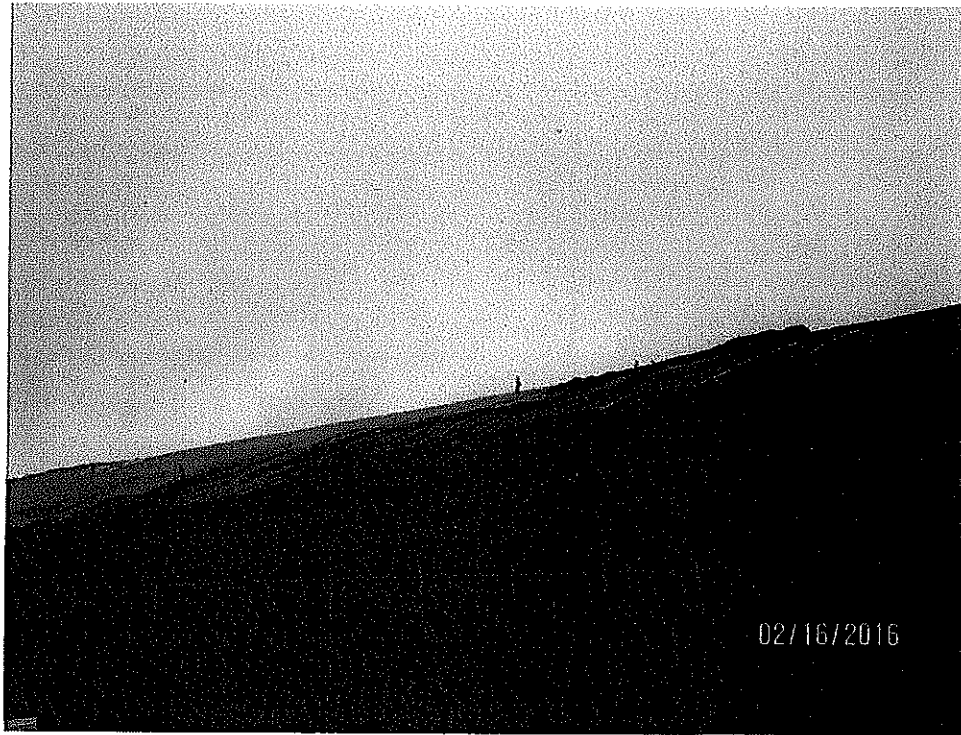
I then asked for an explanation of the incident. He stated that the high winds had caused the synthetic material that had been placed on the south slope for temporary capping to lift, or "balloon up" in places. All of the gas wells sticking up through the cap are "booted", or attached, to create a gas-tight seal. The lifting force was strong enough to pull the tops off of three (3) of the wells, all in the same area. The wells are under a vacuum to collect landfill gas and send it to the landfill flare for burning. Once the well tops were dislodged, the wells were open to the atmosphere, and the vacuum caused ambient air to be drawn into the gas collection system. When the flow containing this air began reaching the flare, it disrupted the flare's normal operation. The addition of ambient air to the landfill gas created a "leaner" fuel mixture than usual, which caused the flare's burning temperature to drop. In response, the flare's automatic louver system sharply throttled back the air intake at the flare itself which is used to regulate the burning temperature, attempting to stabilize the temperature. The flare continued to run and did not "trip" off line, thanks to the automatic louver adjustments. Mr. Schleyer ordered IESI's air quality consultant, Blue Flame Crew, to "throttle back" the flare, then had his workers repair the open wells and begin placing sand bags on the liner to weight it down and prevent further lifting. Mr. Schleyer theorized that the sound generated by the flare may have come from the initial, sudden closing of the louvers. He stated that later, when he was at the flare talking with Blue Flame Crew, it was making some unusual "whooshing" sounds, but these were not even loud enough to drown out their conversation.

1. From office parking lot, looking northwest toward area of temporary capping affected by wind (note areas of cap "blown up" on right side of photo).

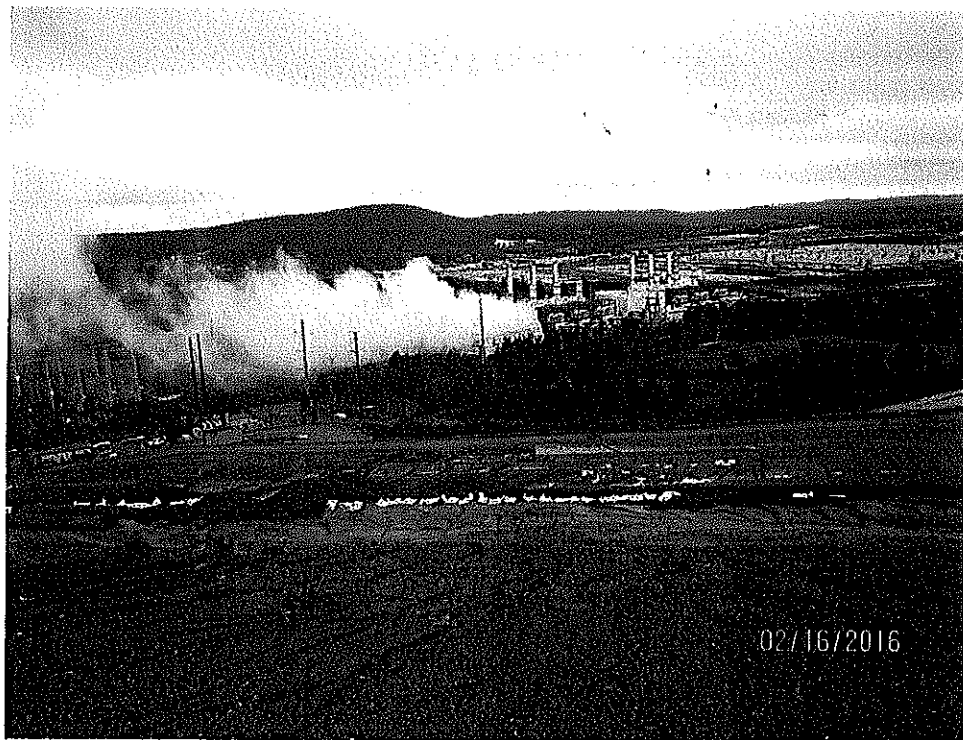
2. From top of landfill, looking south across area of temporary cap. Note sandbags in place to weigh cap down.

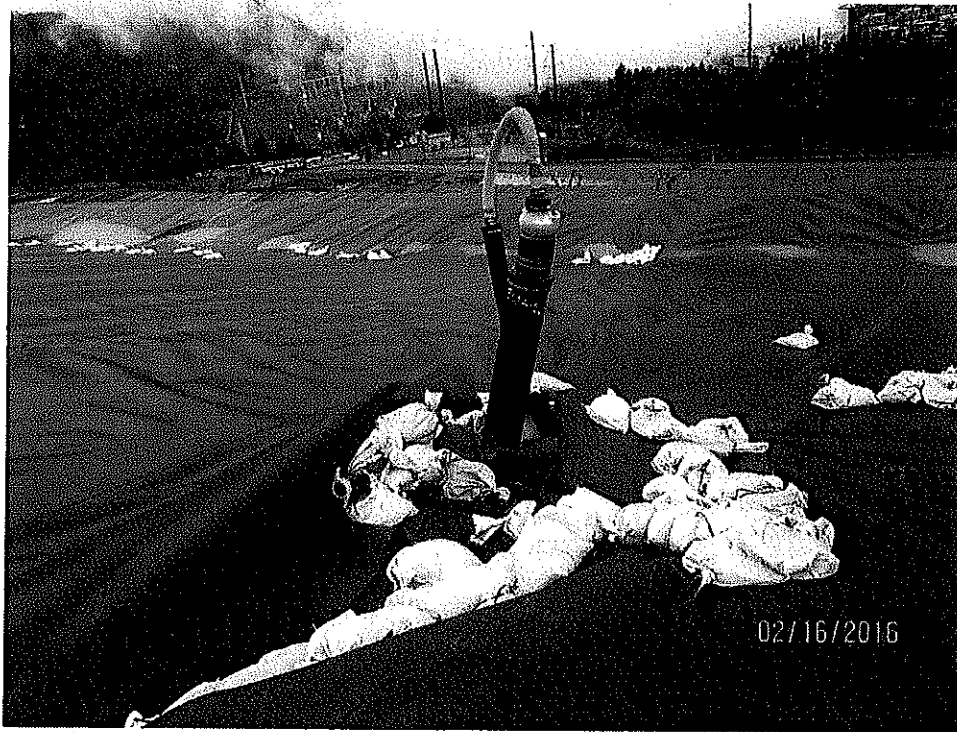
3. View of one (1) of the affected wells, showing that vacuum line has been reattached, liner has been cut, and sandbags have been placed.

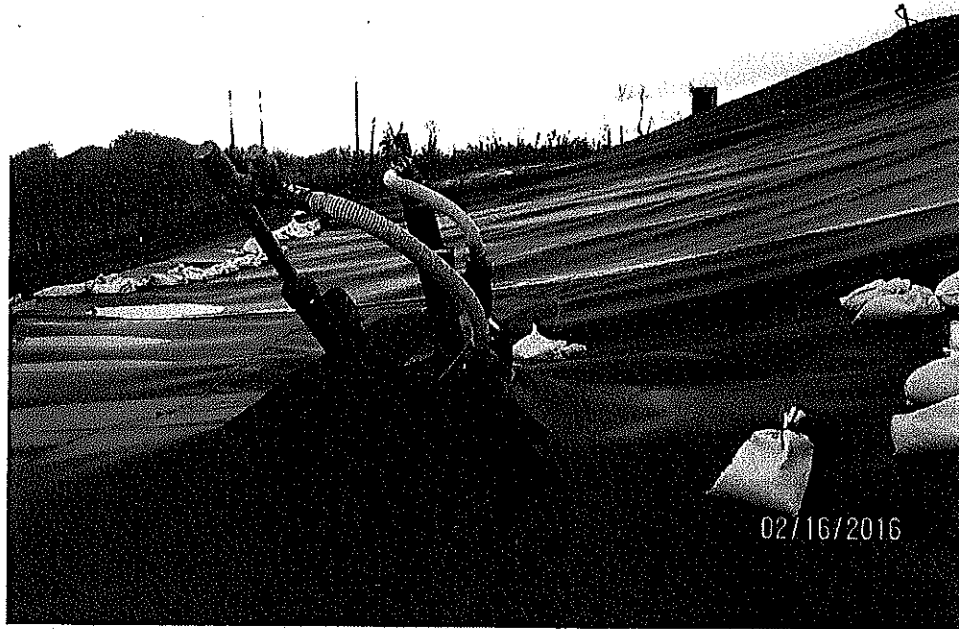
4. View of other two (2) affected wells, showing that vacuum lines have been reattached, liner has been cut, and sand bags have been placed. View is looking west (note LSA water tank in background).

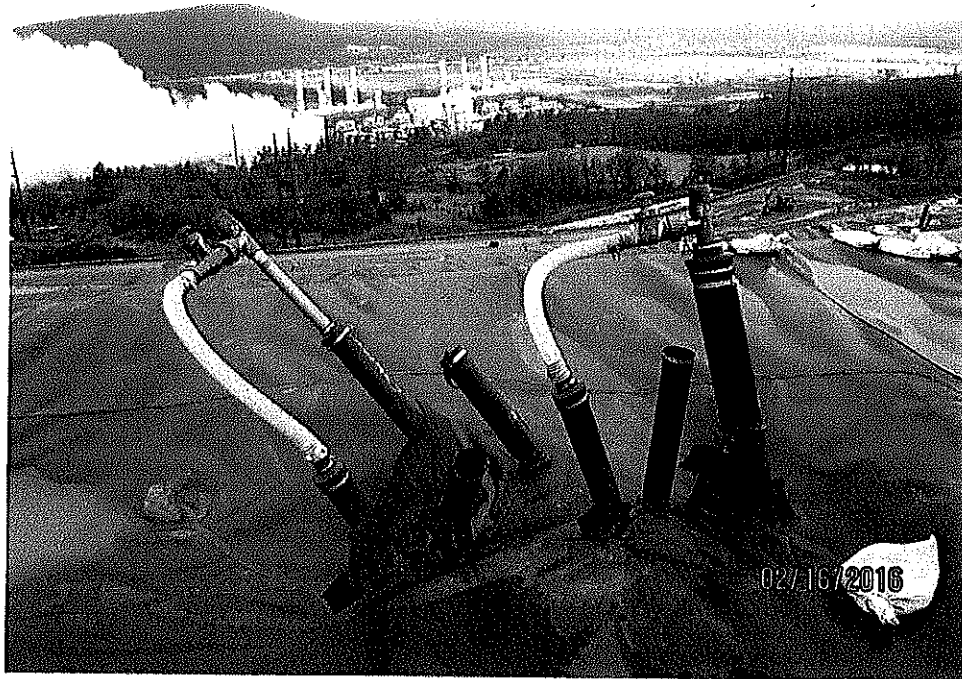
5. Additional view of affected wells.

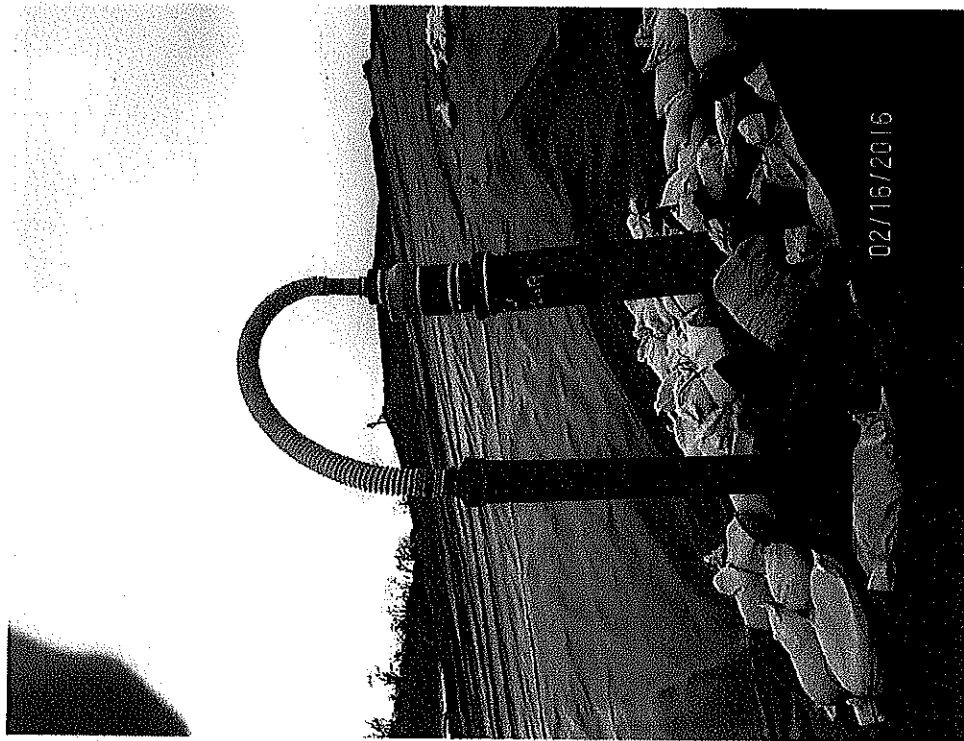
6. Additional view of affected well.
