February 17, 2021

RE: Inspection Conducted on February 4, 2021
IESI Bethlehem Landfill
Hanover Project LS90-7

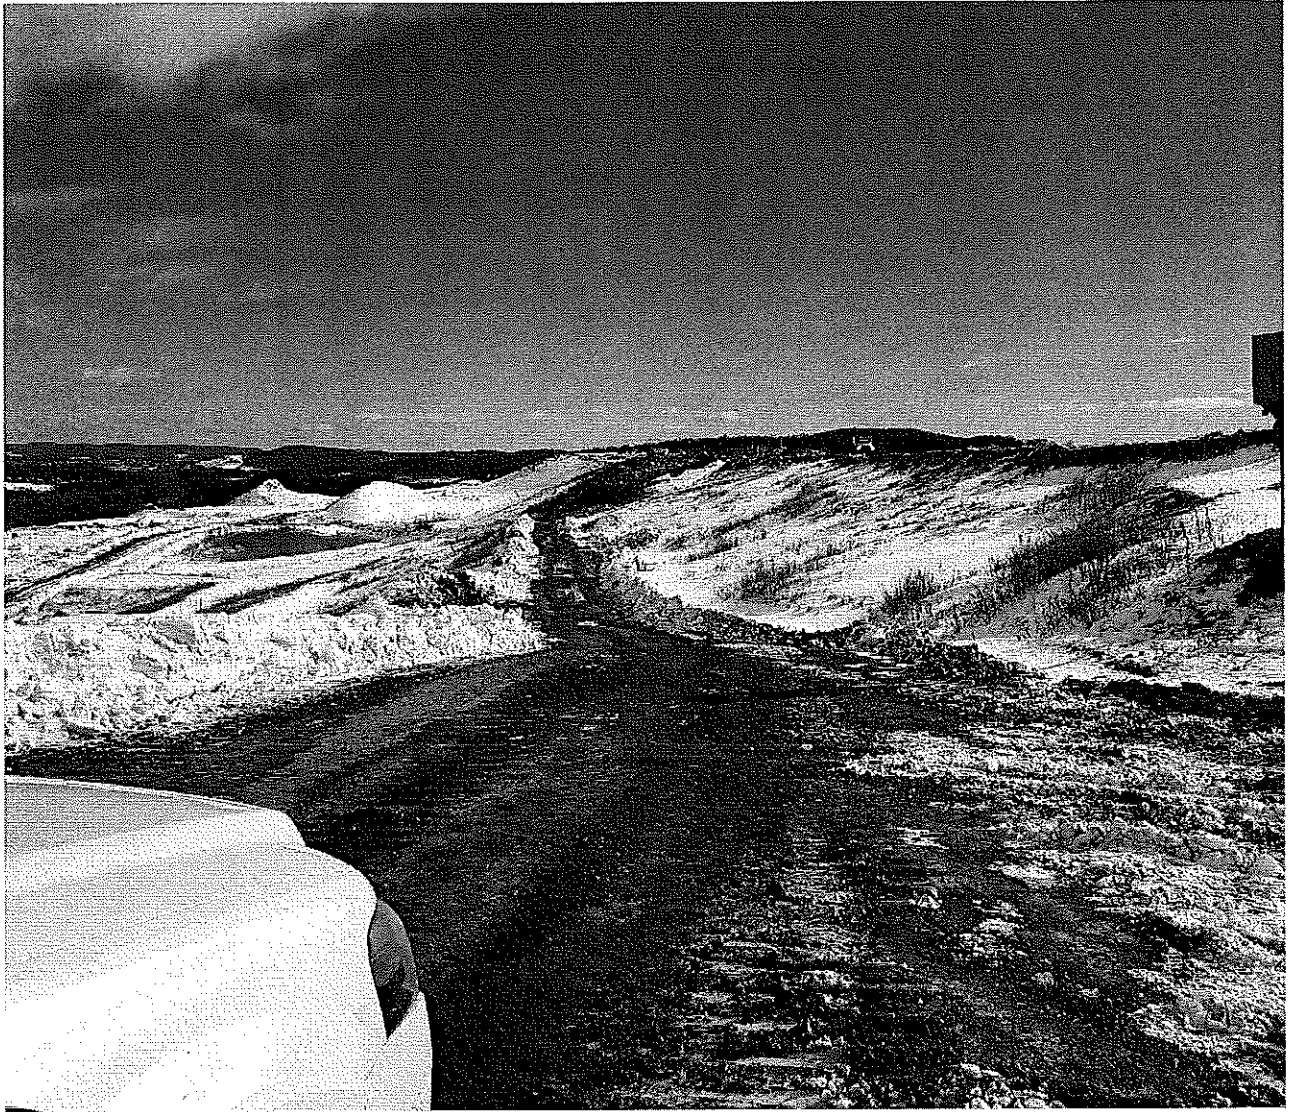
Photo 1

8. Garbage was being disposed along the northern face of Cell 1B, see photo 1. The approach to and departure from the working face was stable and passable. The trailer tipper was in use. Trucks were also unloading waste conventionally. One (1) compactor was working in the garbage. One (1) dozer was spreading soil to spread cover on the south face near the working face. Very slight intermittent garbage odor was detected while we were at the top of the landfill observing the daily operation two hundred (200) yards west of the working face. Waste disposal at the working face is being increased due to the expected DEP certification of the new cell 2A/B, Phase 1 construction in a day or two.

9. No pickers were observed working on site to remove blown litter from the north slope of the working face. Temporary litter fence was in place at several locations around the working face, see photo 1 for fencing. The wind-blown waste (mostly plastic bags) observed during the last inspection, has been cleaned up along the eastern permit limit.
