# 50 YEARS Hanover Engineering

July 13, 2021

RE: Inspection Conducted on July 1, 2021  
 Bethlehem Landfill  
 Hanover Project LS90-7

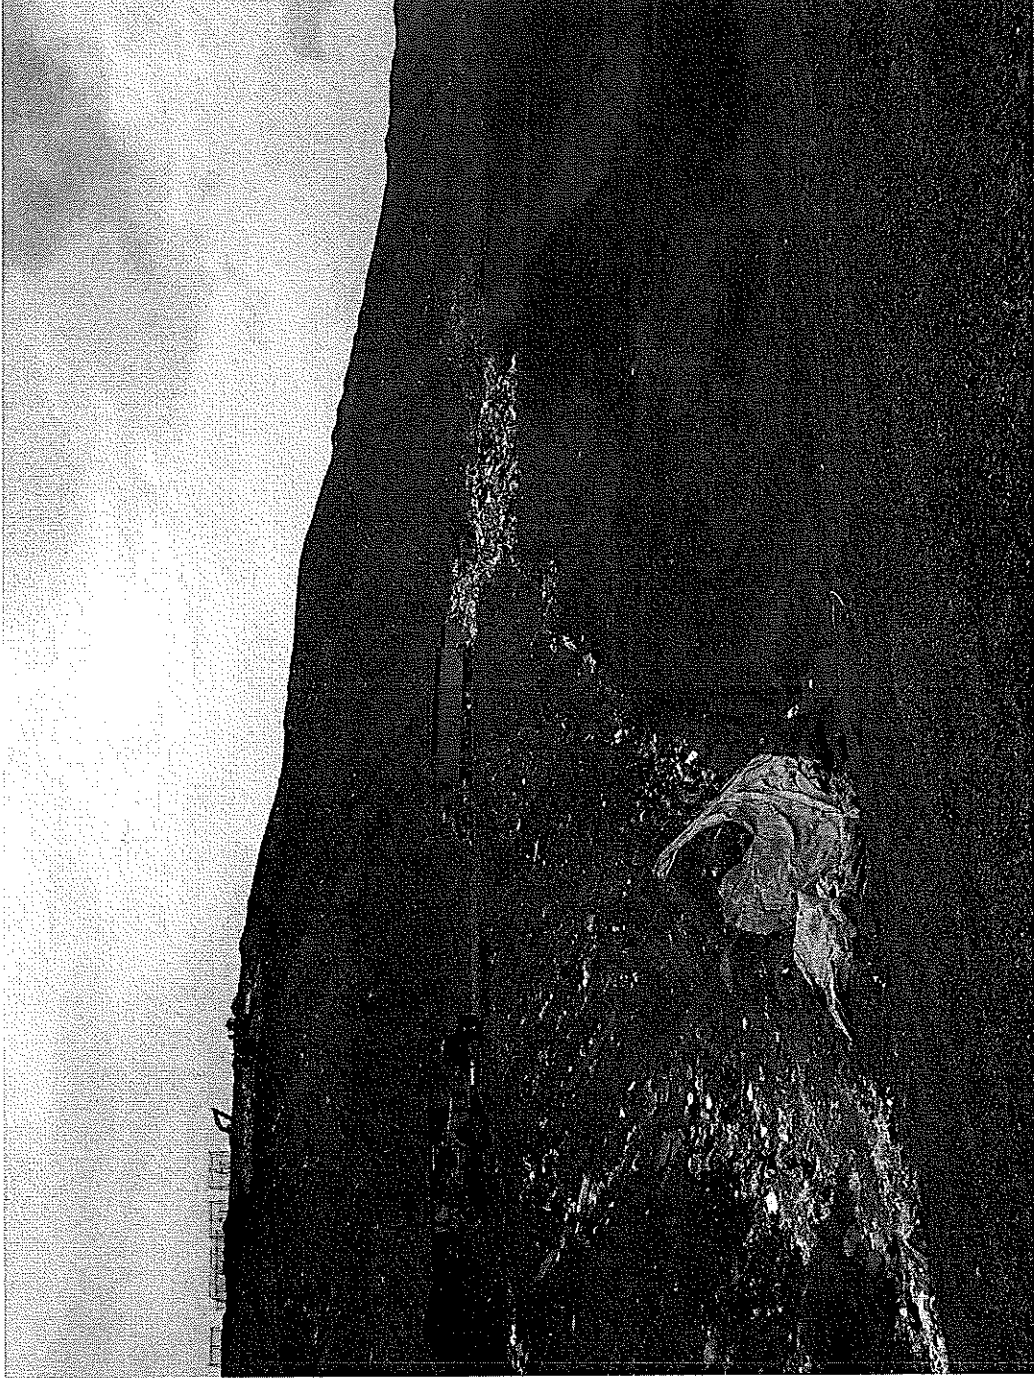
7. Garbage was being disposed in Cell SE2-AB Phase 1 (see Photo 1 and 2 looking from bottom north and from top looking east respectively). The approach to and departure from the working face was stable and passable with a pickup truck. The trailer tipper was in use on the north end of the cell. One (1) compactor and one (1) dozer were working in the garbage at this location. A slight garbage odor was detected at the north end working face. Portable litter fencing is being utilized.
