October 29, 2020

RE: Inspection Conducted on October 15, 2020
IESI Bethlehem Landfill
Hanover Project LS90-7

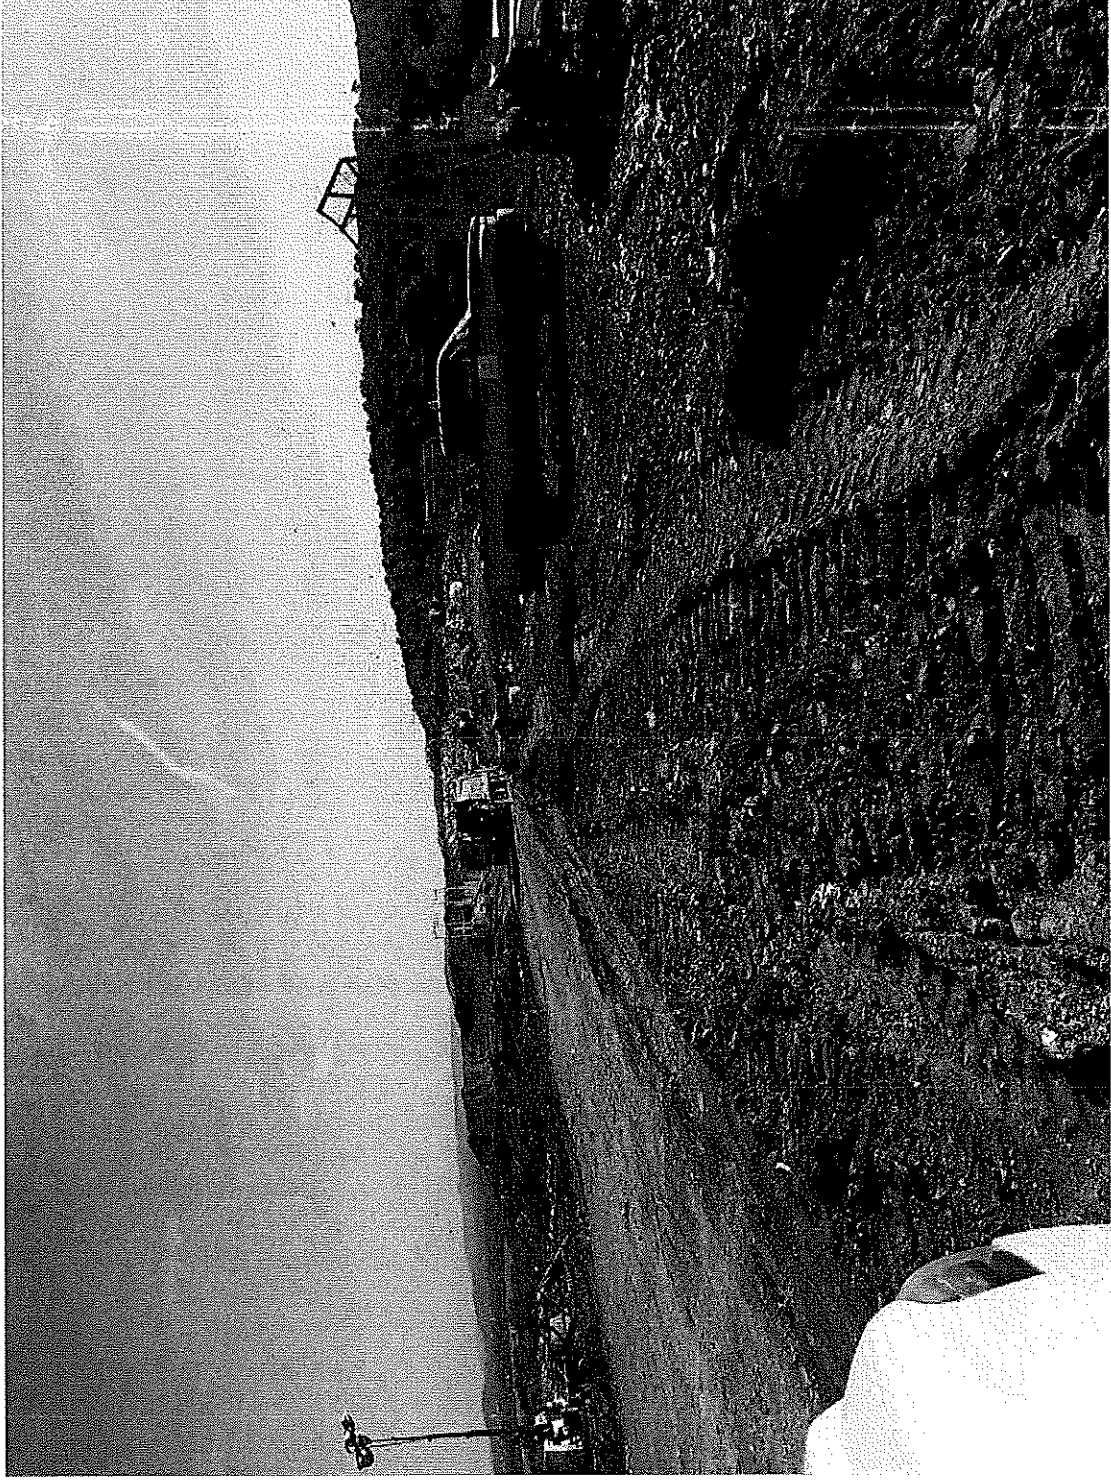
Photo 1

6. The truck wash was open and being utilized.
7. One (1) picker was observed working on site to remove blown litter from the north slope of the working face. Temporary litter fence was in place at several locations around the working face (see photo 1 for fencing).

8. Garbage was being disposed at the top of Cell 1B (see photo 1). The approach to and departure from the working face was stable and passable. One (1) compactor was working in the garbage. One (1) dozer was spreading soil to spread cover on the south and east face of the working face. No garbage odor was detected while we were at the top of the landfill observing the daily operation two hundred (200) yards west of the working face. The working face continues to be minimized as a result of the planned reduction in the waste acceptance until the new cell 2A/B, phase 1 construction is completed. The cell construction is anticipated to start in approximately one (1) week.

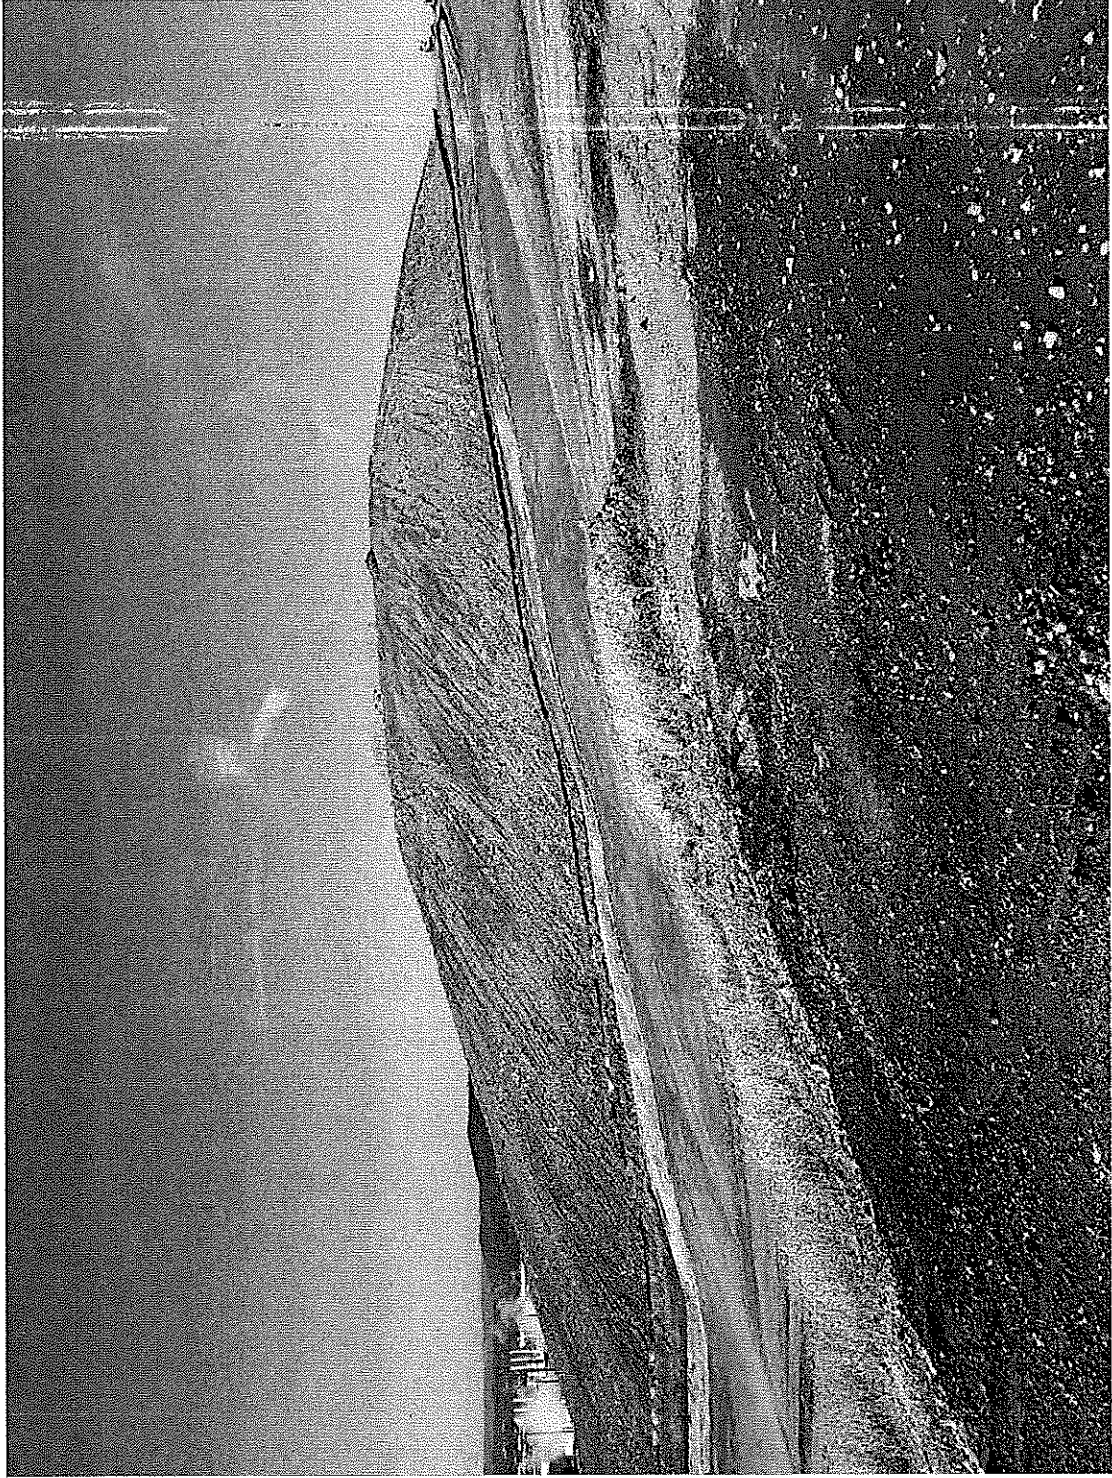
Photo 3

5. Stormwater is being controlled properly and no substantial erosion rills were observed. The intermediate cover on the southern slope of cell 1B is stable (see photo 3). The stormwater collection system for cell 3A that drains to sedimentation pond #1 that was repaired after the hurricane appears to be functional. There has not been any substantial rain events in the past month. Removal of sediment from sedimentation pond is ongoing.
