# 50 YEARS Hanover Engineering

October 26, 2022

RE: Inspection Conducted on October 20, 2022  
Bethlehem Landfill  
Hanover Project LS90-7

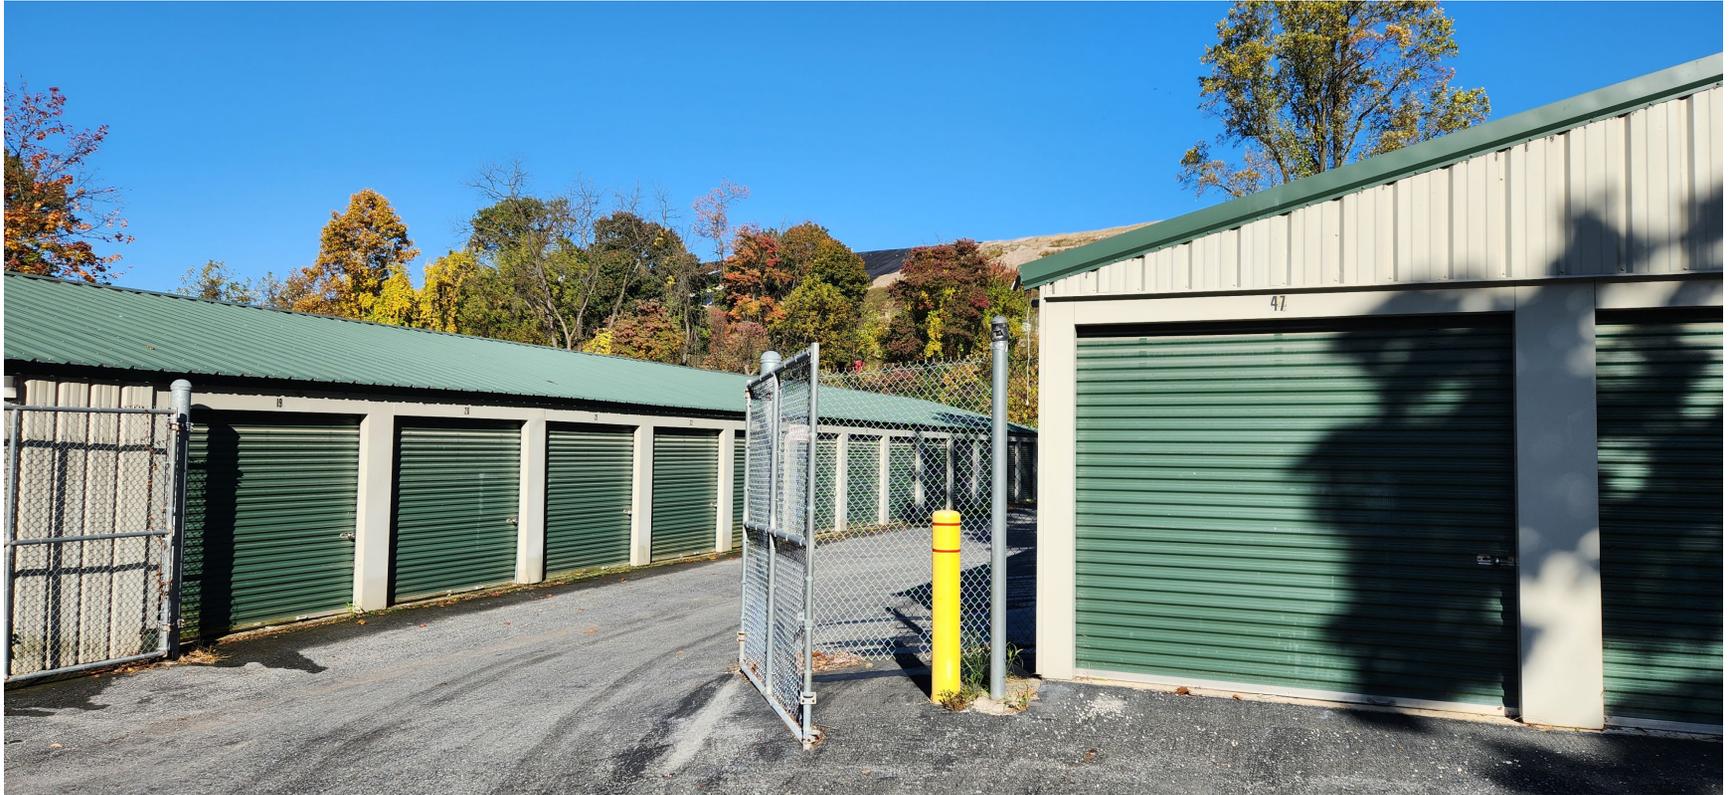
Photo 1

7. NAPA is on site to continue the capping project. The HDPE capping material portion of the project has been completed and the cover soil is now being placed over cell 3-D's southern slope (see Photos 1, 2 and 3 from the south side of the self-storage units along Applebutter and the intersection of Applebutter Road and Ringhoffer Road. Photos 4, 5 and 6 are from access road immediately south of the capping).

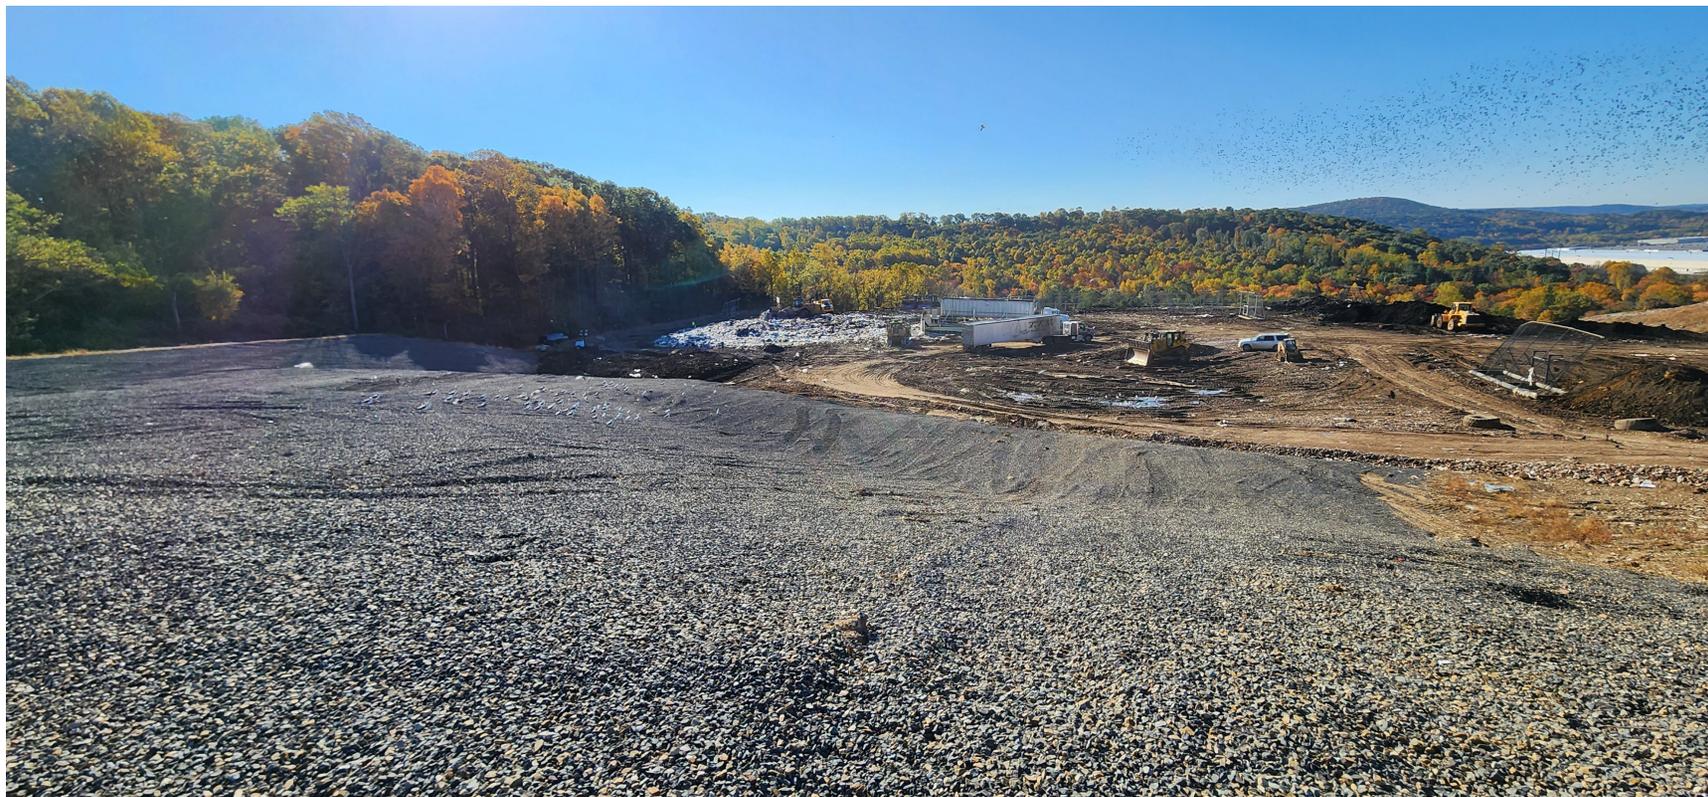
Photo 7

8. The current working face is in the sump area of cell SE-2AB Phase II (see Photos 7 and 8). The trailer tipper, walking floor trailers, and garbage trucks are offloading waste. BL continues to take part in a trial to utilize a new mister system that is attached to the truck tipper. The new mister is being activated when the tipper starts to raise, and the waste starts to empty out of the trailer. The mister is spraying the waste with an odor neutralizer and a masking scent. The mister is also minimizing the dust during the offloading process.
