November 17, 2021

RE: Inspection Conducted on November 2, 2021
Bethlehem Landfill
Hanover Project LS90-7

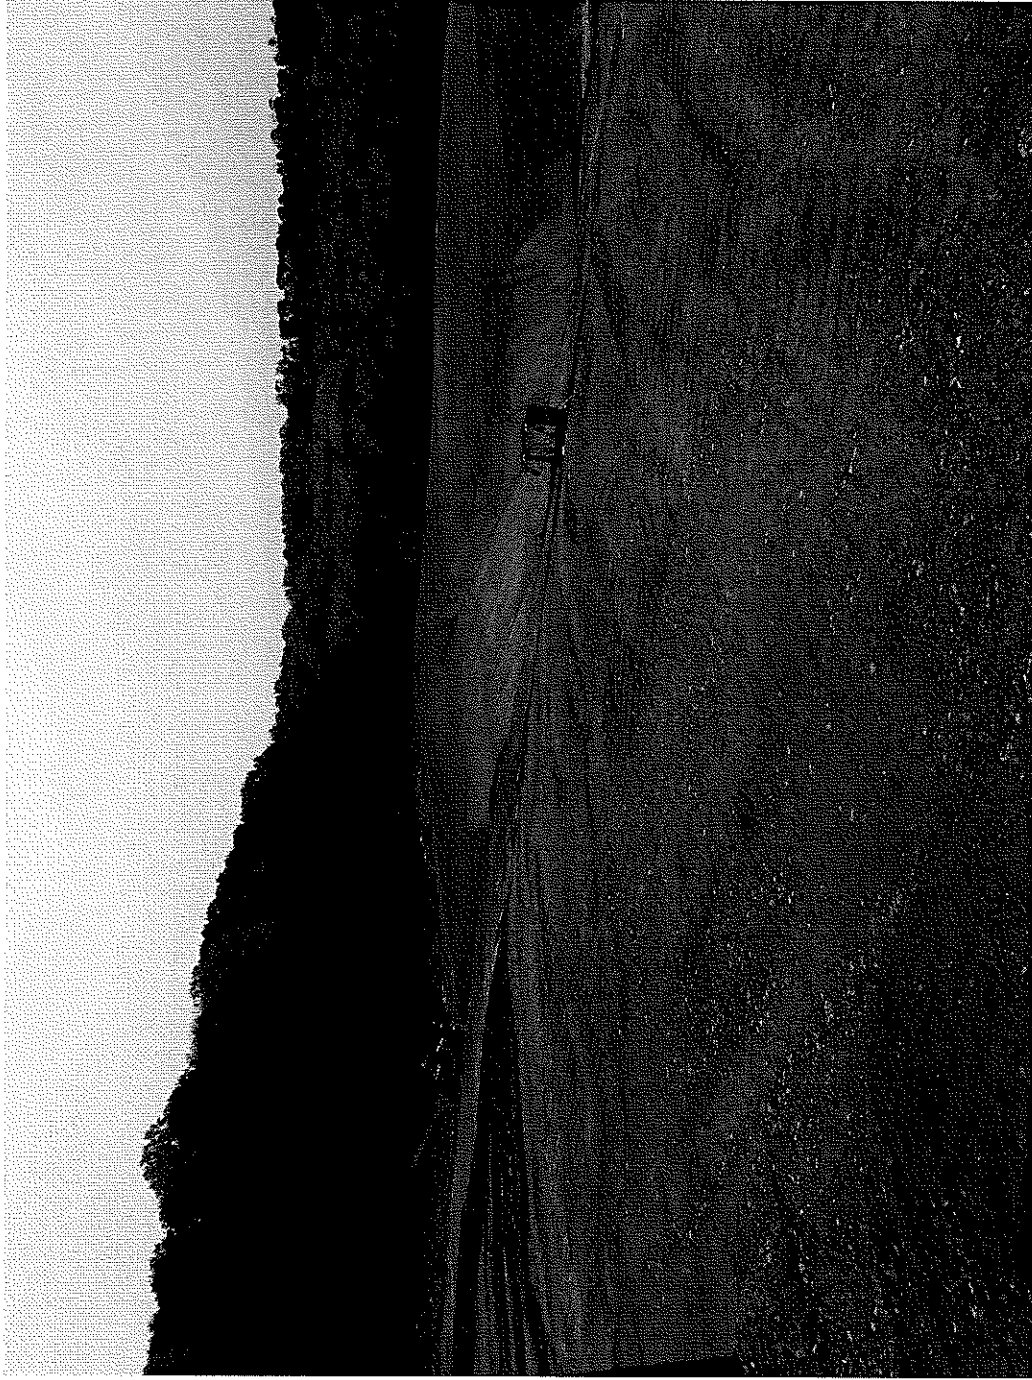
Photo 2

17. Construction of the new cell continues with placement of the fine aggregate base, the process has been slow due to the shortage of truck drivers to deliver the aggregate (see Photo 2).
