Issued: April 10, 2025

Railroad Investigation Report: RIR-25-06

Norfolk Southern Railway Multitrain Collision and Derailment

Location	Easton, Pennsylvania
Date	March 2, 2024
Accident type	Multitrain collision and derailment
Eastbound striking train	Freight train NS268H429 2 crewmembers 2 locomotives, 39 intermodal railcars
Stopped train	Freight train NS24XH101 2 crewmembers 3 locomotives, 27 intermodal railcars
Westbound striking train	Mixed freight train NS19GH501 3 crewmembers 3 locomotives, 199 mixed manifest railcars
Track	Main track, signalized
Hazardous materials	Ethanol residue and butane residue
Fatalities	0
Injuries	4
Damages	\$2.5 million

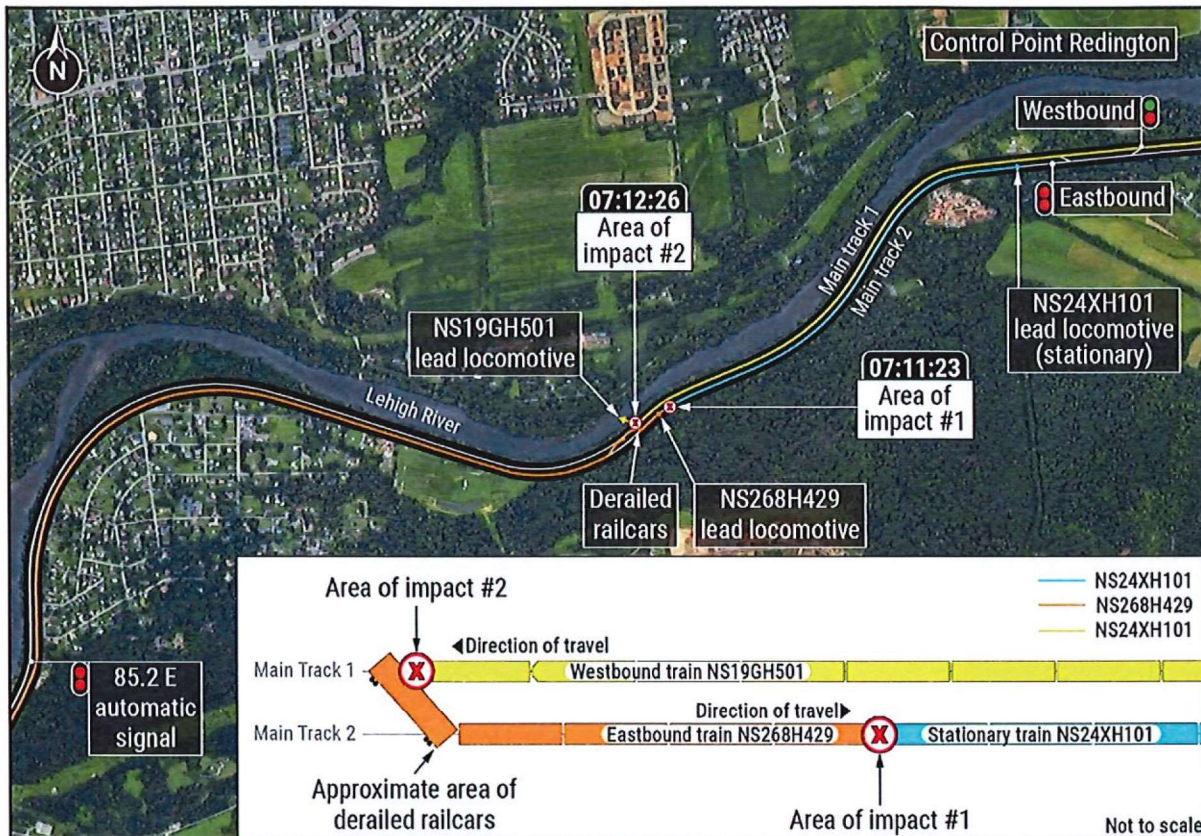
placarded as hazardous materials tank cars: one containing ethanol residue and two containing butane residue.³ The tank cars did not breach or release hazardous materials. The two derailed locomotives partially submerged in the Lehigh River and discharged locomotive diesel fuel into the water. (See figure.) Four crewmembers from the accident trains were transported to a local hospital, treated for minor injuries, and released. At the time of the collisions, visibility conditions were daylight and overcast; the weather was 35°F with light rain.

Figure. Graphic showing aerial view of train routes and derailment illustration. (Source: Google Earth.)
