Re: IESI PA Bethlehem Landfill  
I.D. #100020  
Lower Saucon Township, Northampton County

**INSPECTION REPORT - MUNICIPAL WASTE LANDFILL**

On January 24<sup>th</sup>, 2012, the Pennsylvania Department of Environmental Protection (Department) conducted a complaint investigation at IESI PA Bethlehem Landfill (IESI). Representing the Department during this inspection was Walter F. Govern III, Solid Waste Specialist (this inspector), Dean Fisher, Solid Waste Supervisor, Andy Schweitzer, Air Quality Supervisor, Jessica Wagoner, Air Quality Specialist, Ralph Policichio, Air Quality Specialist, Susan French, Waste Management Program Engineer, Sheena Ripple, Water Quality Specialist, and Bharat Bham, Hydrogeologist. Representing IESI was Al Schleyer, Compliance Manager.

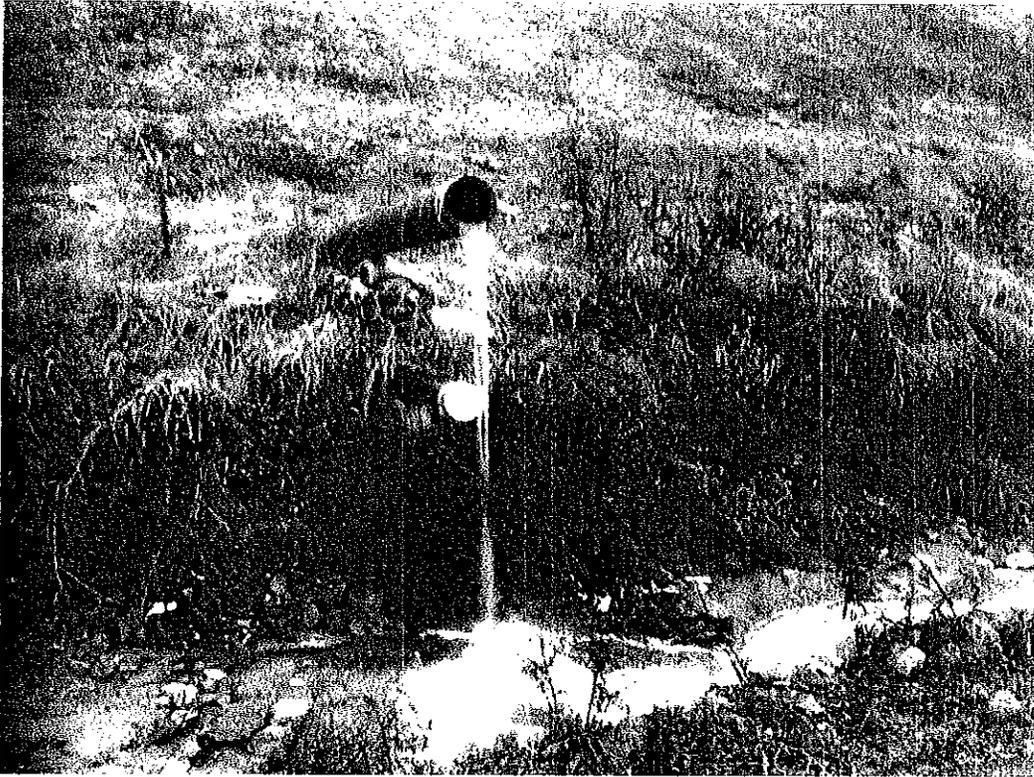
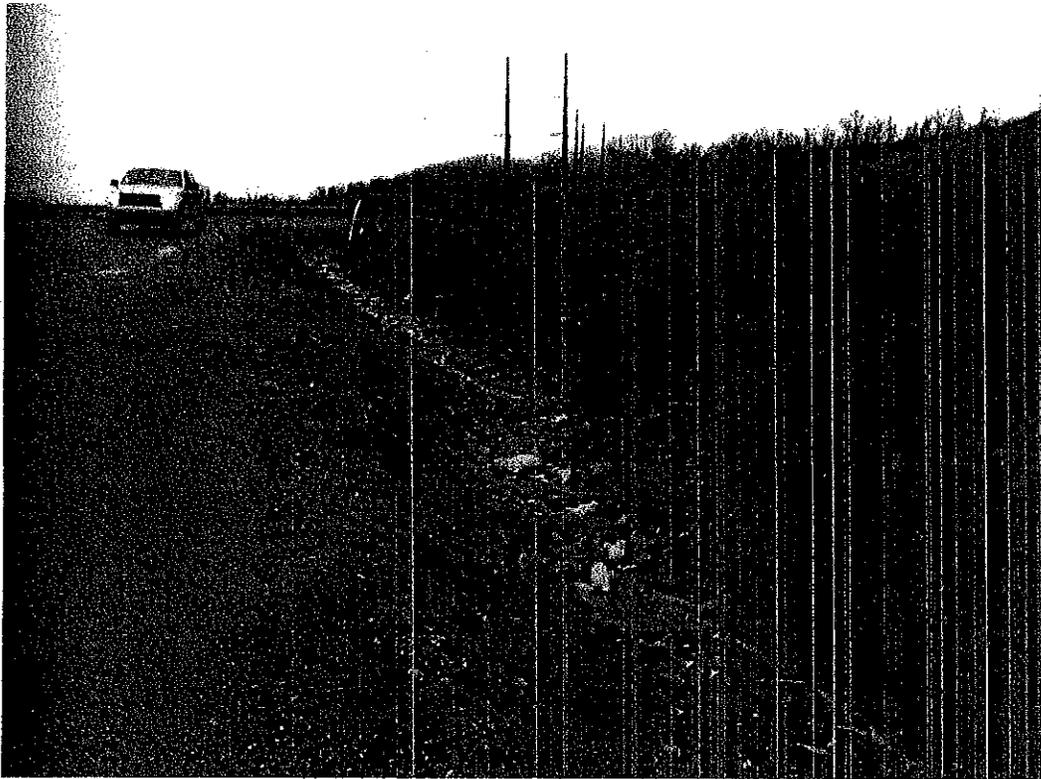
**DEP Complaint ID# 285822 – IESI PA Bethlehem Landfill**  
January 24, 2012

- Leachate Discharge Unreported November 2011 (See Attached Images)
- White & Teal Colored Seeps Entering Stormwater Basins
- Elevated pH Of Stormwater Basin Discharges
- Improperly Installed/Maintained Stormwater Basin Risers Limiting Detention Time And Therefore Not Minimizing Sediment Discharge
- Intermediate & Final Capping Behind Schedule
- Slopes Are Too Steep And Not Properly Benched
- Intermediate Cover Inadequate To Support Vegetation Or Prevent Escape Of Landfill Gas/Odors
- Failure To Properly Vegetate Slopes
- Landfill Gas Odors Leaving Site To West Of Landfill
- Truck Wash Water Not Discharged To Sanitary Sewer And Allowed To Enter Stormwater Conveyances
- No Grid System For Tracking Waste Disposal Location

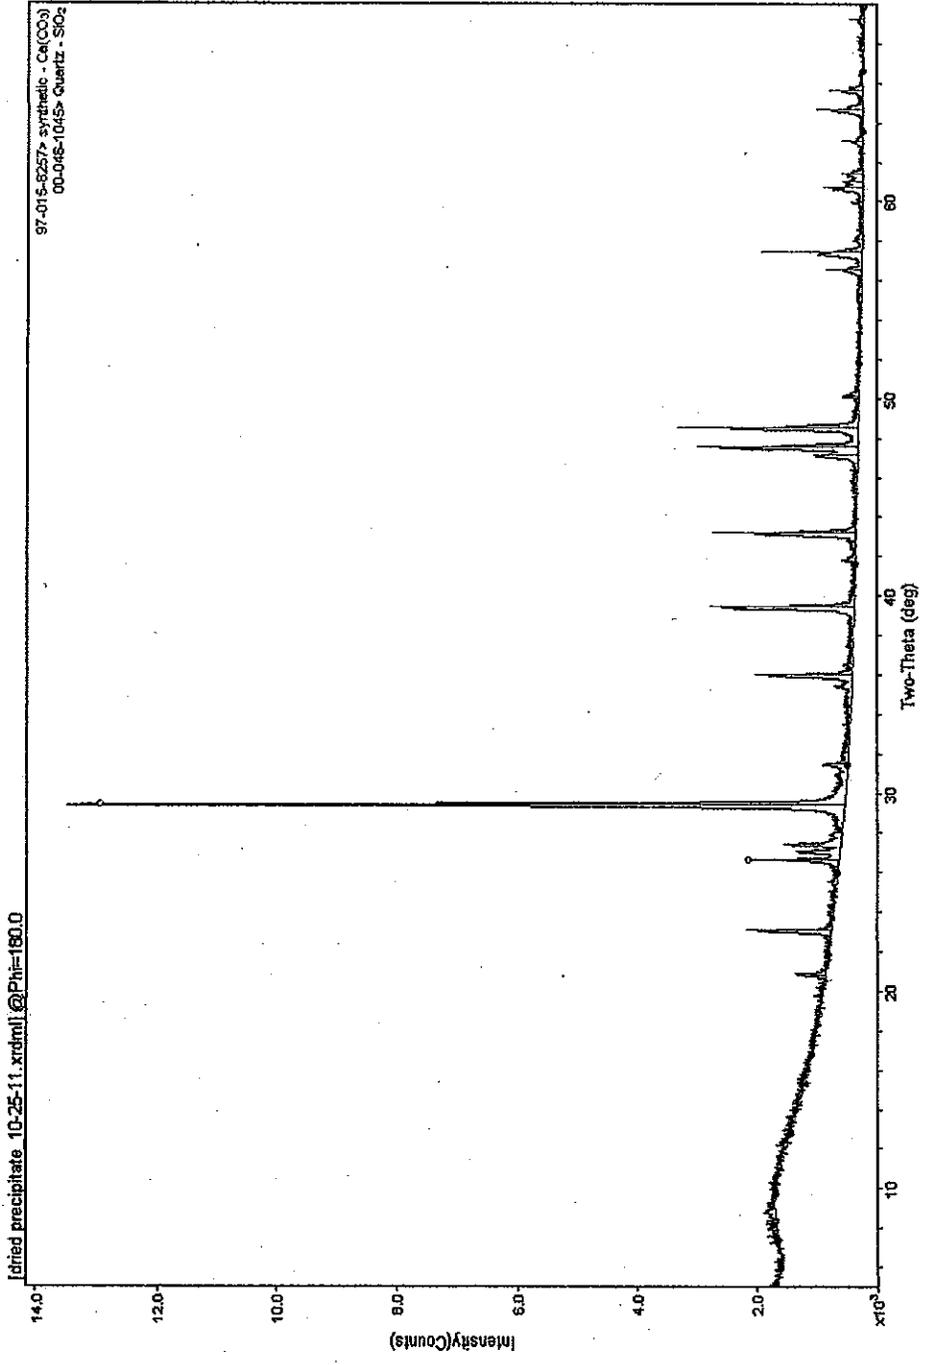
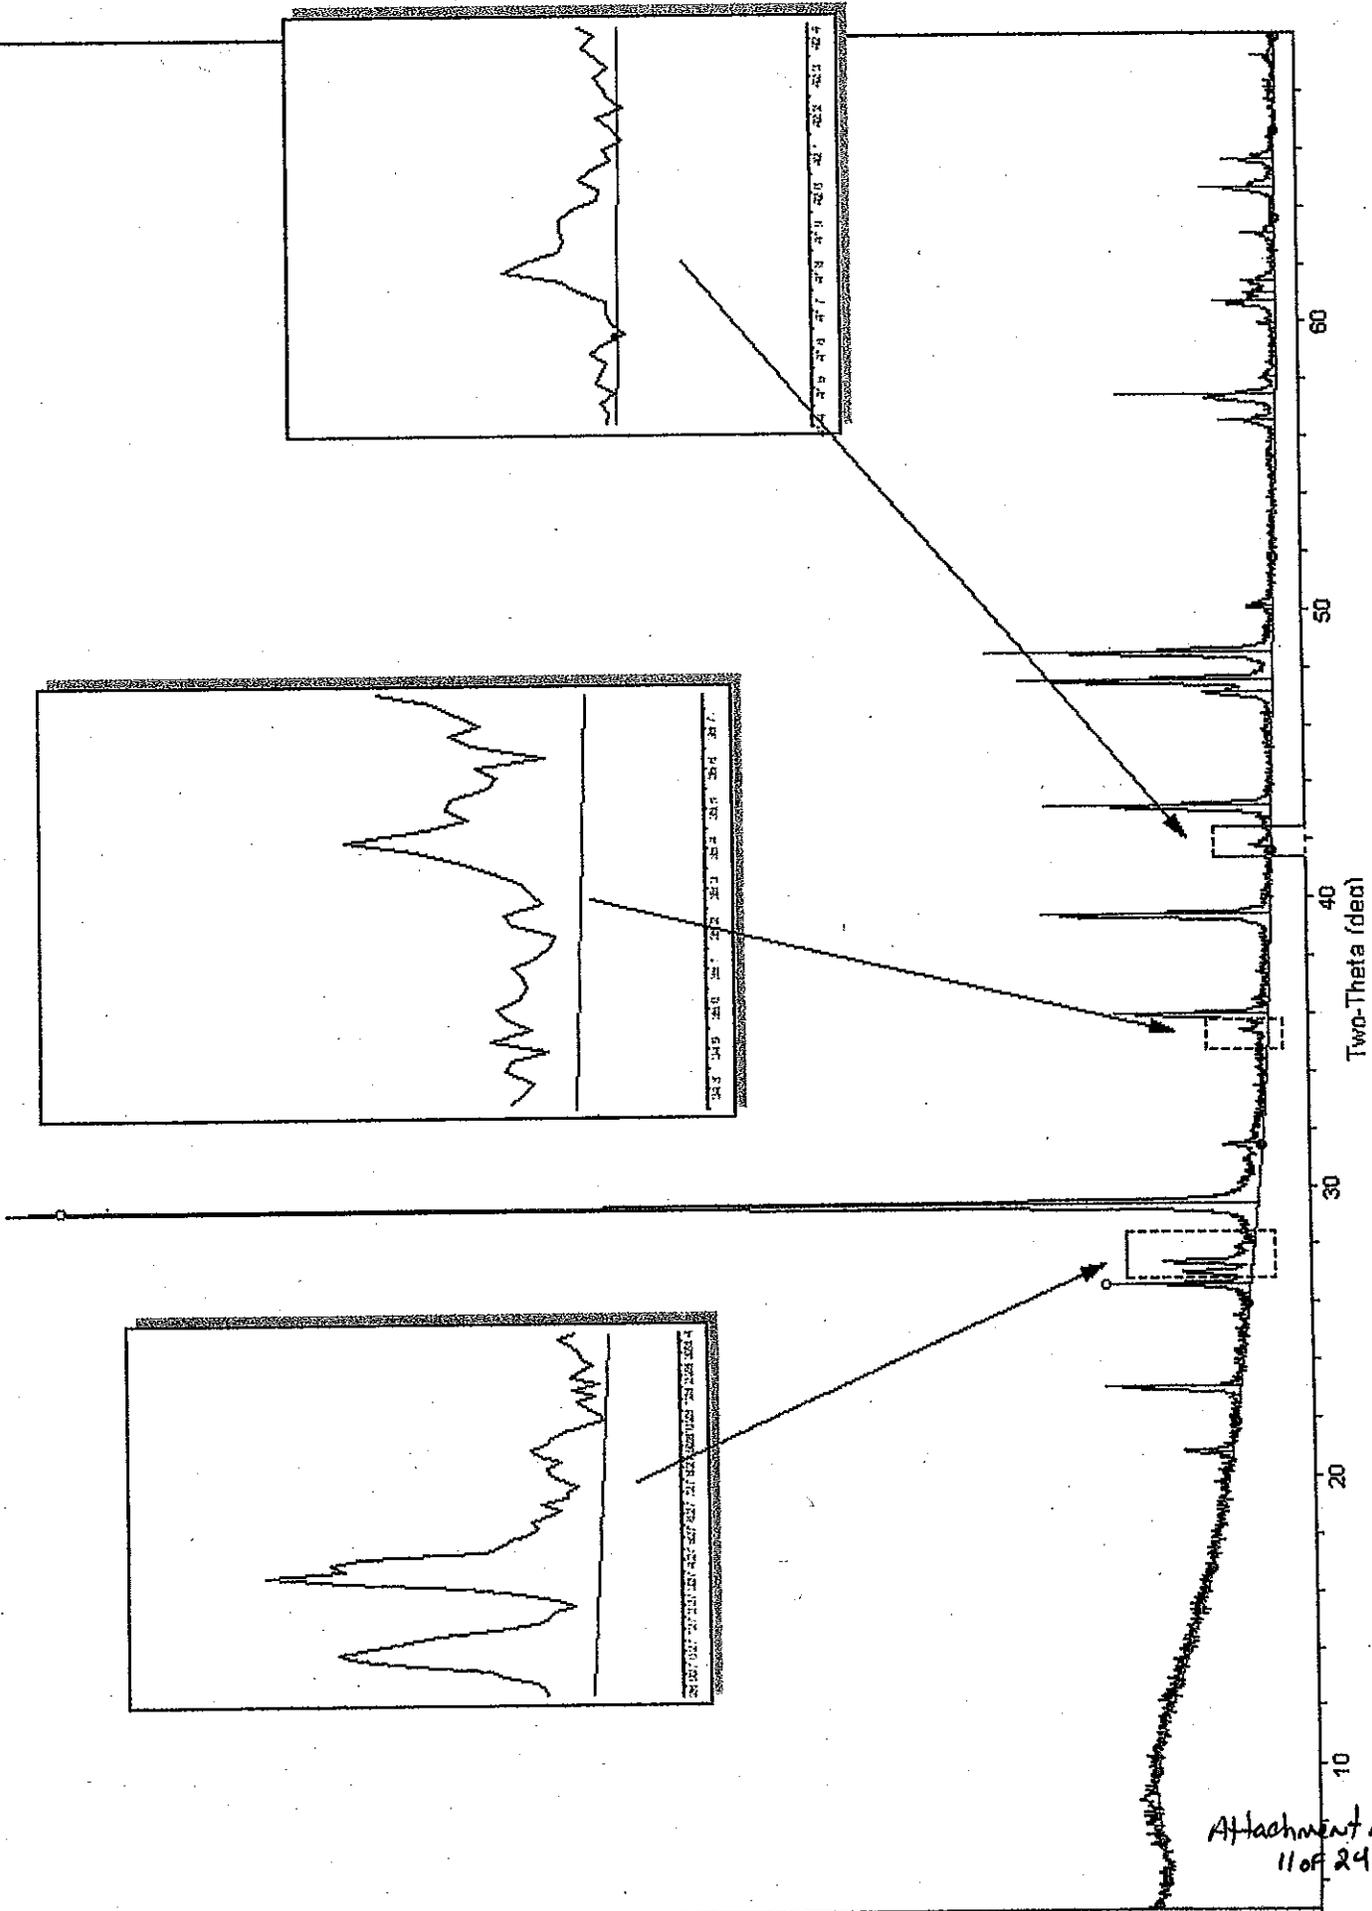
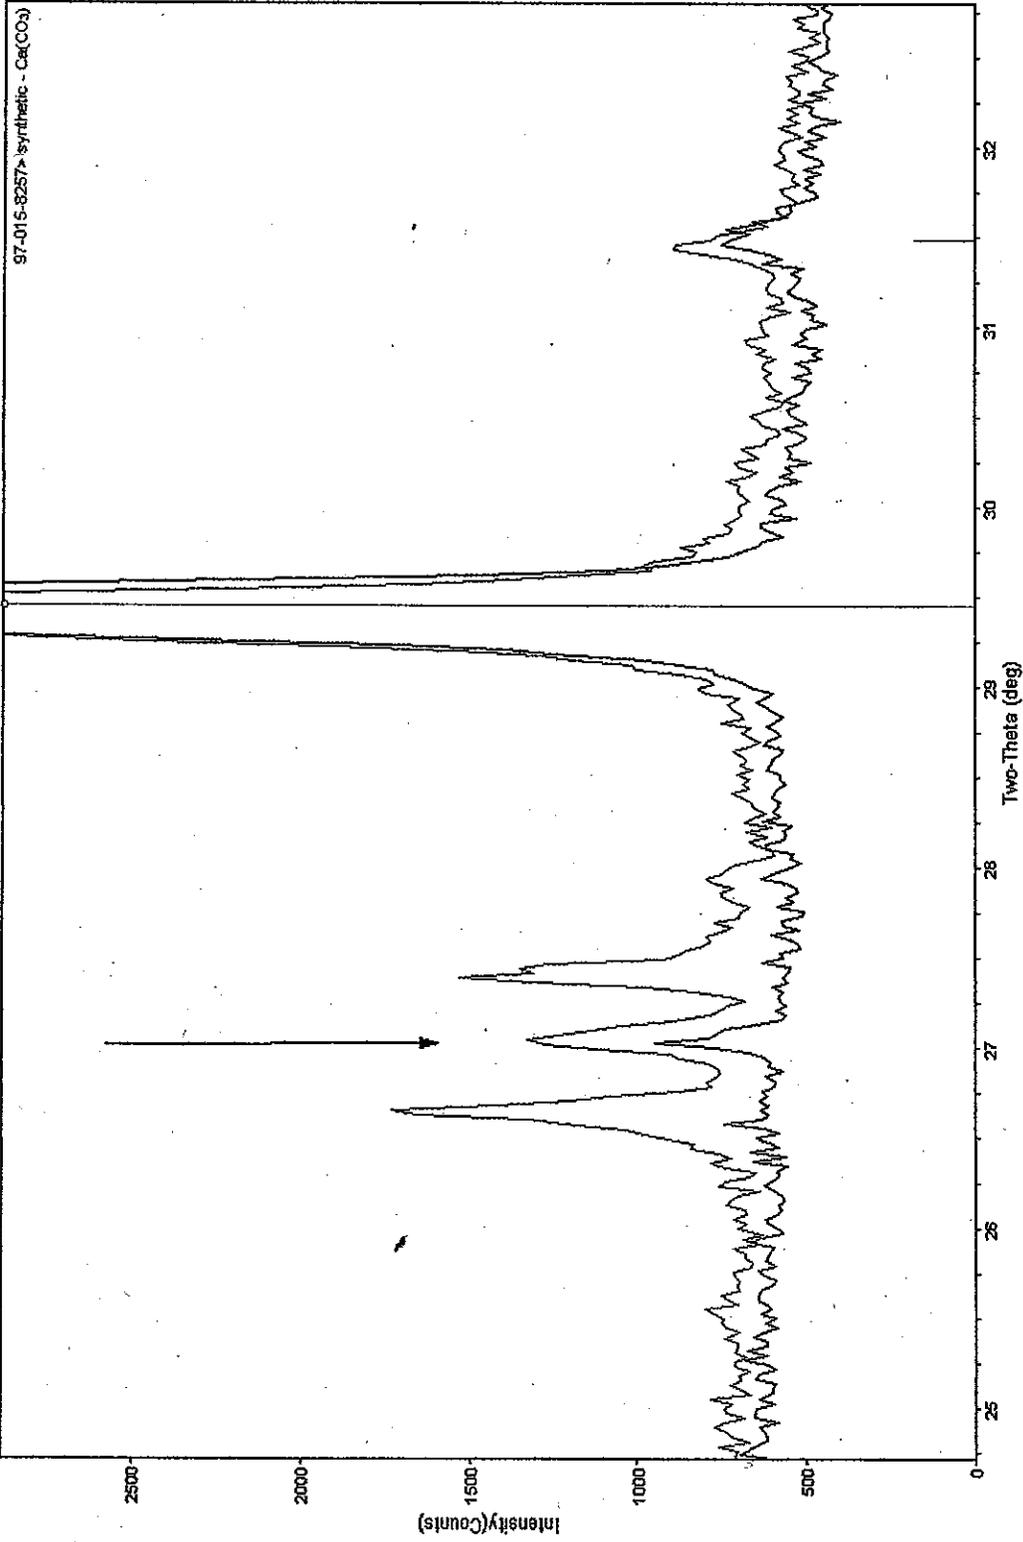
Attachment A  
10 of 24

Dried material appears to be primarily calcite (calcium carbonate). A small amount of quartz is also present. Additional compound(s) that were unidentifiable are present and indicated by the zoomed boxes in the pattern at right. (Scroll to right to see additional view.) Additional testing (i.e., a chemical analysis to determine elemental composition) is required if it is necessary to determine the nature of these unidentified peaks. The unidentified peaks likely correspond to a small weight percent of unknown compounds.

97-015-8257> synthetic - Ca(CO<sub>3</sub>)  
00-046-1045> Quartz - SiO<sub>2</sub>

[dried precipitate\_10-25-11.xrdm] @Phi=180.0  
[creamy white substance\_10-25-11.xrdm] @Phi=180.0

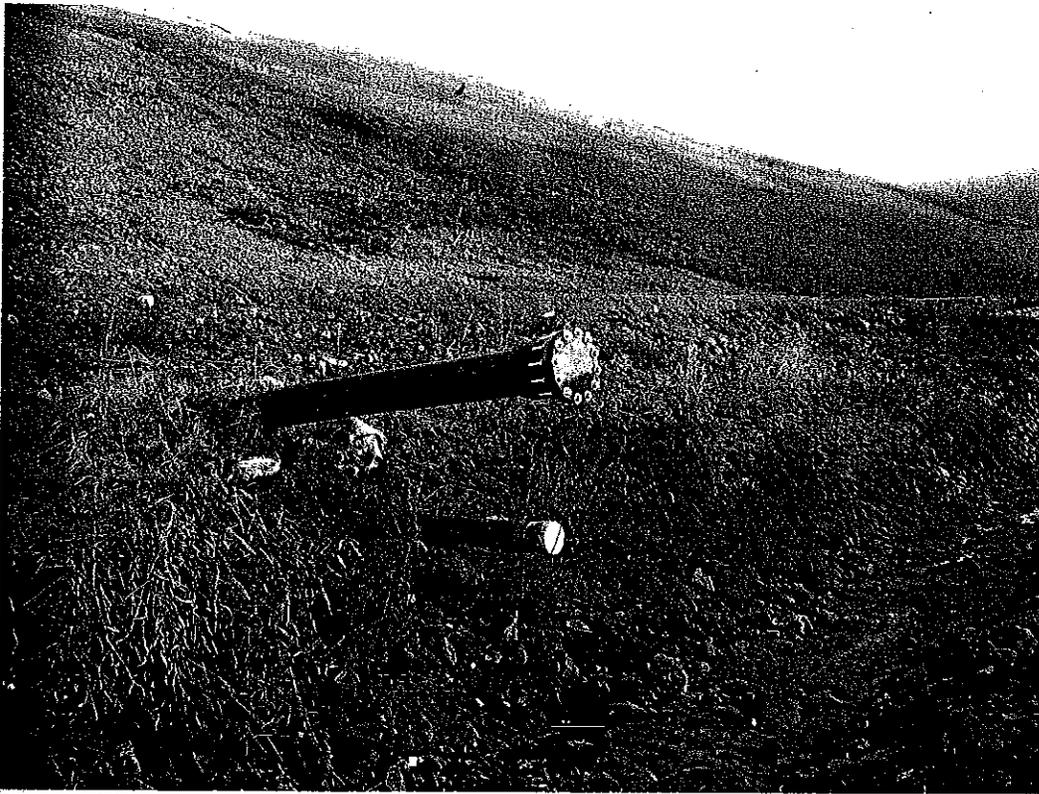
Photos of the leachate clean out line. IESI installed a cap with gasket and bolted it closed.

IESI hypothesized that there was a blockage in the leachate line between pump station one and the clean out line. IESI hired Mobile Dredge to try to remove the blockage in the leachate line. The blockage was successfully removed and a cap with gasket was installed on the clean out line and bolted in place. A photograph of the clean out line as observed by this inspector during the time of this investigation is attached to this report as Attachment B.

The cap on the cleanout pipe that discharged leachate was replaced. The cap is bolted & sealed. It should not come off again.

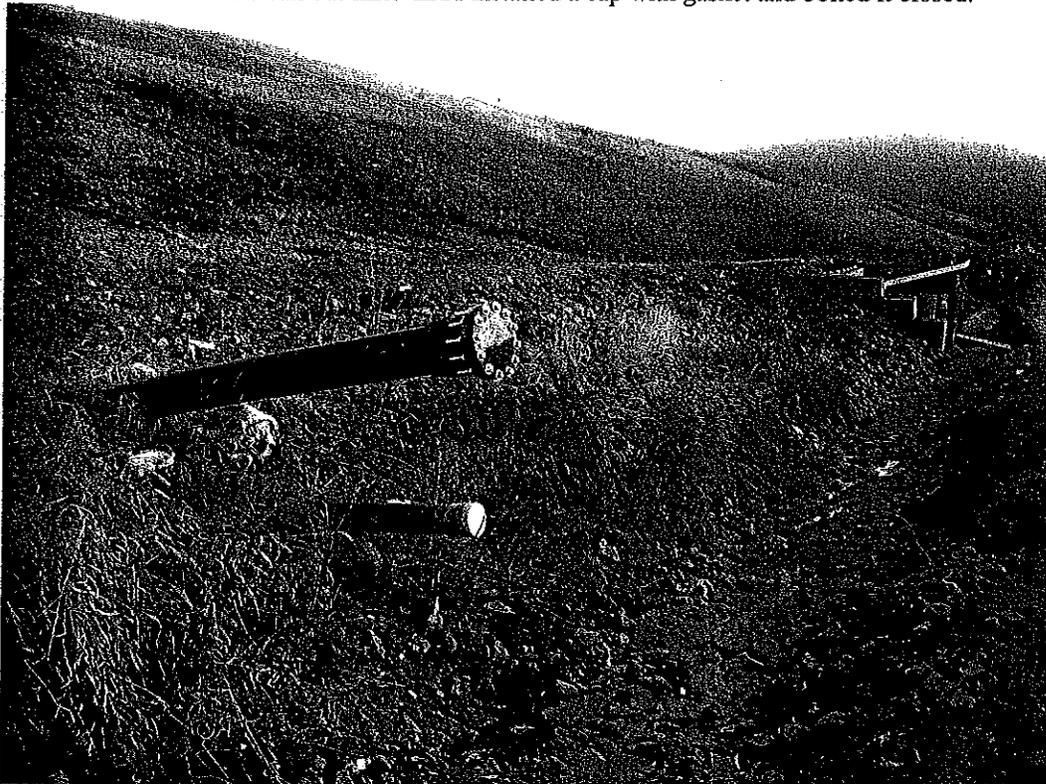
Photos of the leachate clean out line. IESI installed a cap with gasket and bolted it closed.
