Re: IESI PA Bethlehem Landfill
I.D. #100020
Lower Saucon Township, Northampton County

INSPECTION REPORT – MUNICIPAL WASTE LANDFILL

Site I.D. 255983
 Site Name IESI PA BETHLEHEM LANDFILL
 Address 2335 APPLEBUTTER RD

Inspection Date: 07/29/2014 Type: Routine Complete Inspection Results: **NO VIOLS** Resolved: / /

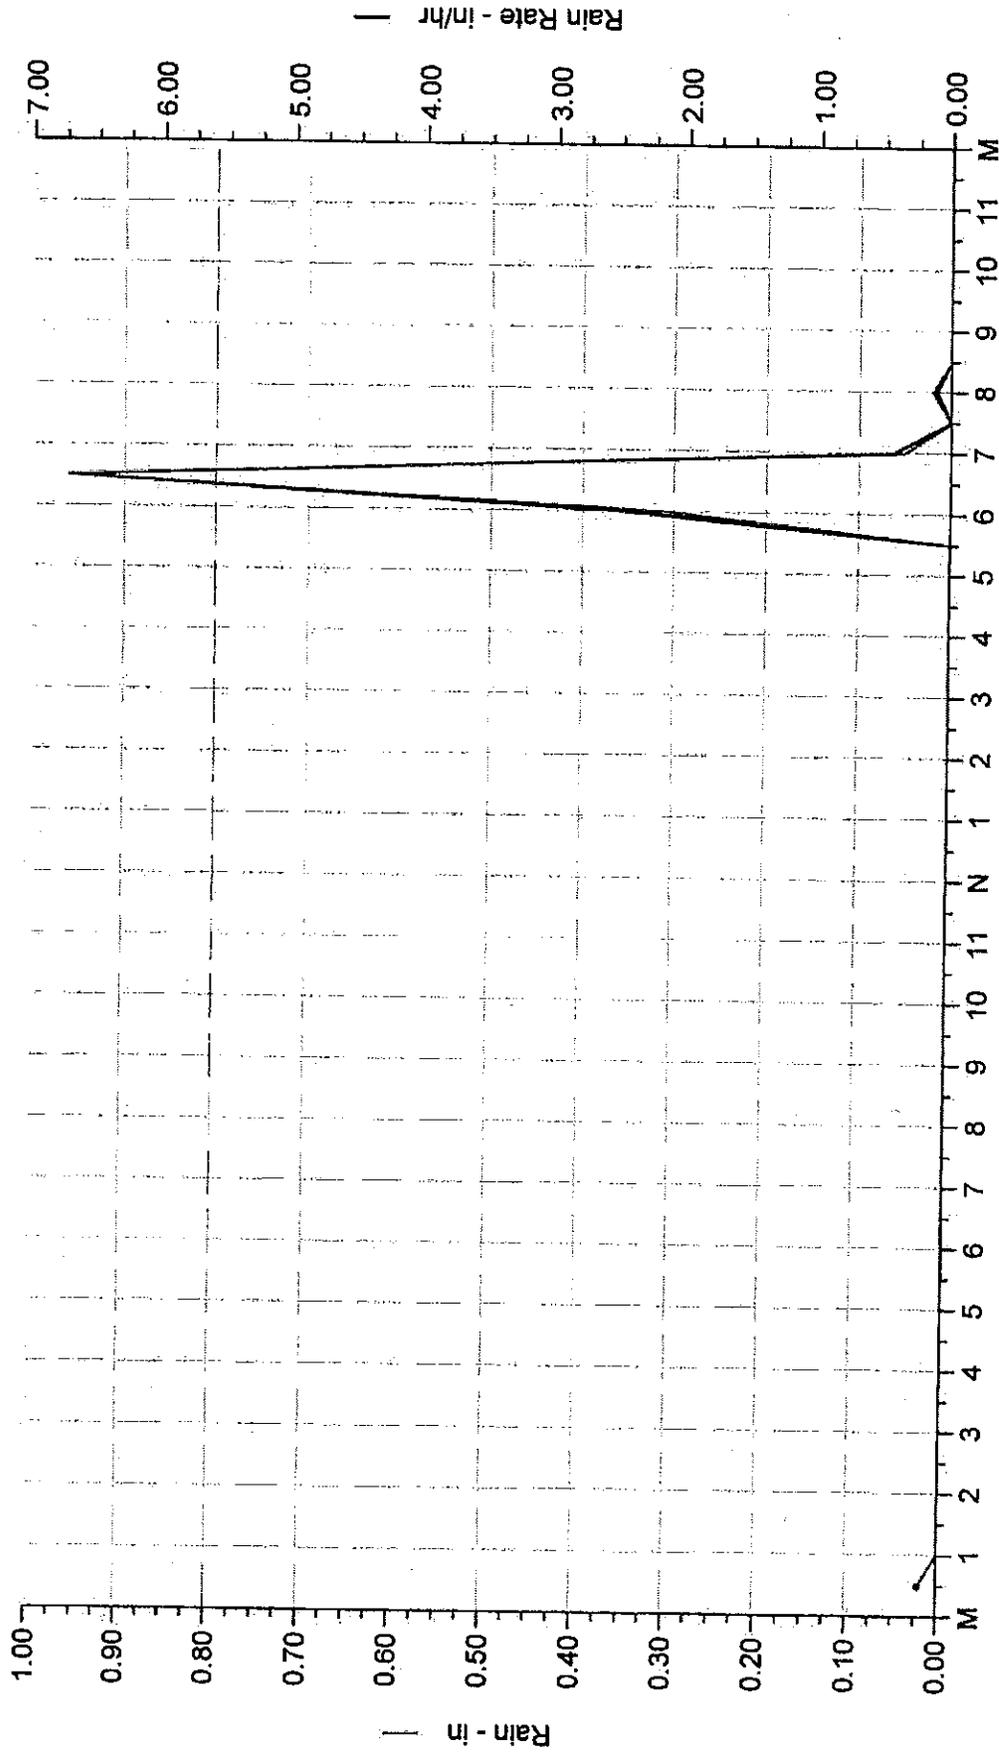
Mon Jul 14, 2014

■ Rain ■ Rain Rate

During this inspection, this inspector was given an overview of what happened during the storm water event on July 14, 2014. Please see the IESI Incident Report dated 07/14/2014, attached to this inspection report. Mr. Schleyer explained that to in order to mitigate the potential for future occurrences, Channel DS-2 is under construction down the newly capped area. This channel travels down the southern slope and discharges to Channel S (a three foot diameter, piped channel that flows parallel to Channel A and discharges to Basin 4). Channel DS-2 will collect water that is flowing along the benches of the south slope of the landfill and by-pass Channel A to Basin 4, lightening the amount of storm water Channel A has been collecting while the new capping area is under construction.

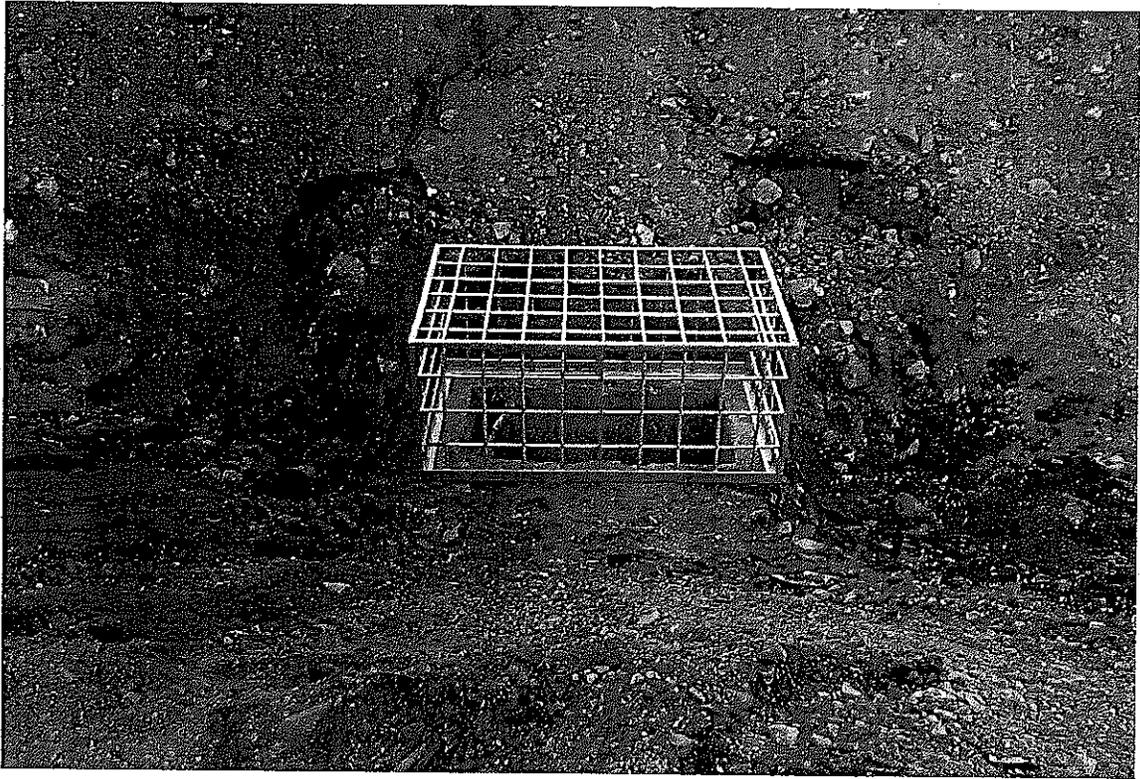
Latona installed the trash rack on the inlet into Basin 6 yesterday.

IESI is also upgrading Inlet 2 between Channel B and Channel A. Inlet 2 at the end of Channel B, discharges storm water to Basin 6. Currently, the inlet has a flat grate that is flush with the bottom of the channel. When storm water carries debris and silt down Channel B, Inlet 2 gets blocked and allows storm water to continue down through Channel A. The plan is to install an elevated cage to Inlet 2. Now when debris flows down channel, the front of the cage may get blocked but water will be allowed to flow around the blockage and down the sides of the inlet cage. This should allow storm water from Channel B to discharge to Basin 6 as designed. Again this lightens the load Channel A will receive during heavy rain events. As of August 1, 2014, the grate on Inlet 2 has been installed at the end of Channel B. See email and attached photo attached to this inspection report.
