Re: IESI PA Bethlehem Landfill
I.D. #100020
Lower Saucon Township, Northampton County

INSPECTION REPORT – MUNICIPAL WASTE LANDFILL

Inspection Date: 08/27/2014 Type: Routine Partial Results: **VIOLS** Resolved: / /
Inspection

INSPECTION REPORT COMMENTS

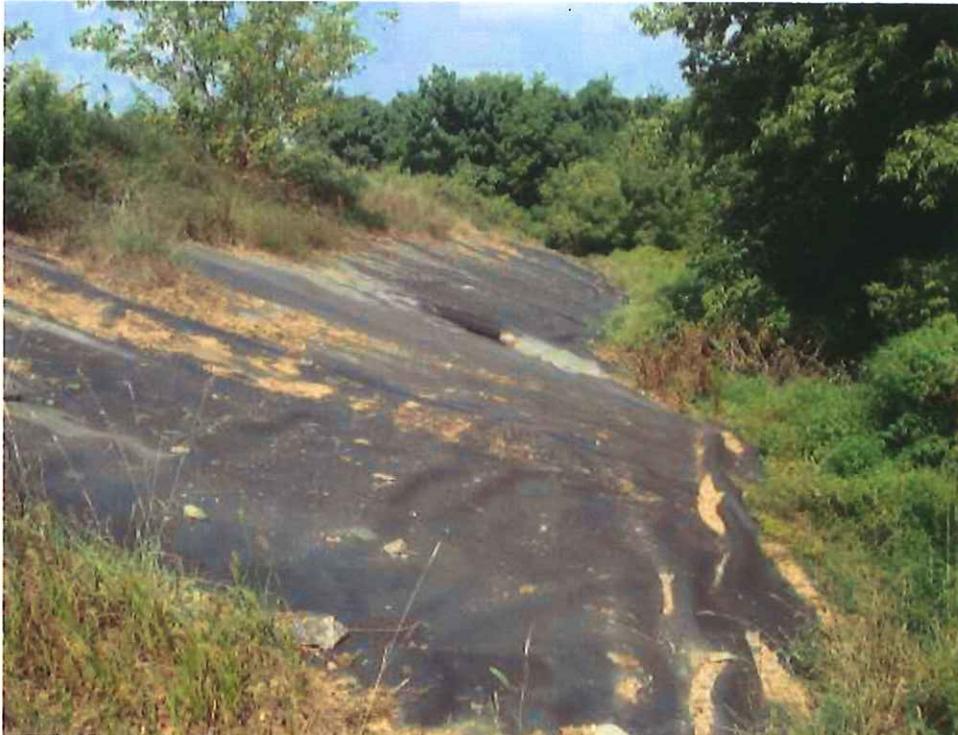
Photo of the liner of the sediment trap at the eastern side of the old landfill (Phase I area). This is not the cap of the landfill. The cap of the landfill is under this protective liner. No odors or gas emissions observed during the time of this inspection.

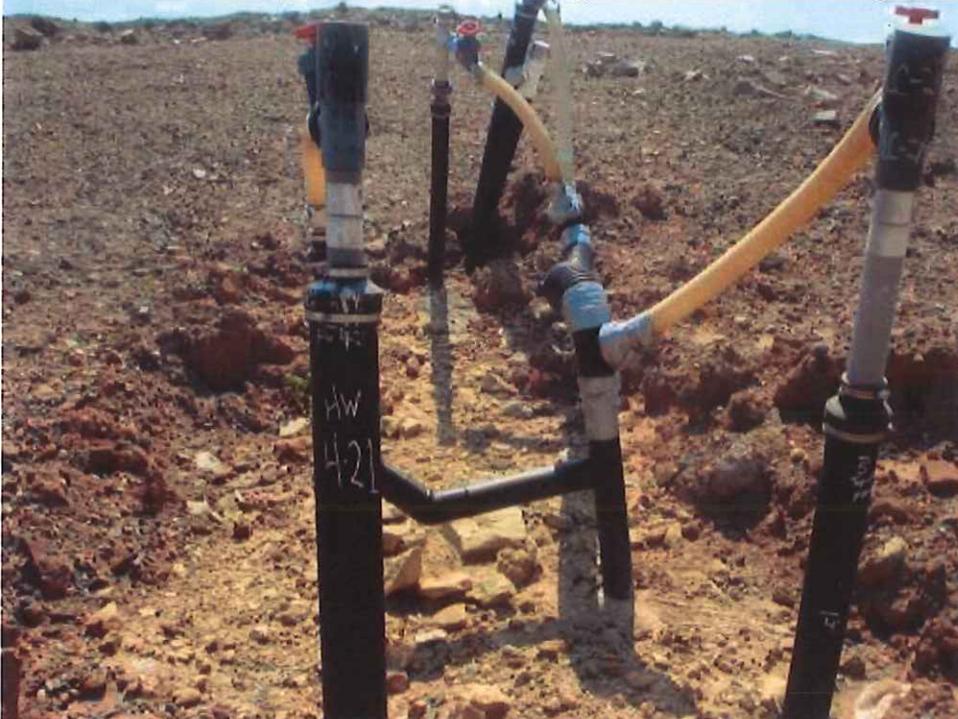
Photo of gas well HW 4-21 in Cell 4F. In the area around this gas well, two holes in the intermediate cover were observed having odors and gas emissions during the time of this inspection.

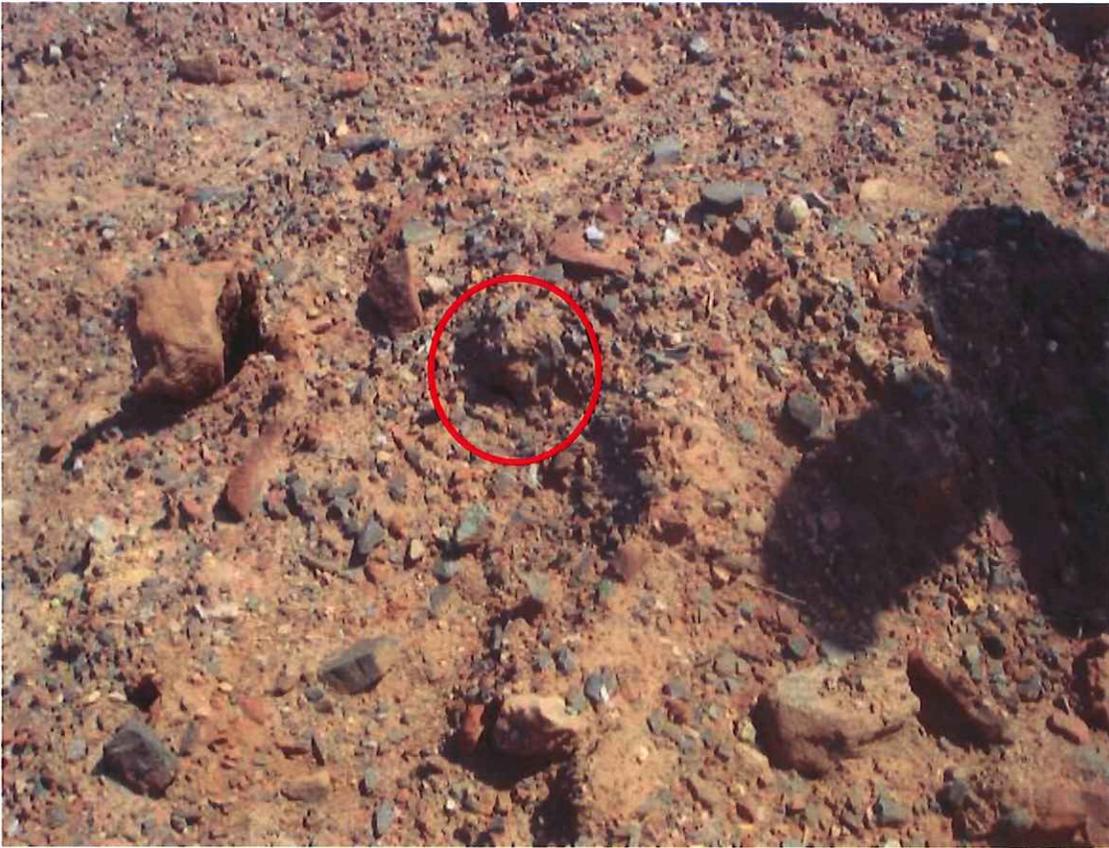
Cell 4F, created by the MSE wall, and Cells 4B, 4C and parts of Cell 4D and 4A were also inspected by this inspector along with Ms. Redding, Ms. Wagoner, and Mr. Tyler. During the tour, cracks and holes in the intermediate cover were observed in Cell 4F, and at the top of the landfill in Cell 4B. In the area of these breaches in the intermediate cover, strong landfill gas odors were observed. Also observed, were areas at the top of the landfill where solid waste was sticking through the intermediate cover. Gas wells on the cells mentioned above were also determined to have gas emissions during the time of this inspection. For details regarding data collected during this part of the inspection, please refer to the Department's Air Quality Inspection Report, completed by Ms. Redding, dated, 08/27/2014.

- 1) IESI PA Bethlehem Landfill failed to operate the landfill in accordance with approved plans and permit in violation of 25 Pa Code § 273.201(c)(2), detailed in violation #2.
- 2) IESI PA Bethlehem Landfill failed to maintain intermediate cover so as to prevent odors and to cover solid waste after it is placed without change in its properties and without regard to weather in violation of 25 Pa Code § 273.233(b)(1) and 25 Pa Code § 273.233(b)(2); specifically, the intermediate cover over Cells 4F, 4B, and 4C were not maintained to prevent holes and cracks where odors were able to escape and where solid waste was visible through the intermediate cover.

Hole in intermediate cover adjacent HW 4-21 where strong landfill gas odors/gas emissions were observed during the time of the inspection.

On August 28, 2014, Sam Donato, IESI PA District Manager, sent an email to the Department outlining corrections made to remediate the violations observed during the time of the inspection. Mr. Donato reported that IESI completed the placement of additional cover soils where surface gas emissions were identified. Corrective measures to gas wells where surface gas emissions where observed began on August 28, 2014 and are expected to be completed by August 29, 2014. In ten days, IESI's consultant will be back on site to re-evaluate the corrective measures that were completed.

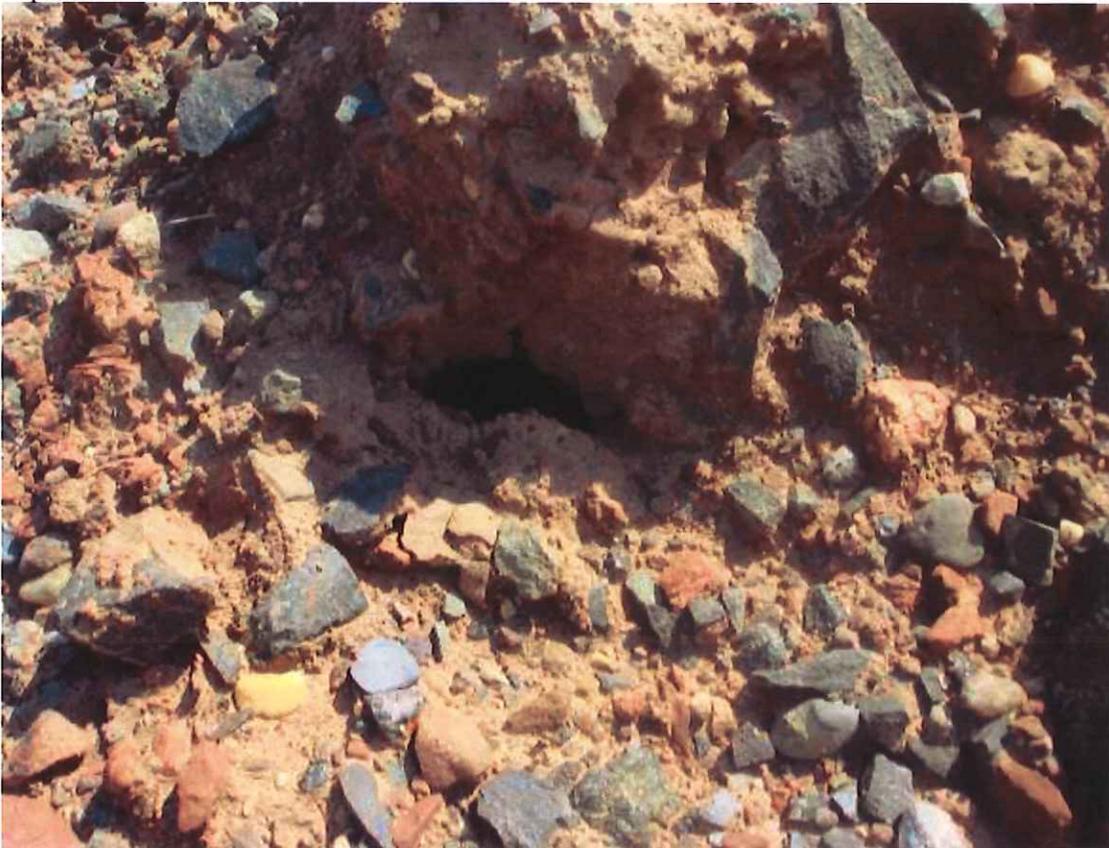
Close-up of the hole from the previous photo.

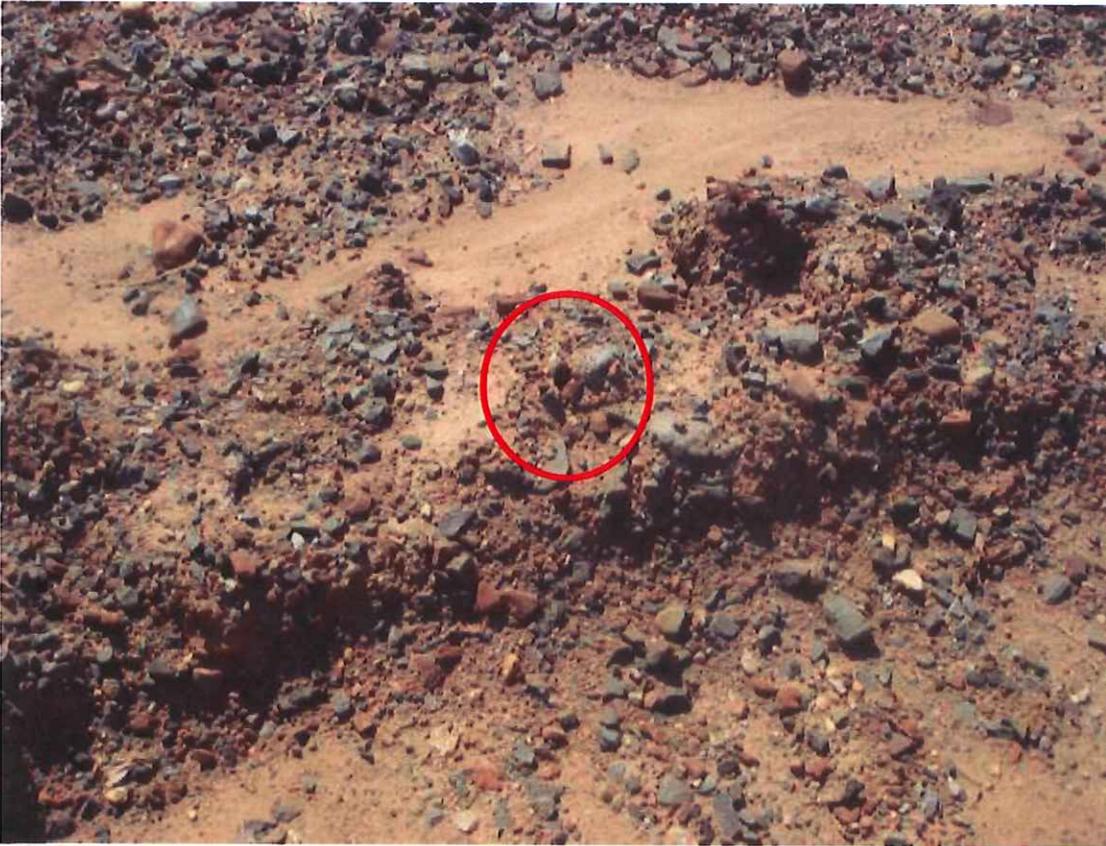
Hole in intermediate cover adjacent HW 4-21 where strong landfill gas odors/gas emissions were observed during the time of the inspection.

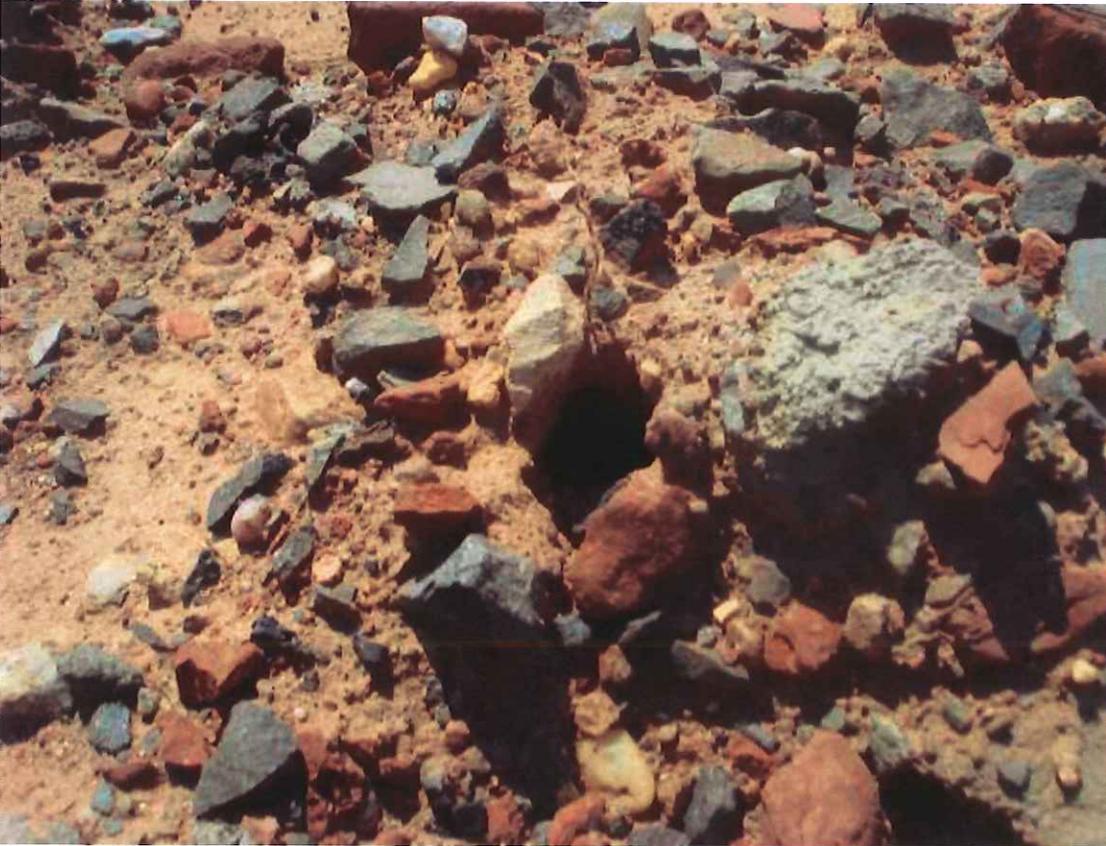
Close-up of hole from previous photo.

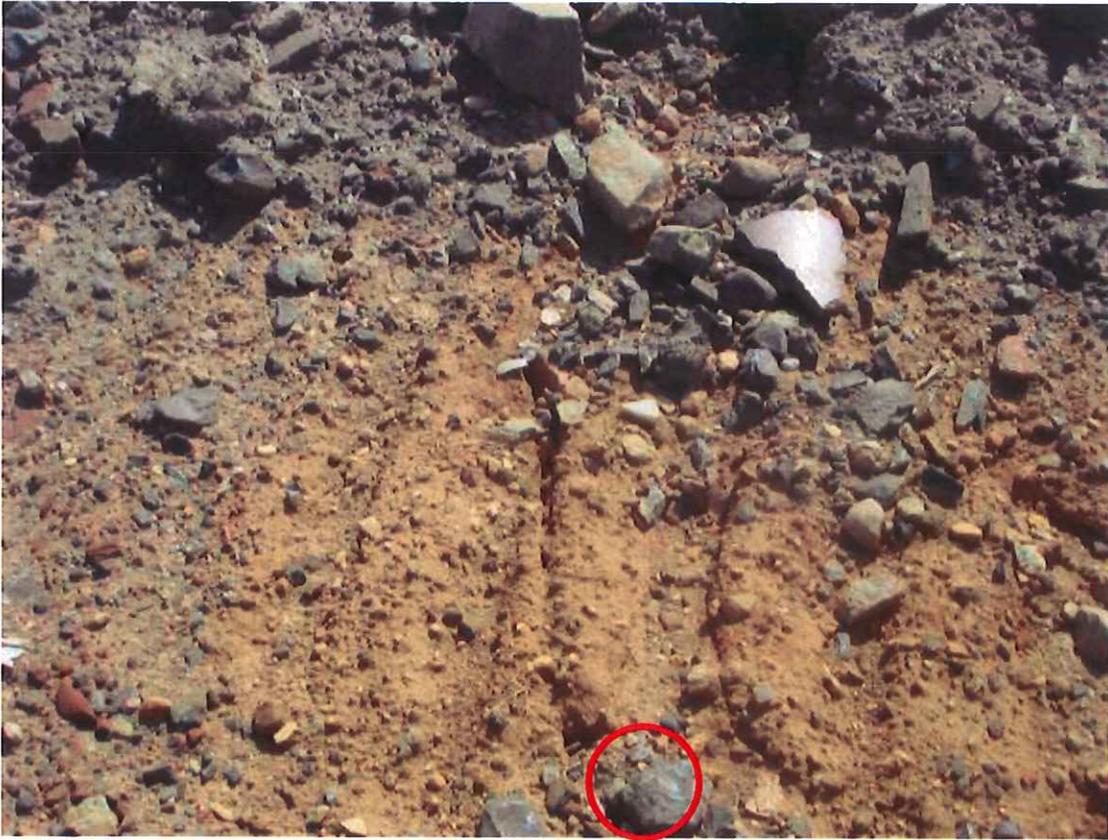
A minor erosion channel and crack where strong landfill gas odors/gas emissions were observed during the time of the inspection.

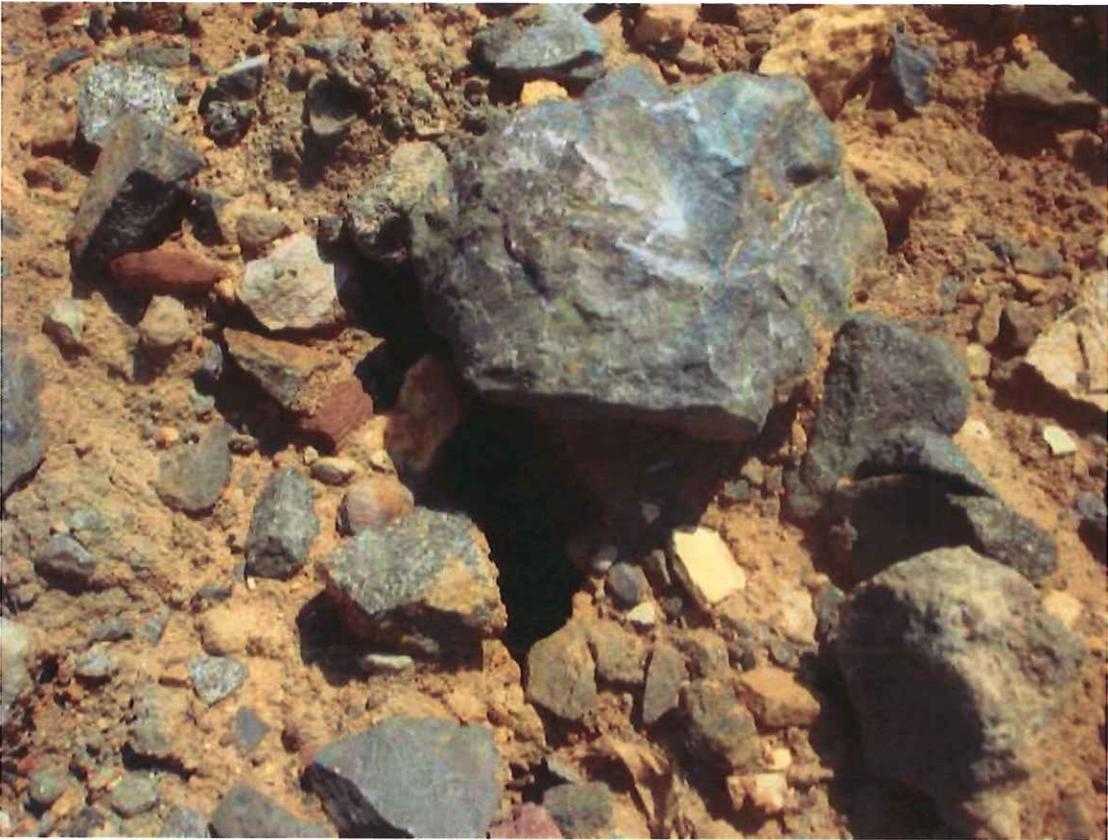
Close-up of crack under a rock from the bottom of the previous photo.

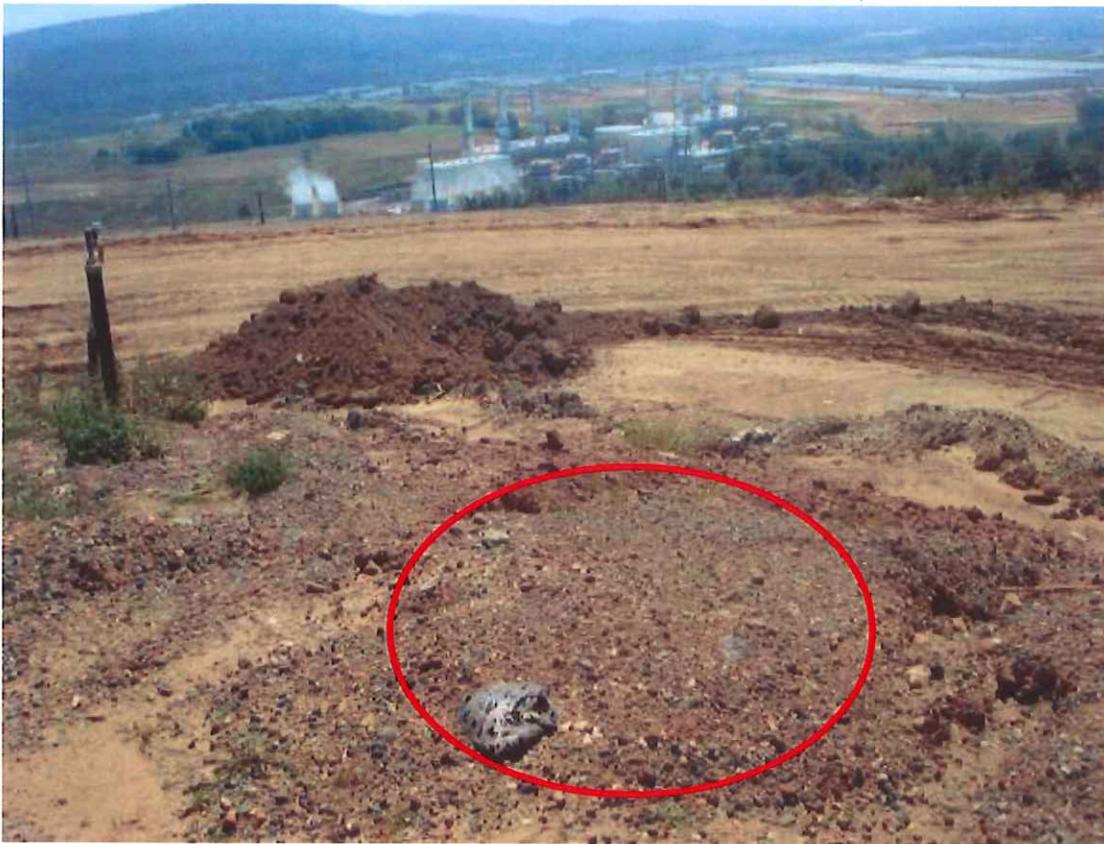
Area at the top of the landfill in Cell 4B, where garbage bags containing waste were observed sticking through the intermediate cover.

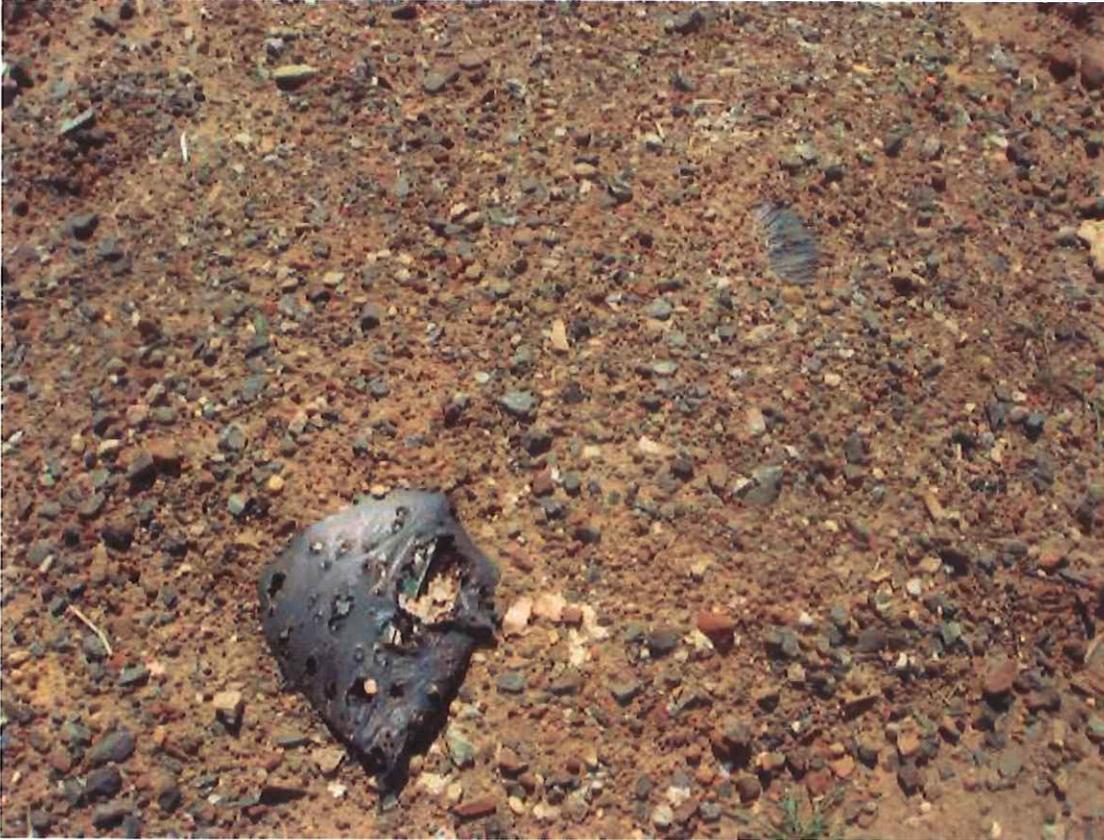
Close-up of the garbage bags from the previous photo.

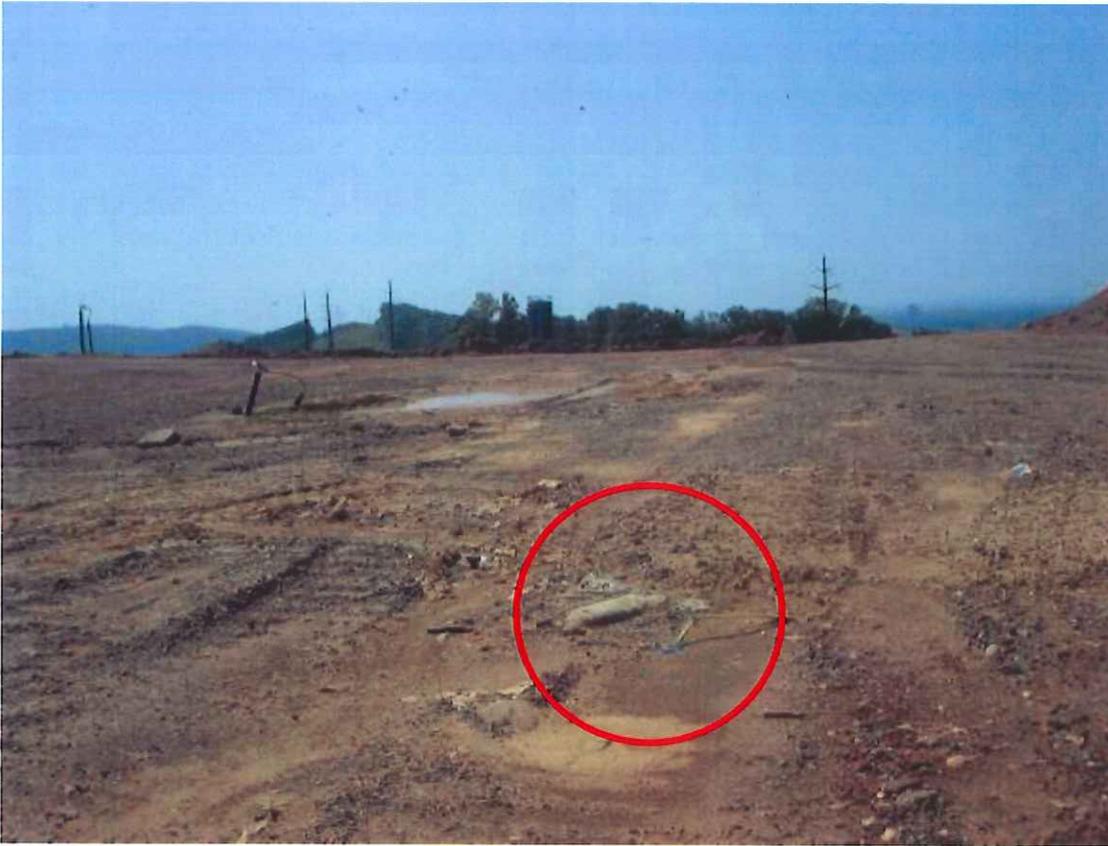
Area at the top of the landfill in Cell 4B, where a roll of carpeting was observed sticking through the intermediate cover.

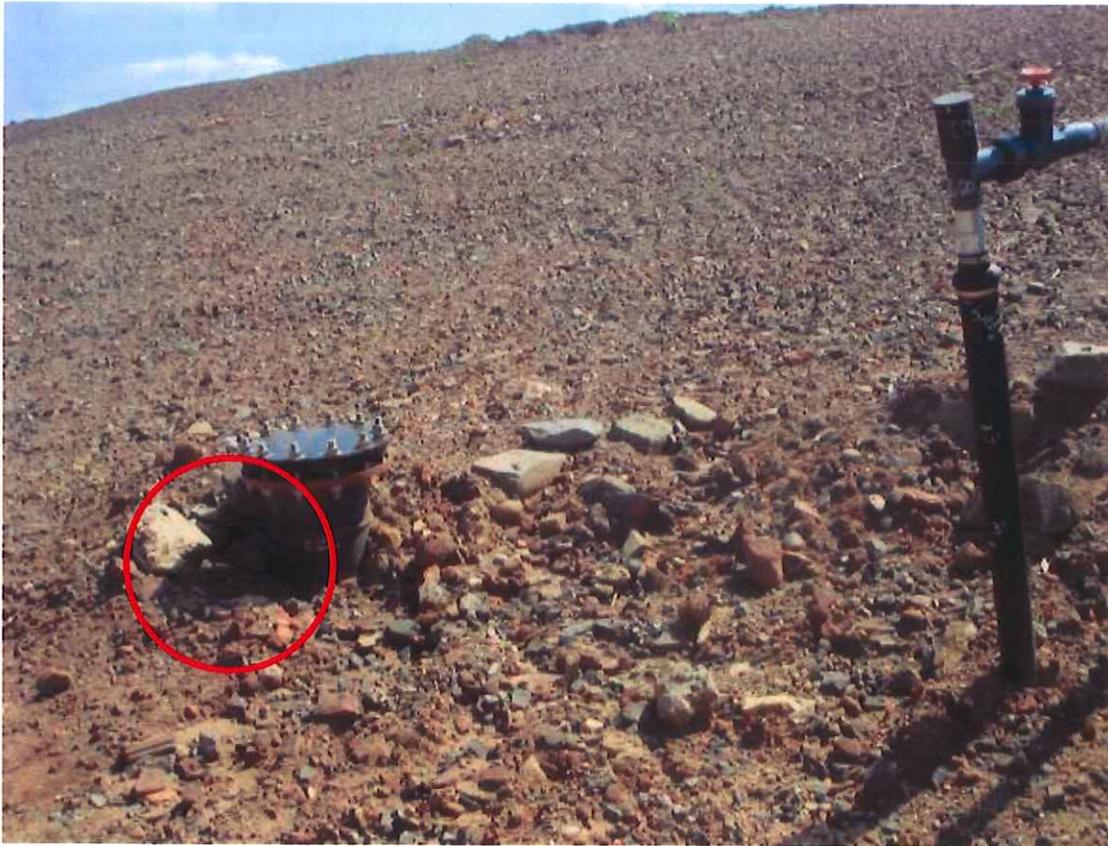
Hole in intermediate cover adjacent LC-20 where strong landfill gas odors/gas emissions were observed during the time of the inspection.

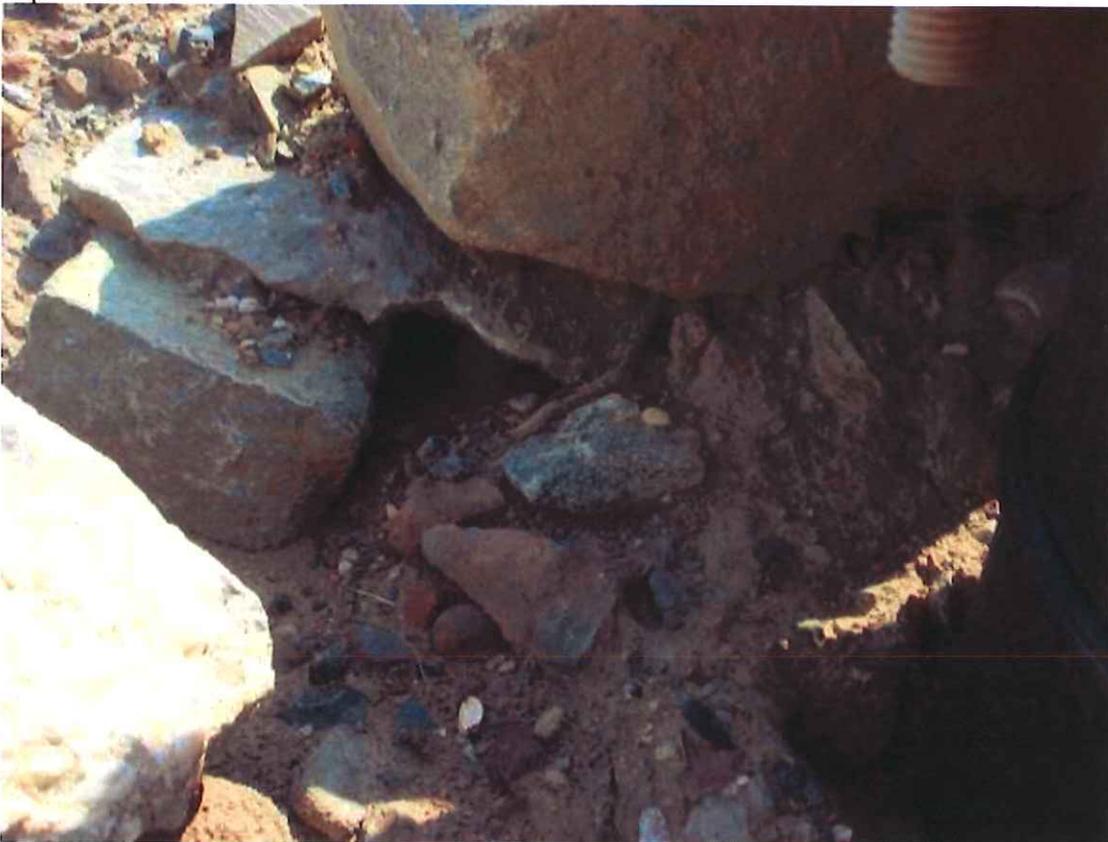
Close-up of the hole from the previous photo.

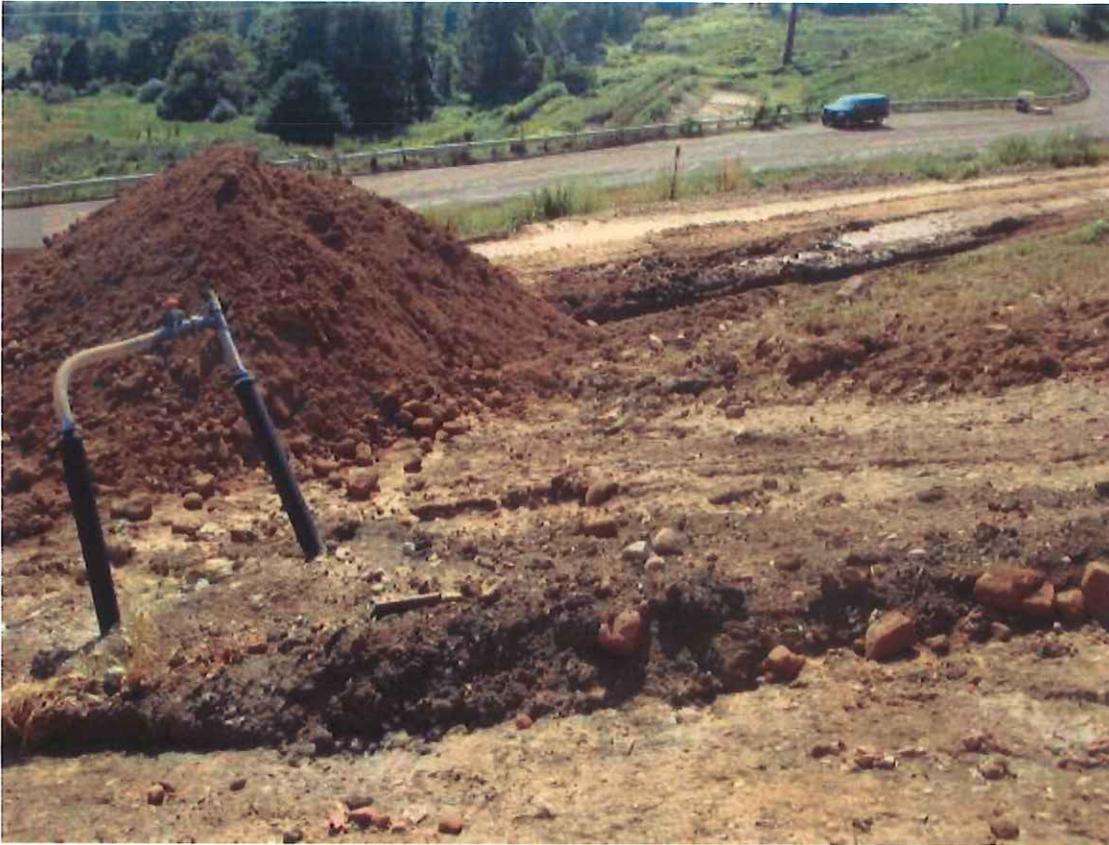
Soil stockpiled on Cell 4C to repair erosion on the southern slope of the landfill.

On September 12, 2014, Sam Donato and Al Schleyer met with Dean Fisher, Department Solid Waste Supervisor, Andy Schweitzer, Department Air Quality Supervisor, and this inspector to discuss the corrective measures completed by IESI to resolve issues noted during the last inspection. Mr. Donato stated that the intermediate cover issues had been remediated on August 28, 2014. Corrective measures to gas wells where surface gas emissions where observed were completed on August 29, 2014. On September 5, 2014, IESI's consultant completed the re-evaluation of the corrective measures on the gas wells and found no exceedances. Mr. Donato also explained that IESI began the installation of new gas wells in the area of Cells 4F, 4B, and 4D on September 3, 2014. IESI plans to install approximately sixteen new gas wells, four of which have been installed as of September 12, 2014. Mr. Donato also stated that IESI plans to revegetate the southern slope of the landfill to help minimize the potential for surface erosion. Mr. Donato stated that due to the drought condition in August, re-vegetation of the southern slope had been delayed.

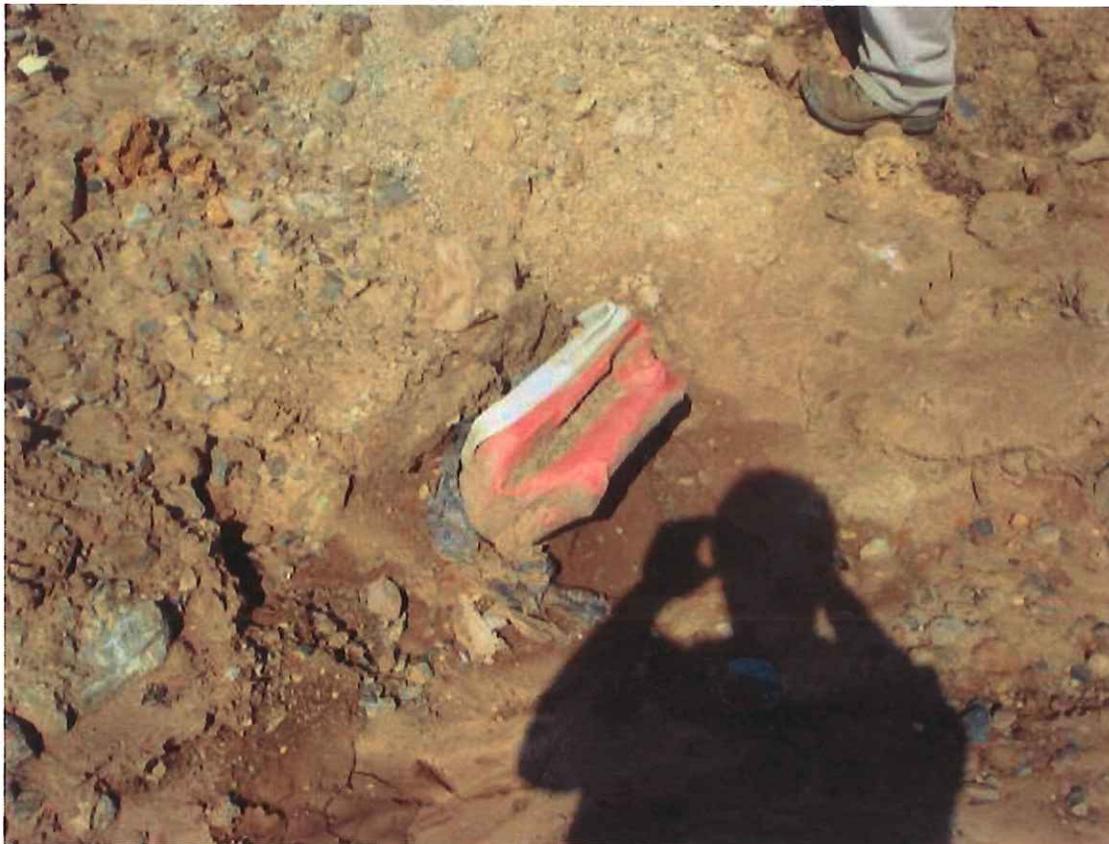
Crushed lunch cooler on the south slope of Cell 4C.

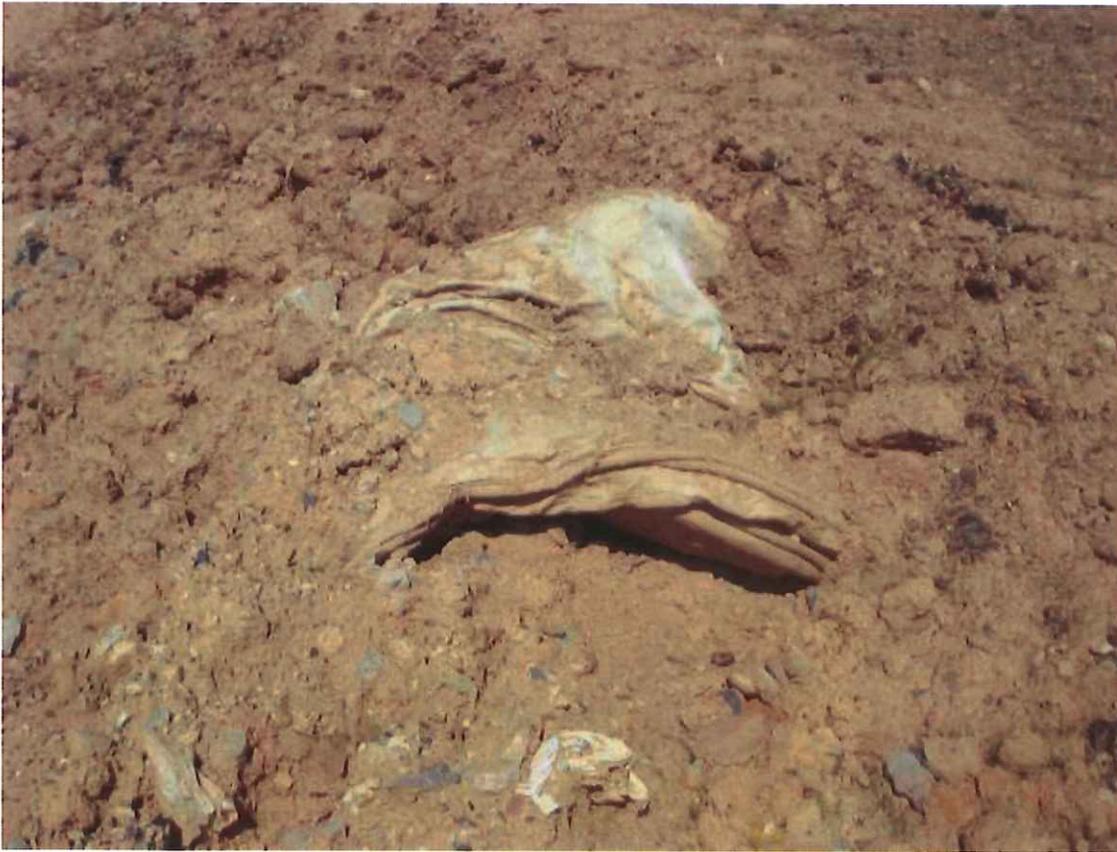
Partially buried mattress in Cell 4C.

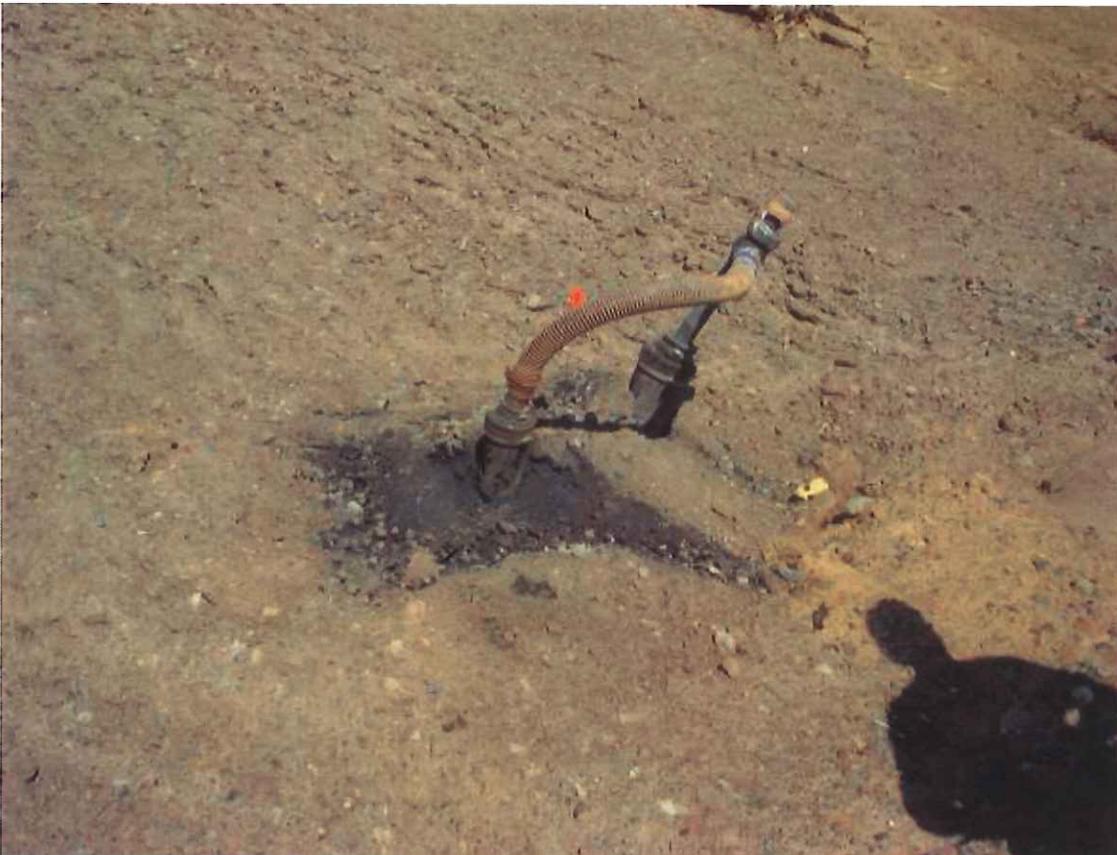
Gas well EW 4-18 with discolored soil around it. Strong landfill gas odor was observed around this gas well.
