RE: Inspection Conducted on January 6, 2022
 Bethlehem Landfill
 Hanover Project LS90-7

The purpose of this letter is to report the results of the above-referenced inspection. The inspection was conducted by the undersigned along with Phillip Garcia, Operations Supervisor. The following items were noted during the inspection:

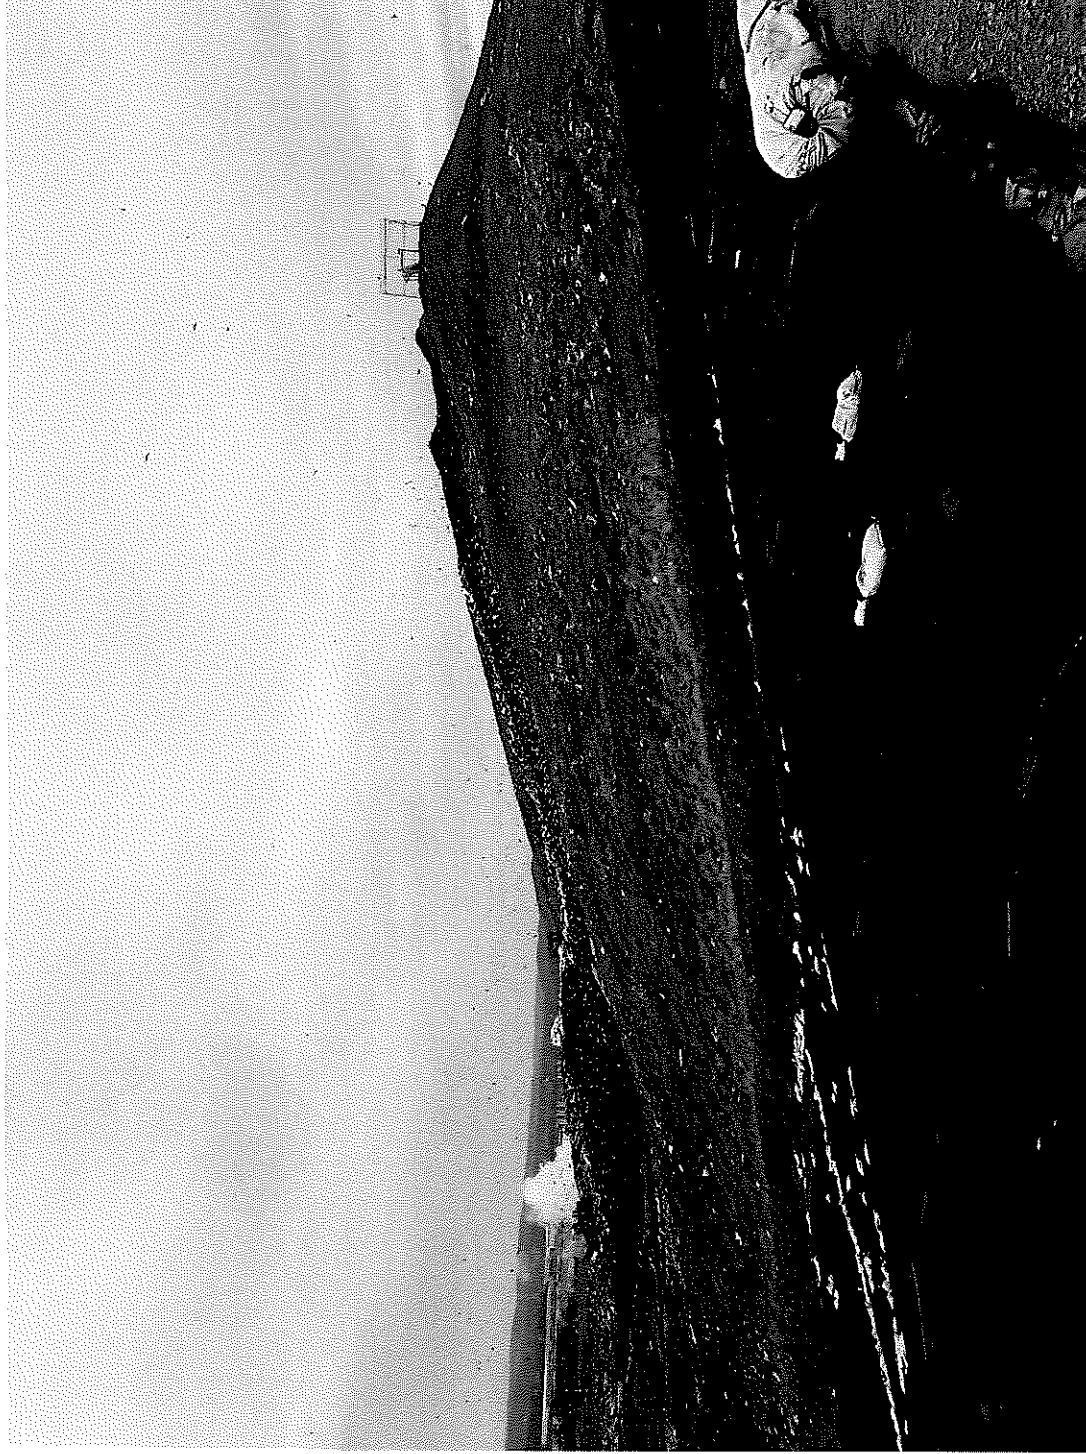
Photo 1

5. The truck wash refurbishing project was completed and observed in use. The shaker grate is being utilized.
6. BL has brought the waste pack up to the required grades in cell 4-F and has started placing the cover soil in preparation for the final capping of cell 4. The current working face is in cell SE-2AB Phase I along the western side. The waste is being dumped at the northwest corner of the cell which is at the very top of the landfill and is being pushed down the side slope several hundred feet to the actual disposal area (see Photos 1 and 2).
