Inspection 3348965
Field Code NA

INSPECTION REPORT – MUNICIPAL WASTE LANDFILL

Site I.D. 255983
Site Name Bethlehem Landfill Company
Address 2335 Applebutter Road
Bethlehem, PA 18015
Municipality Lower Saucon Township
Responsible Official Astor Lawson
Person Interviewed Astor Lawson, Cody White
Inspector Mathew Vipond
eFACTS ID # PF 268729

Inspection Date: 04/18/2022 Type: RTNC Results: **OUTST** Resolved: / /
Permit Expiration Date: 4 / 17 / 2023 Days/Week Operated: 6 Max. Daily Volume: 1800

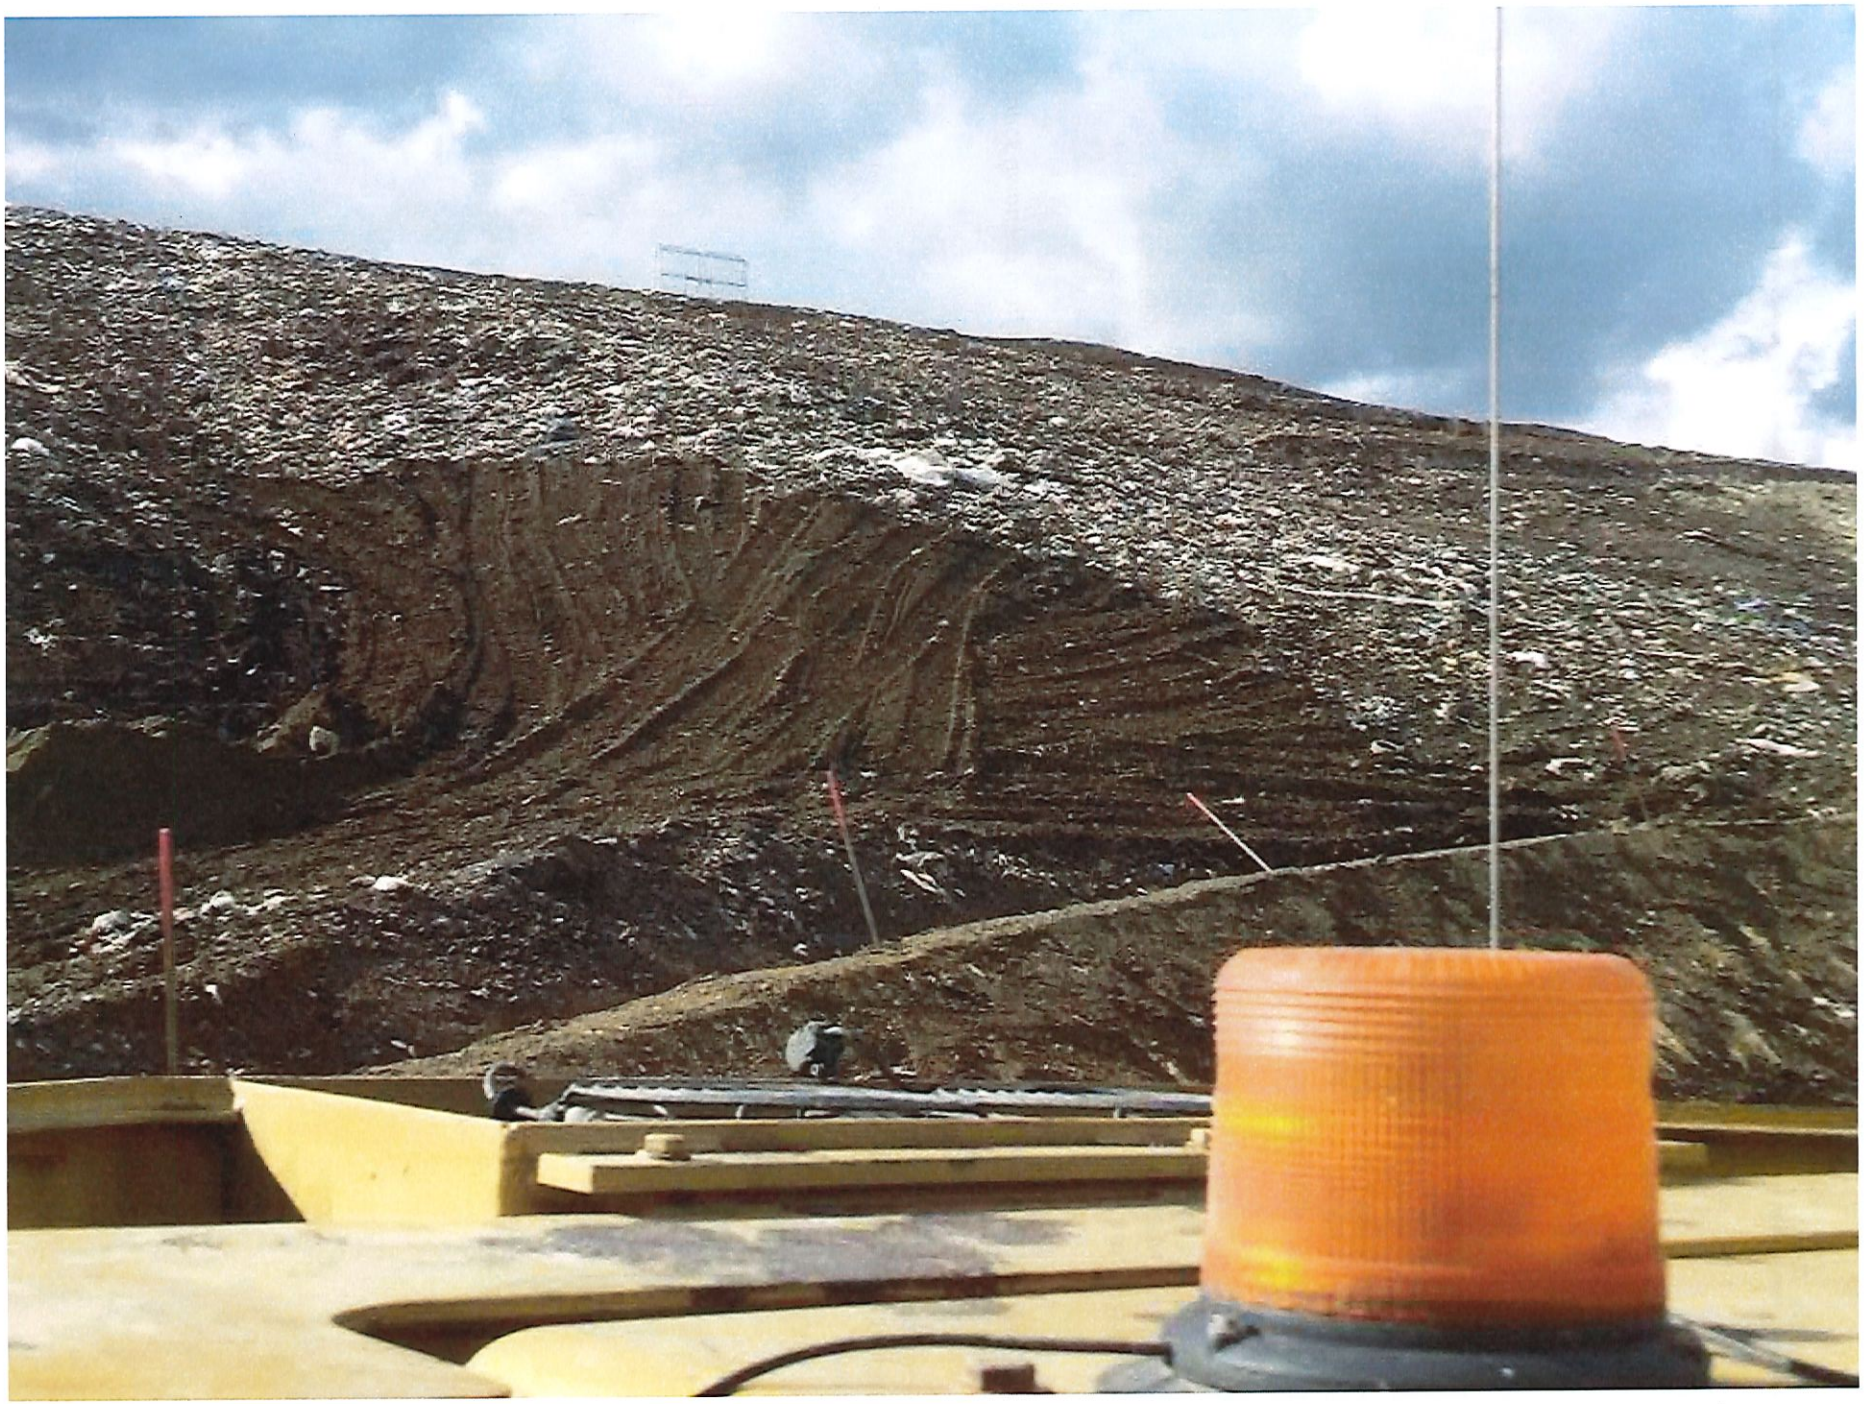
Could you please send me photos of the covered waste at the end of the working day? I would like to see the tarped waste at the toe of the pad where you are currently tipping as well as the larger slope opposite it that we discussed yesterday. I attached the photo from yesterday for the perspective I am talking about.
